# Dexter-Huron Metropark Stormwater Management Plan

September 2019

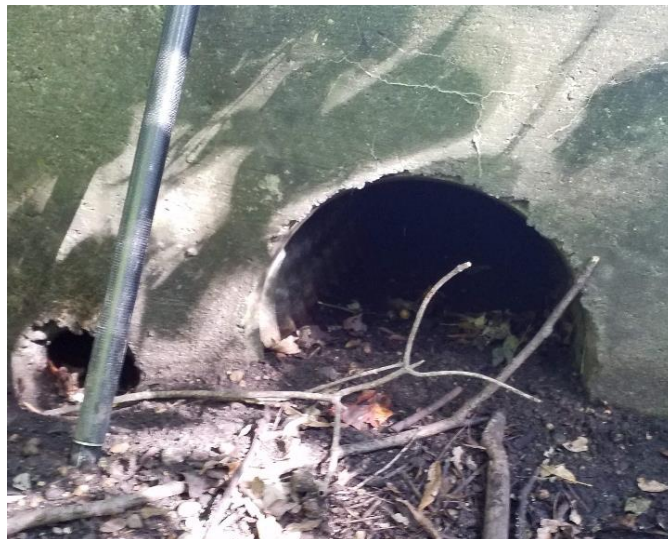
Left: Moderate culvert in Dexter-Huron Metropark. Right: Proportion of culverts in each condition category.

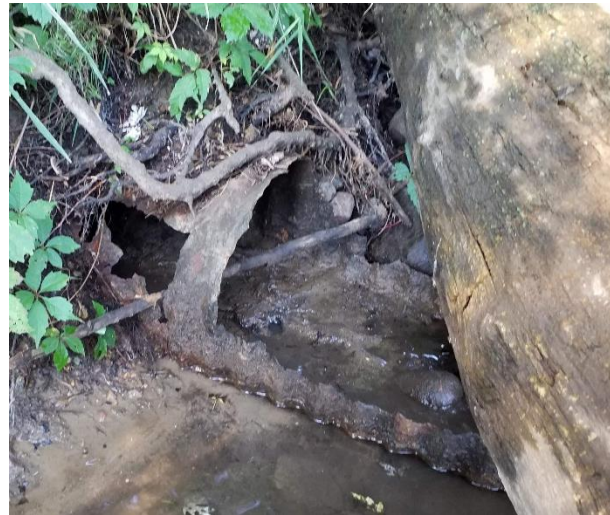
Left: Proportion of outfalls in each condition category. Right: Outfall in failing condition in Dexter-Huron Metropark.

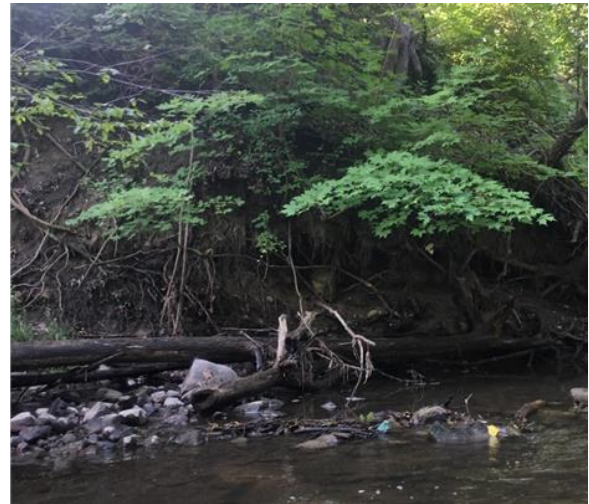
*Left: Proportion of stream bank in each erosion severity category. Right: High erosion on a bank in Dexter-Huron Metropark.*

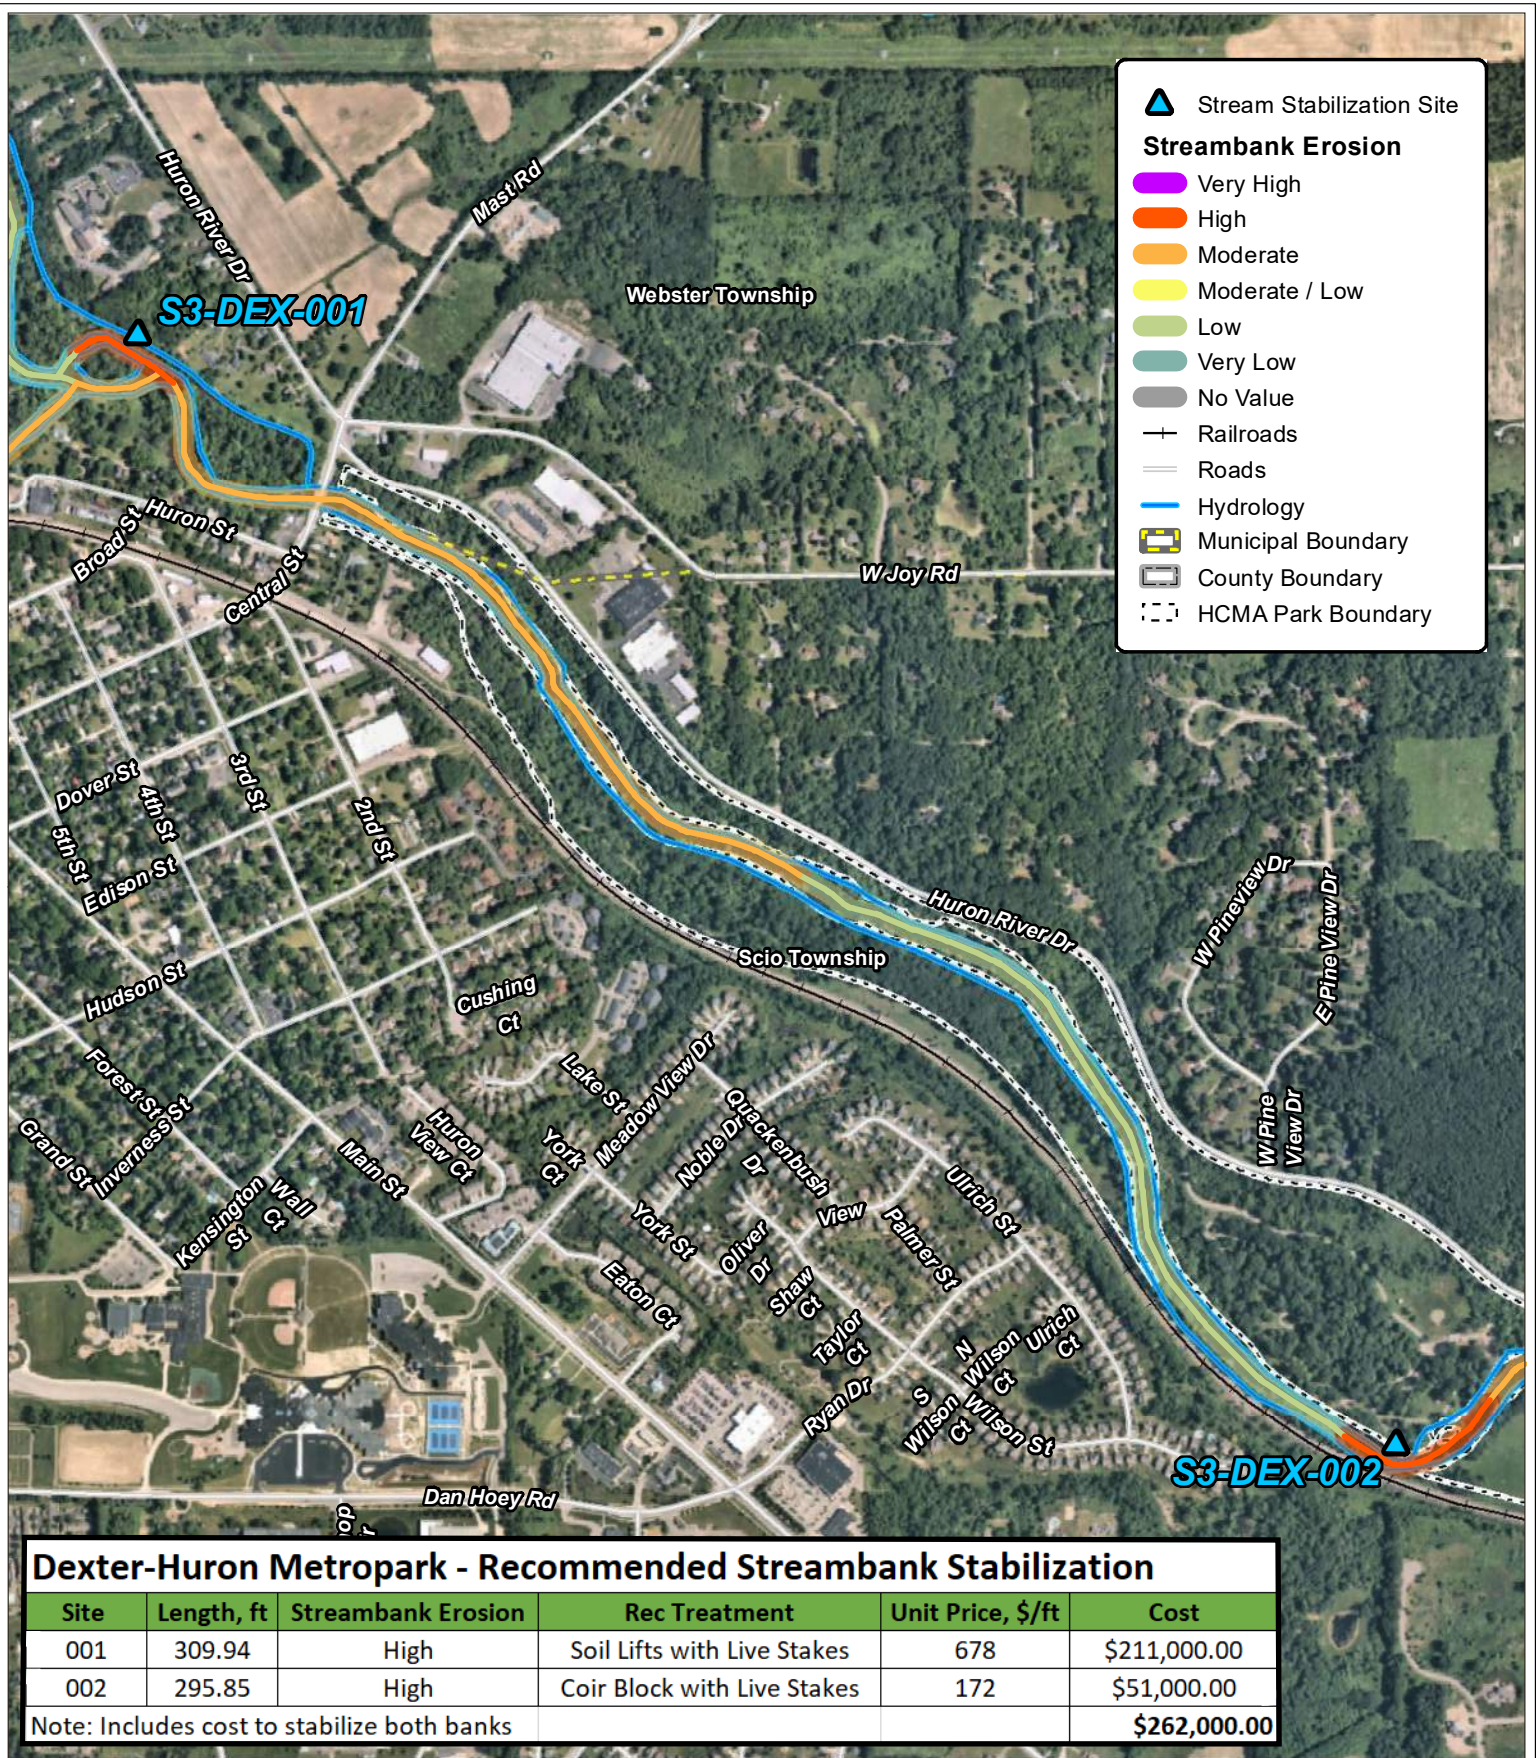
### S3-DEX-001

Length: 309.94 ft

Recommended Treatment: Soil Lifts with Live Stakes

Construction Cost: \$211,000
