HURON-CLINTON
metroparks

Huron-Clinton Metropolitan Authority Stormwater Management Plan

September 2019

Stormwater Management Plan Executive Summary

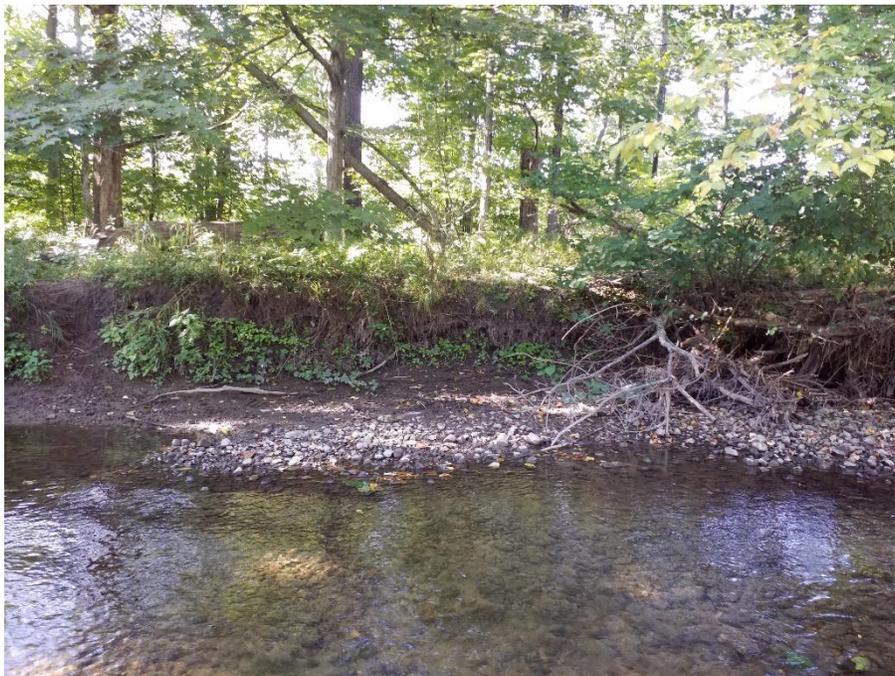
Figure 2. Photo of high erosion at Kensington Metropark.
