HURON-CLINTON
metroparks

Hudson Mills Metropark Stormwater Management Plan

September 2019

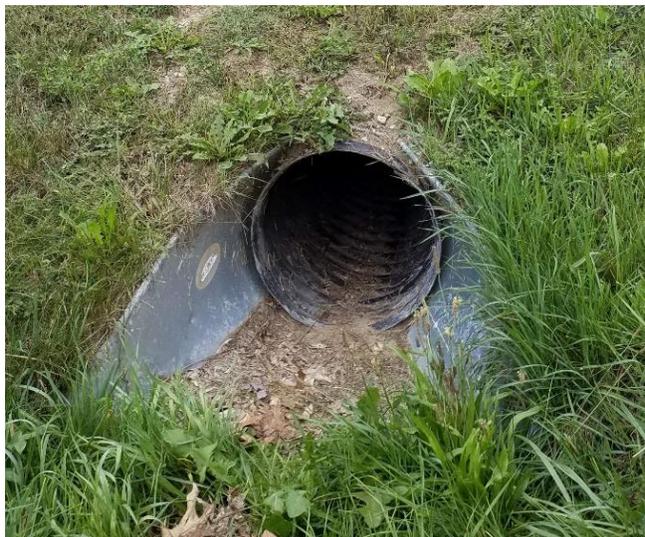
Left: Moderate culvert in Hudson Mills Metropark. Right: Proportion of culverts in each condition category.

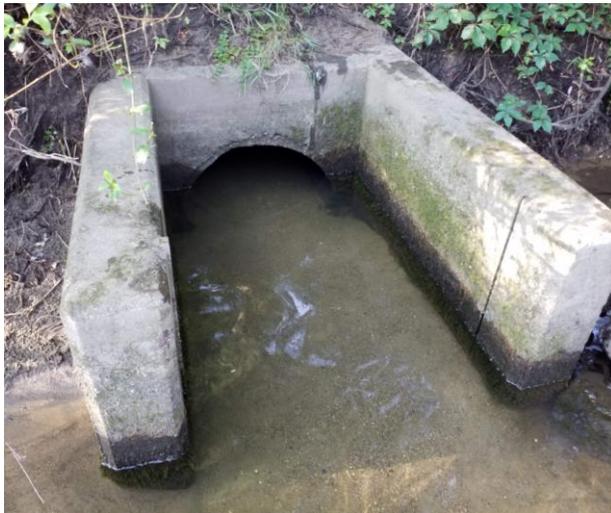
Left: Fair outfall in Hudson Mills Metropark. Right: Proportion of outfalls in each condition category.

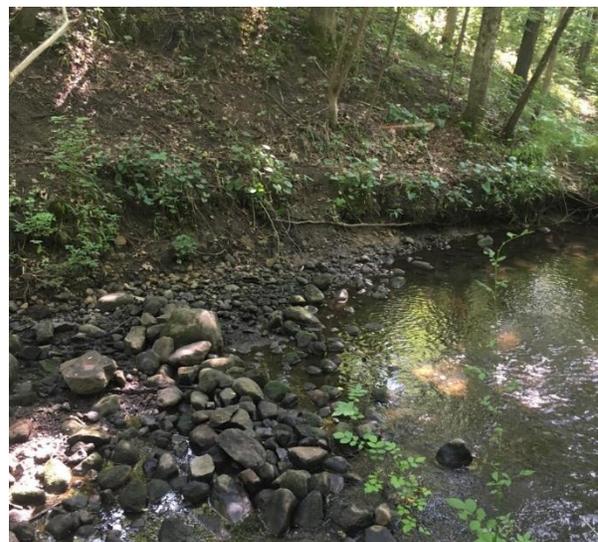
Left: Proportion of stream bank in each erosion severity category. Right: Severe erosion on a bank in Hudson Mills Metropark.

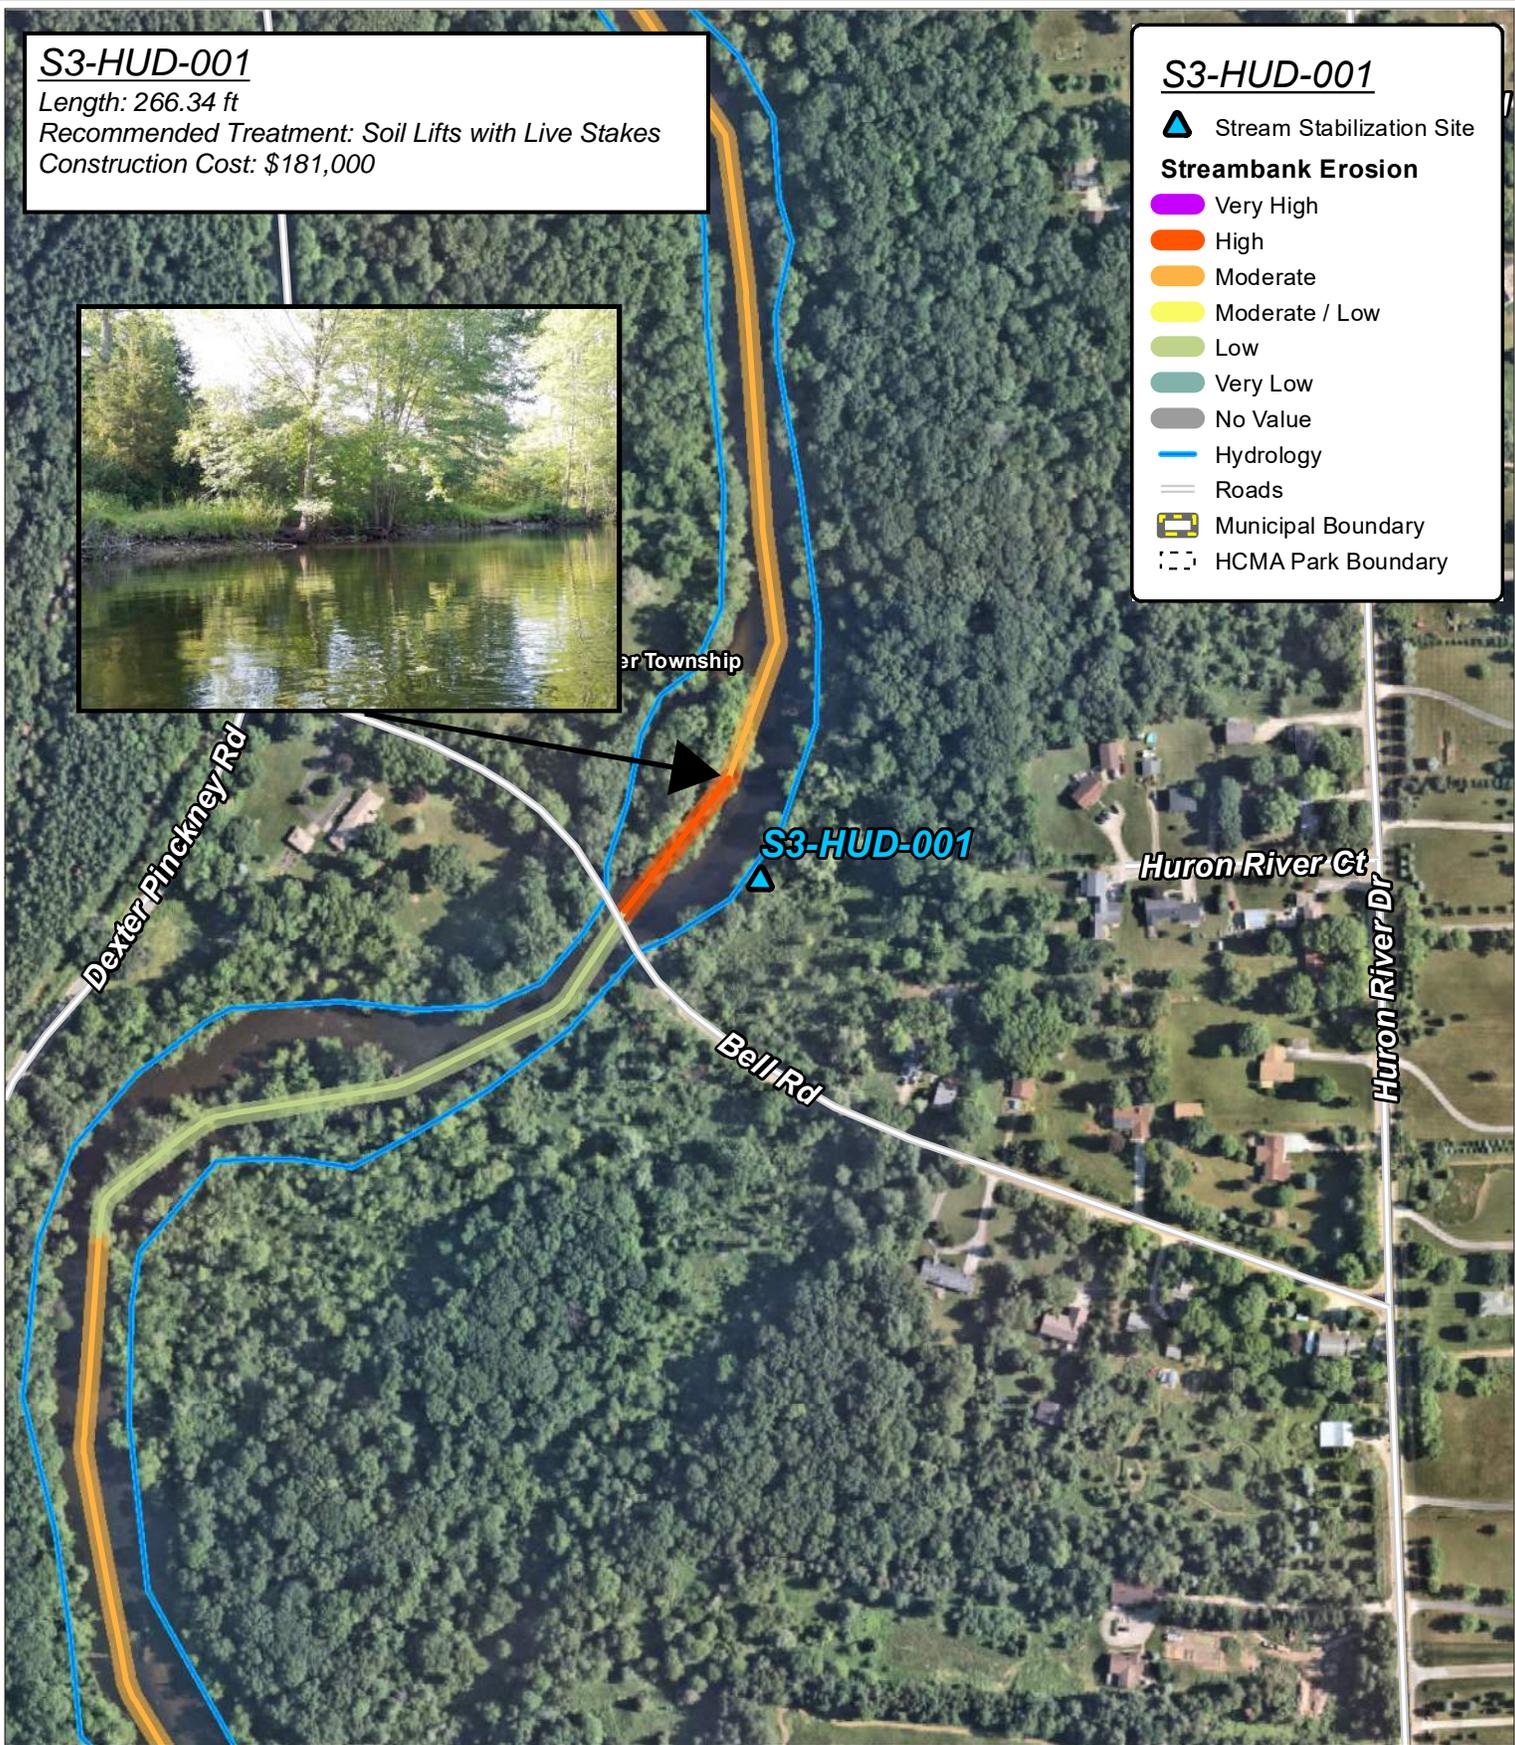
S3-HUD-001

Length: 266.34 ft

Recommended Treatment: Soil Lifts with Live Stakes

Construction Cost: \$181,000

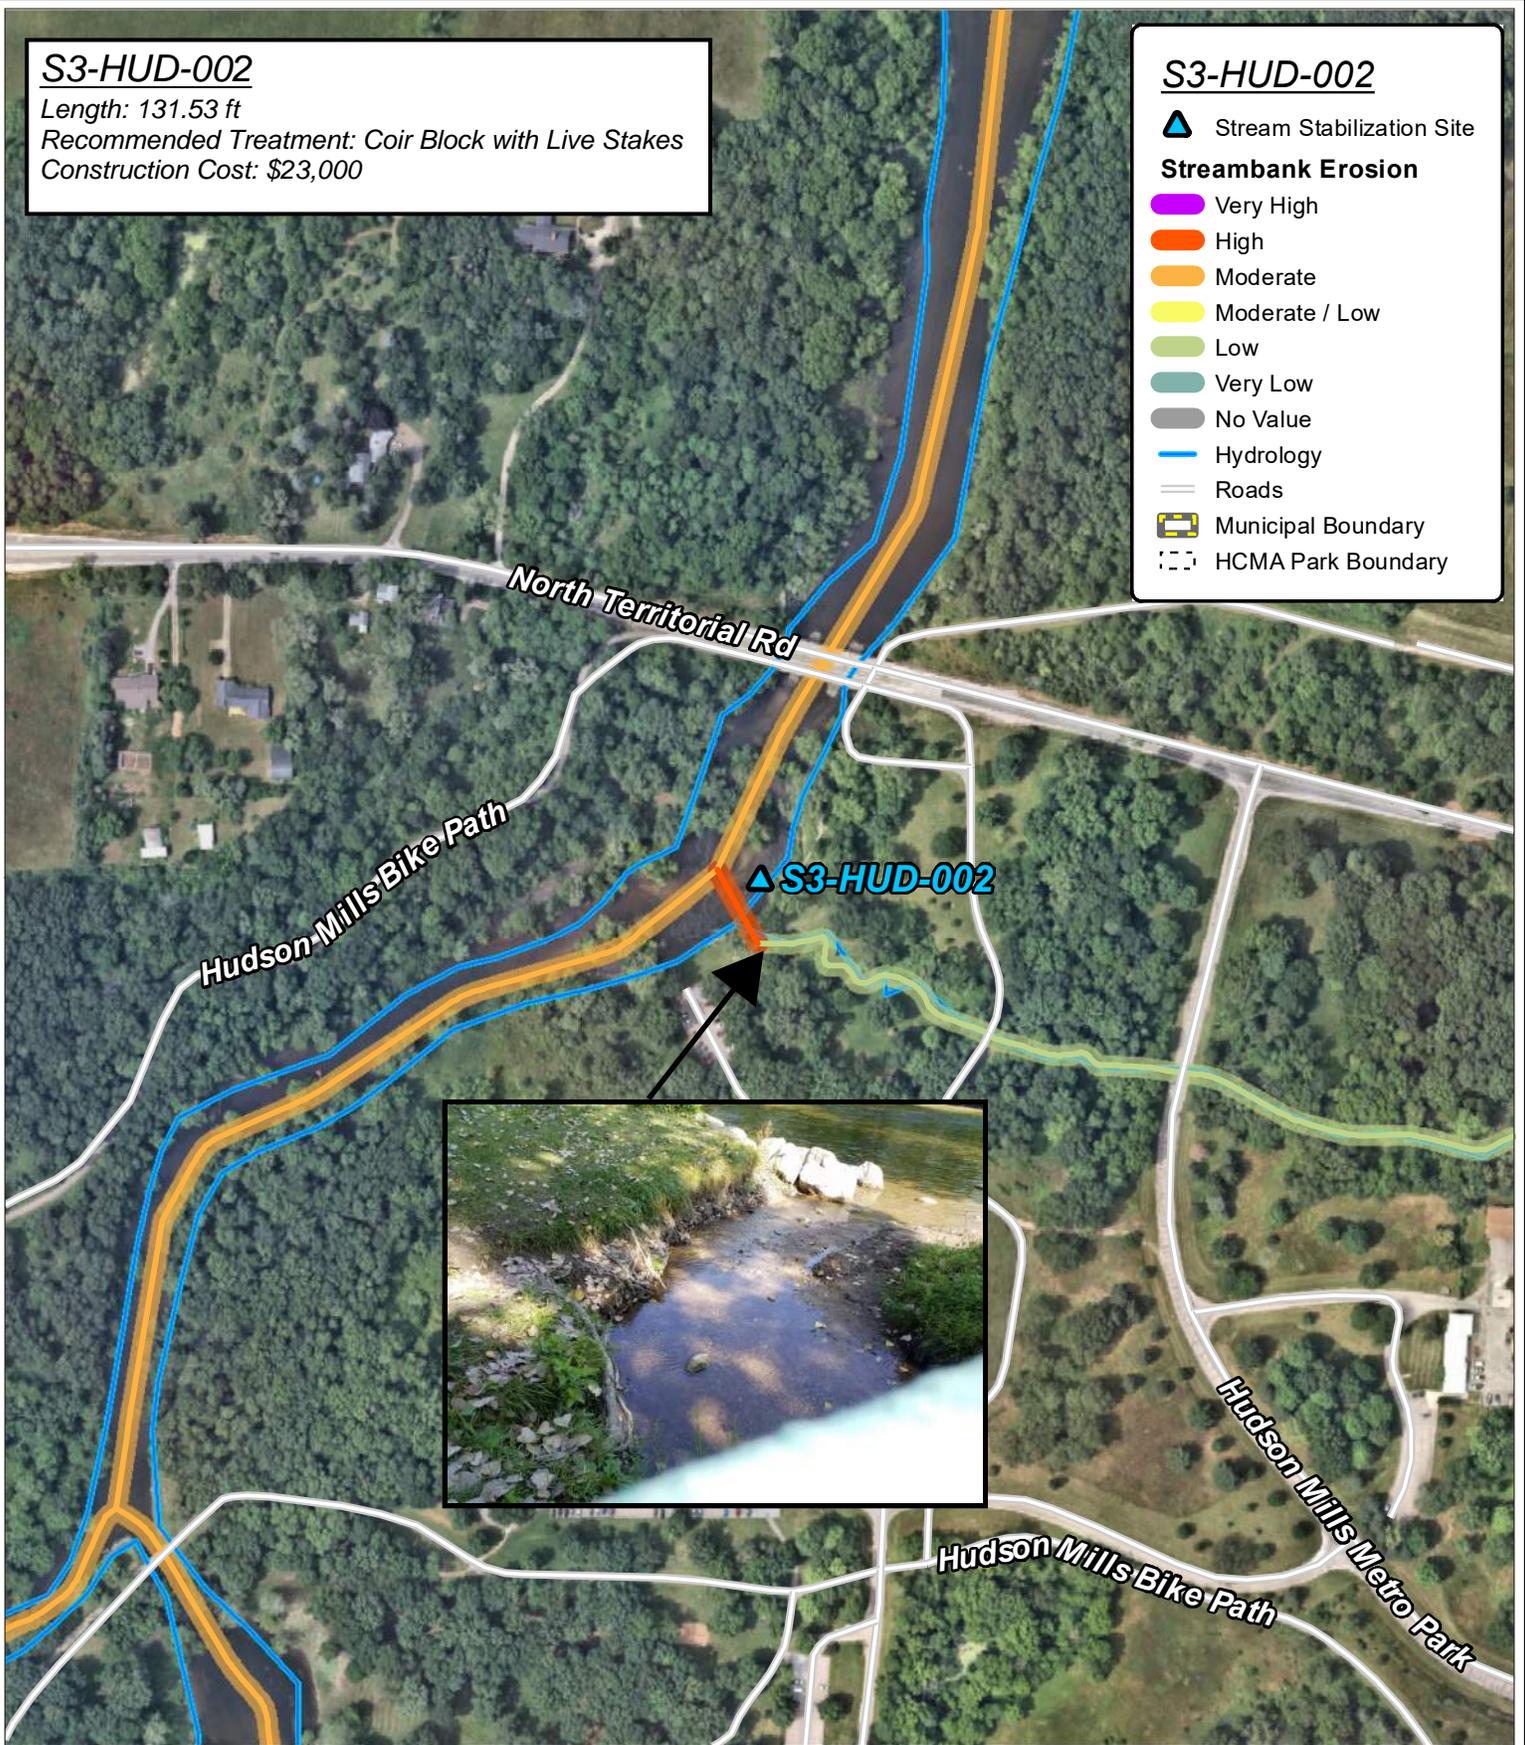
S3-HUD-002

Length: 131.53 ft

Recommended Treatment: Coir Block with Live Stakes
Construction Cost: \$23,000

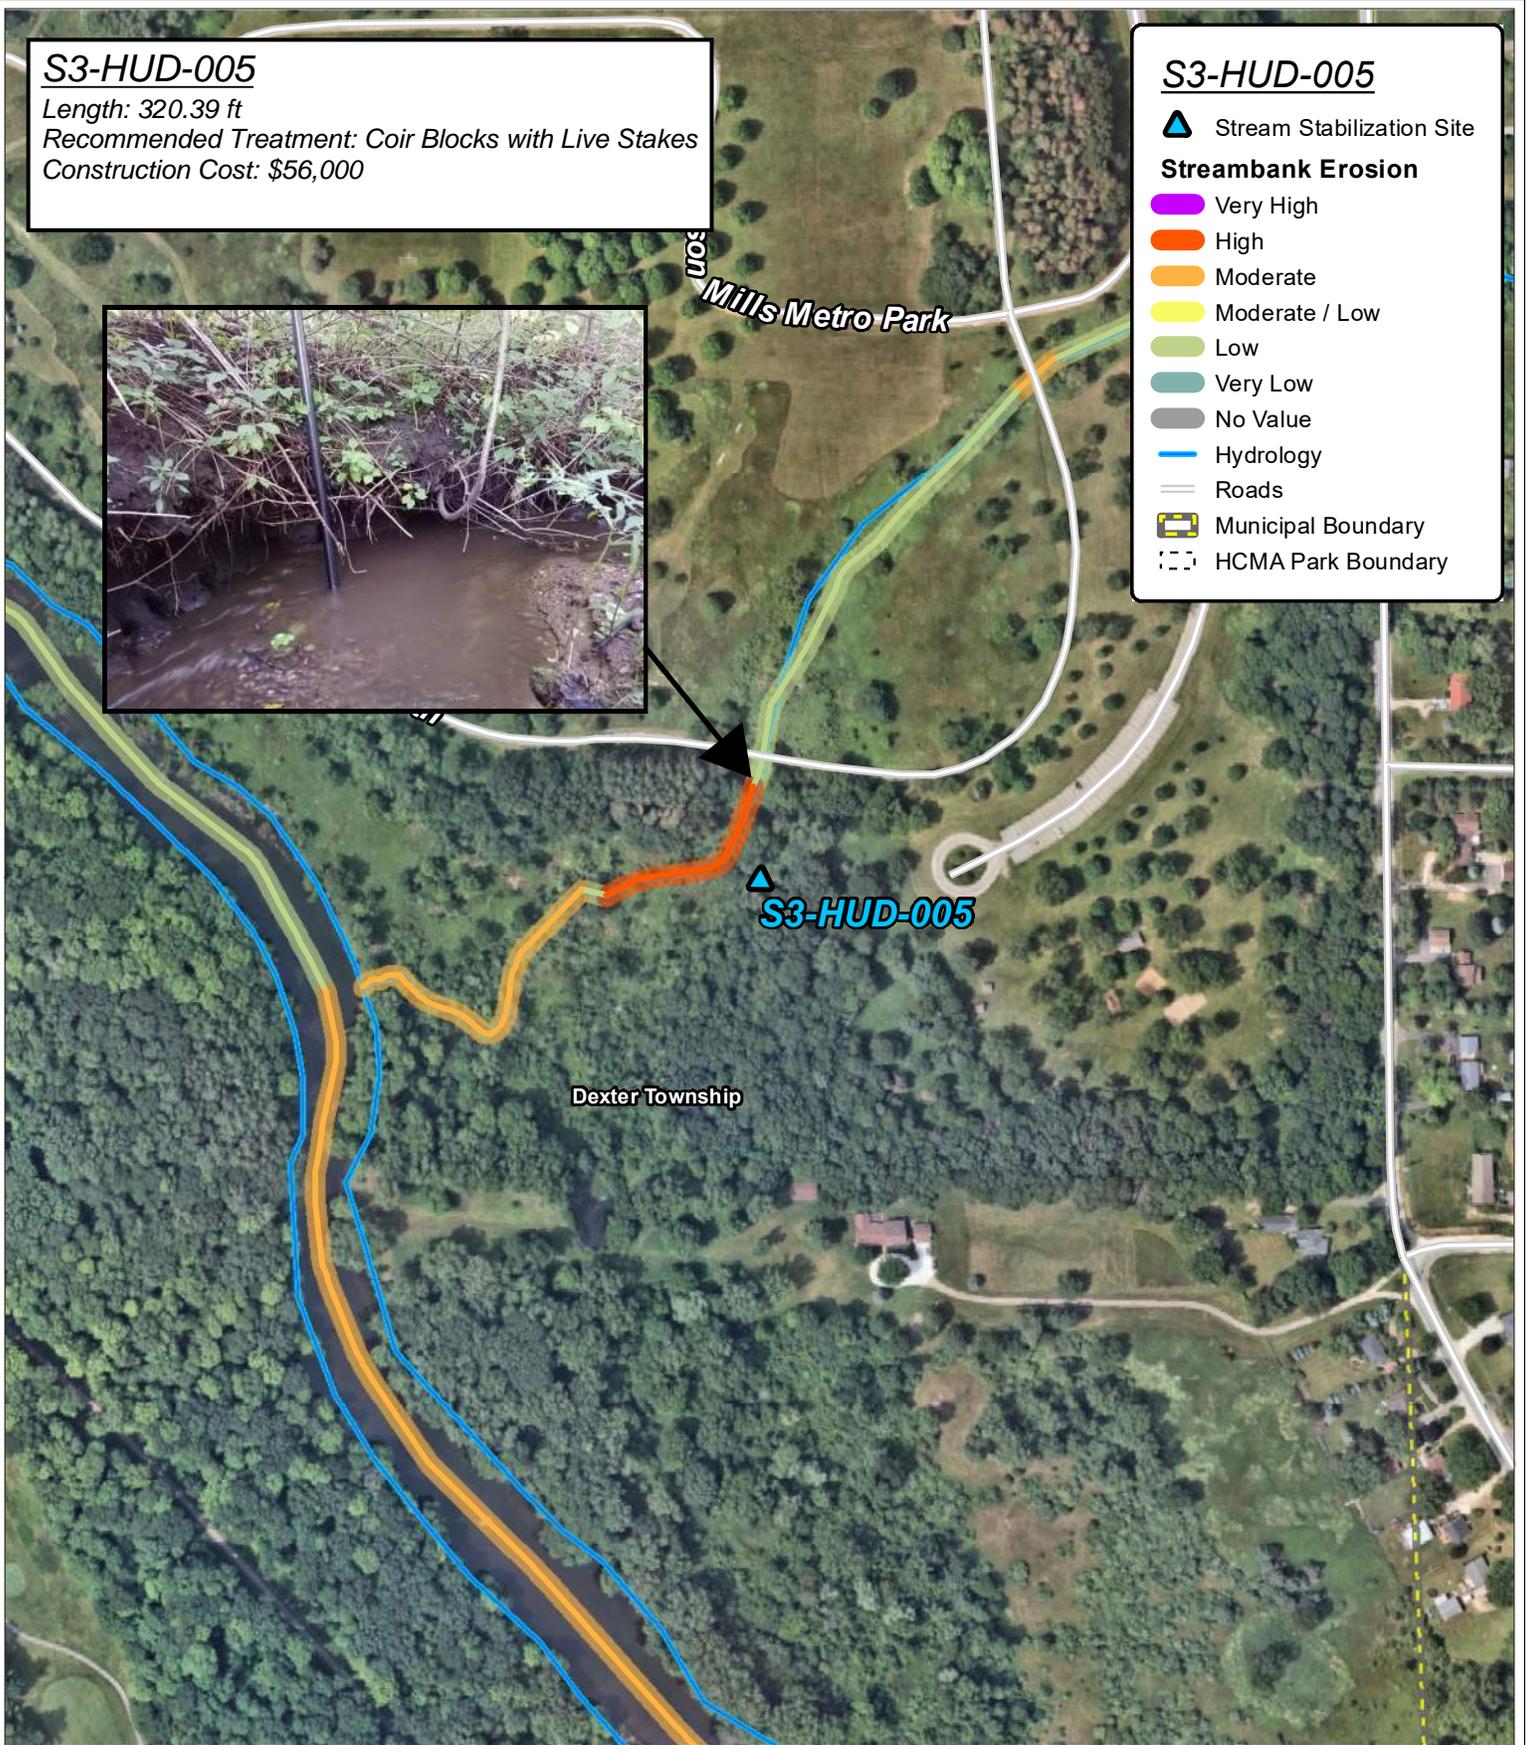
S3-HUD-005

Length: 320.39 ft

Recommended Treatment: Coir Blocks with Live Stakes
Construction Cost: \$56,000

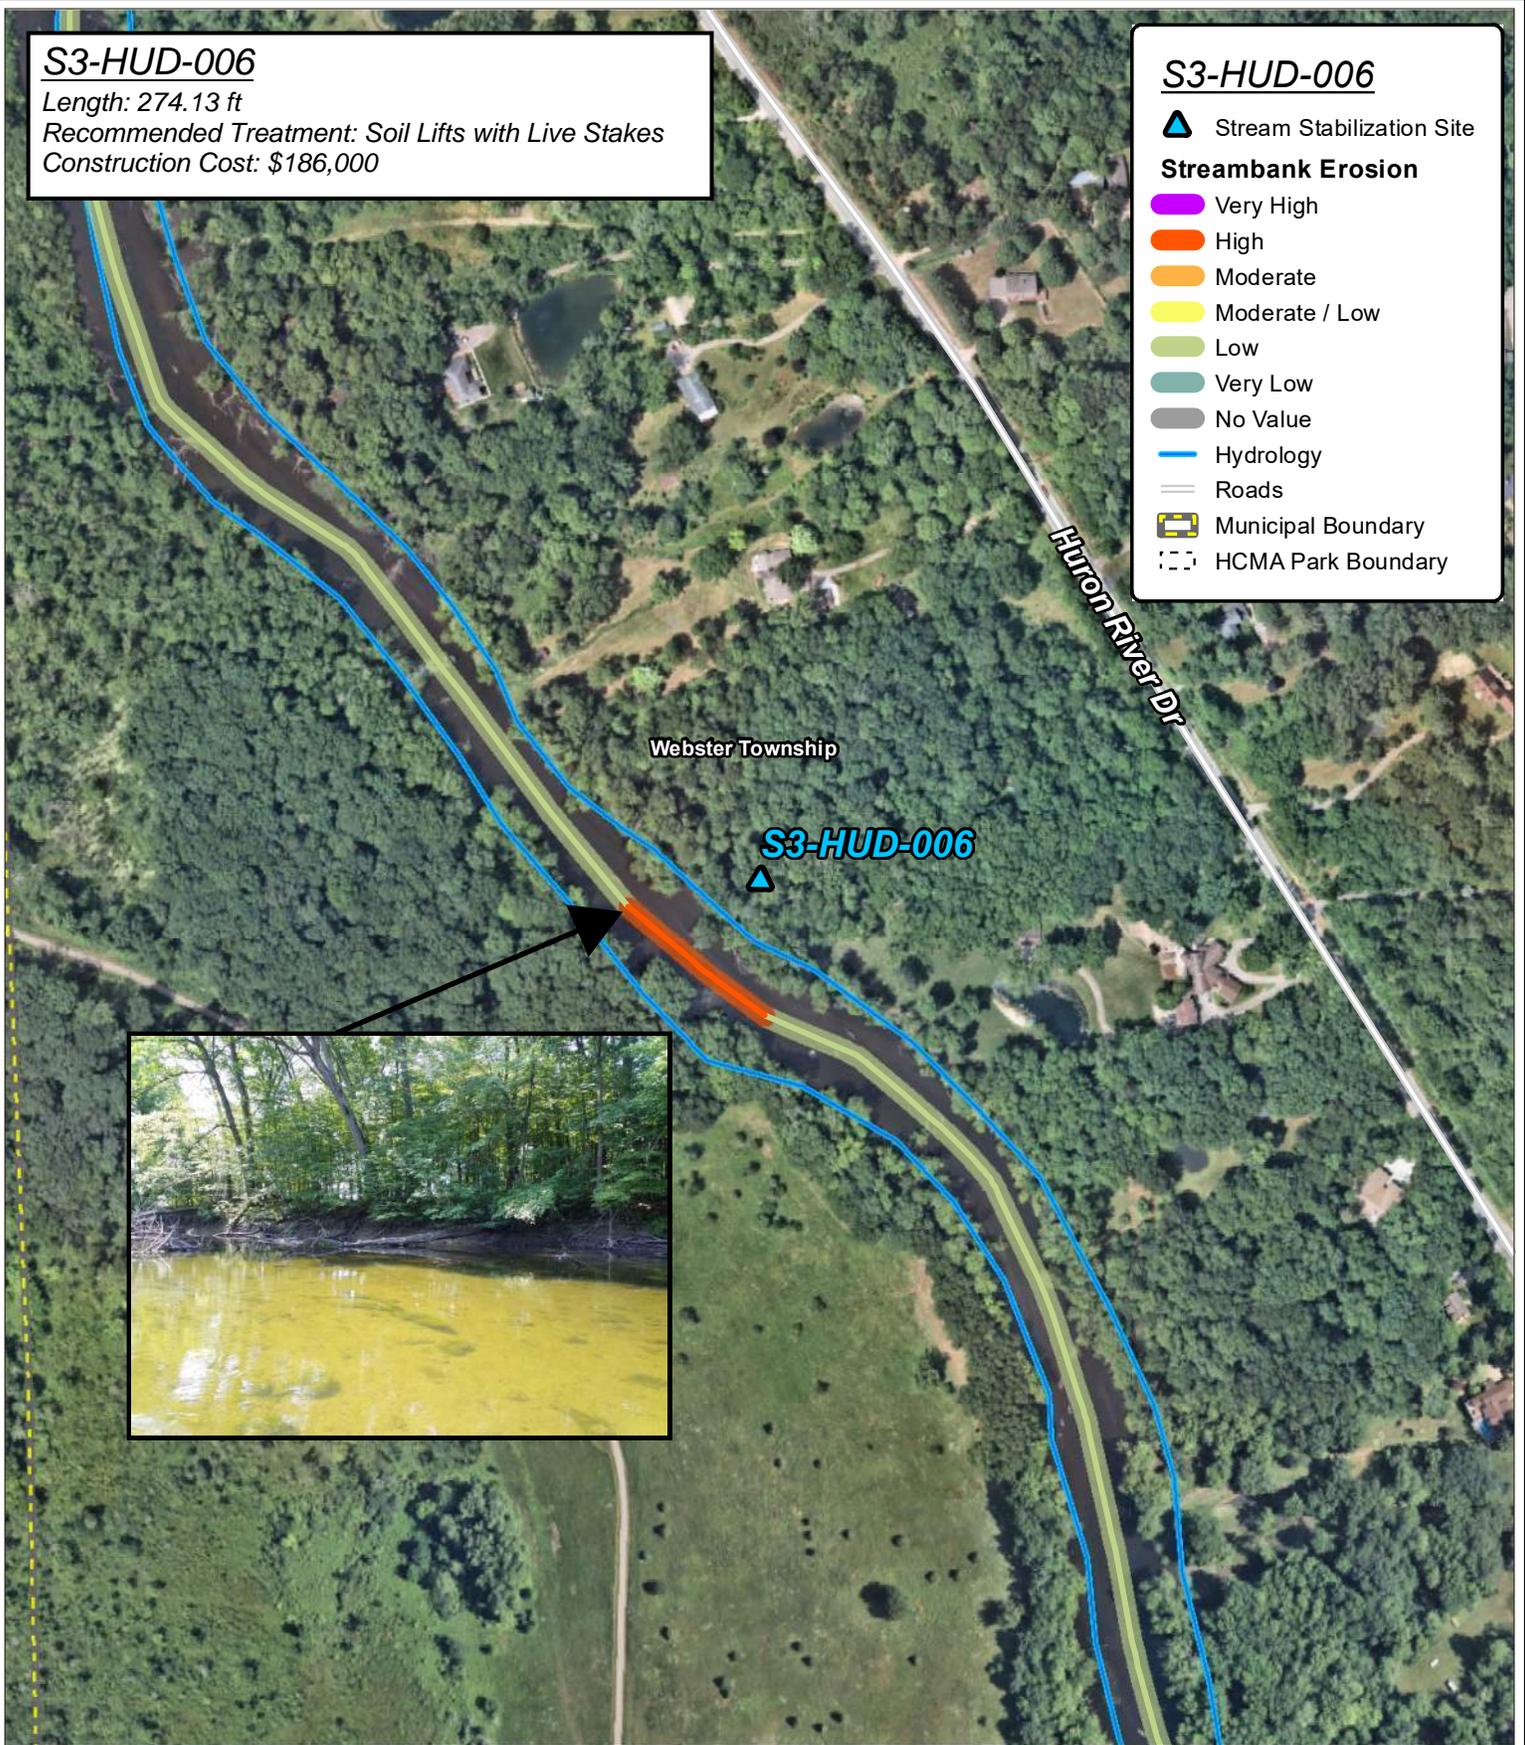
S3-HUD-006

Length: 274.13 ft

Recommended Treatment: Soil Lifts with Live Stakes

Construction Cost: \$186,000
