HURON-CLINTON
metroparks

Huron Meadows Metropark Stormwater Management Plan

September 2019

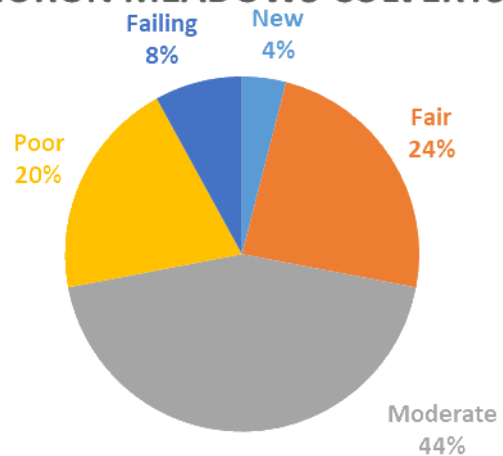
Left: Failing culvert in Huron Meadows Metropark. Right: Proportion of culverts in each condition category.

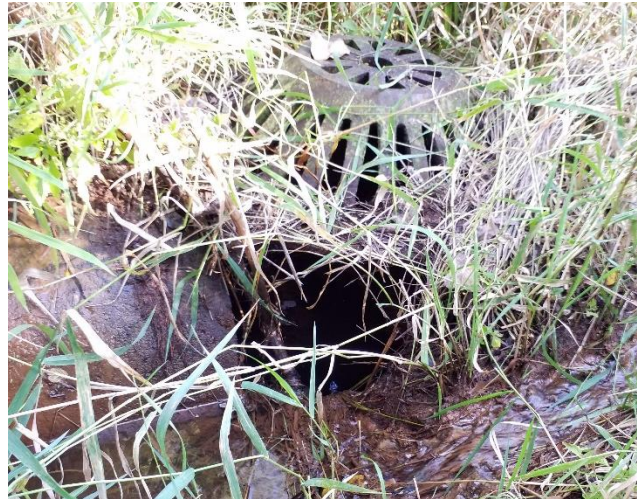
Proportion of outfalls in each condition category. Right: Damaged catchbasin leading to outfall in failing condition in Huron Meadows Metropark.

Outfall ID	Diameter (in)	Condition	Maintenance Need	Cost Opinion
SDC-HUR-005	12	Failing	Replacement	\$6,250
Total:				\$6,250

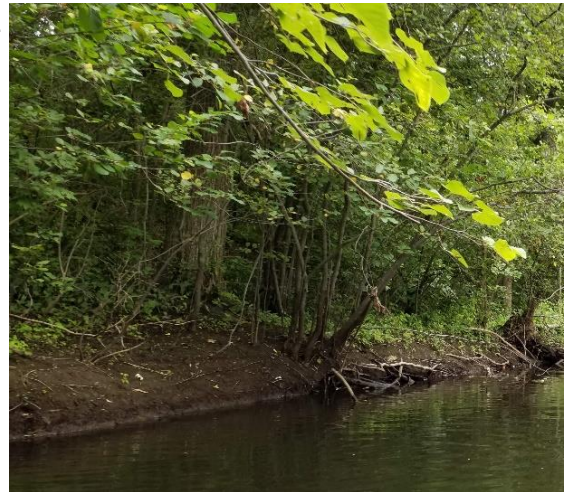
Left: Proportion of stream in each erosion severity category. Right: Moderate erosion on a bank in Huron Meadows Metropark.

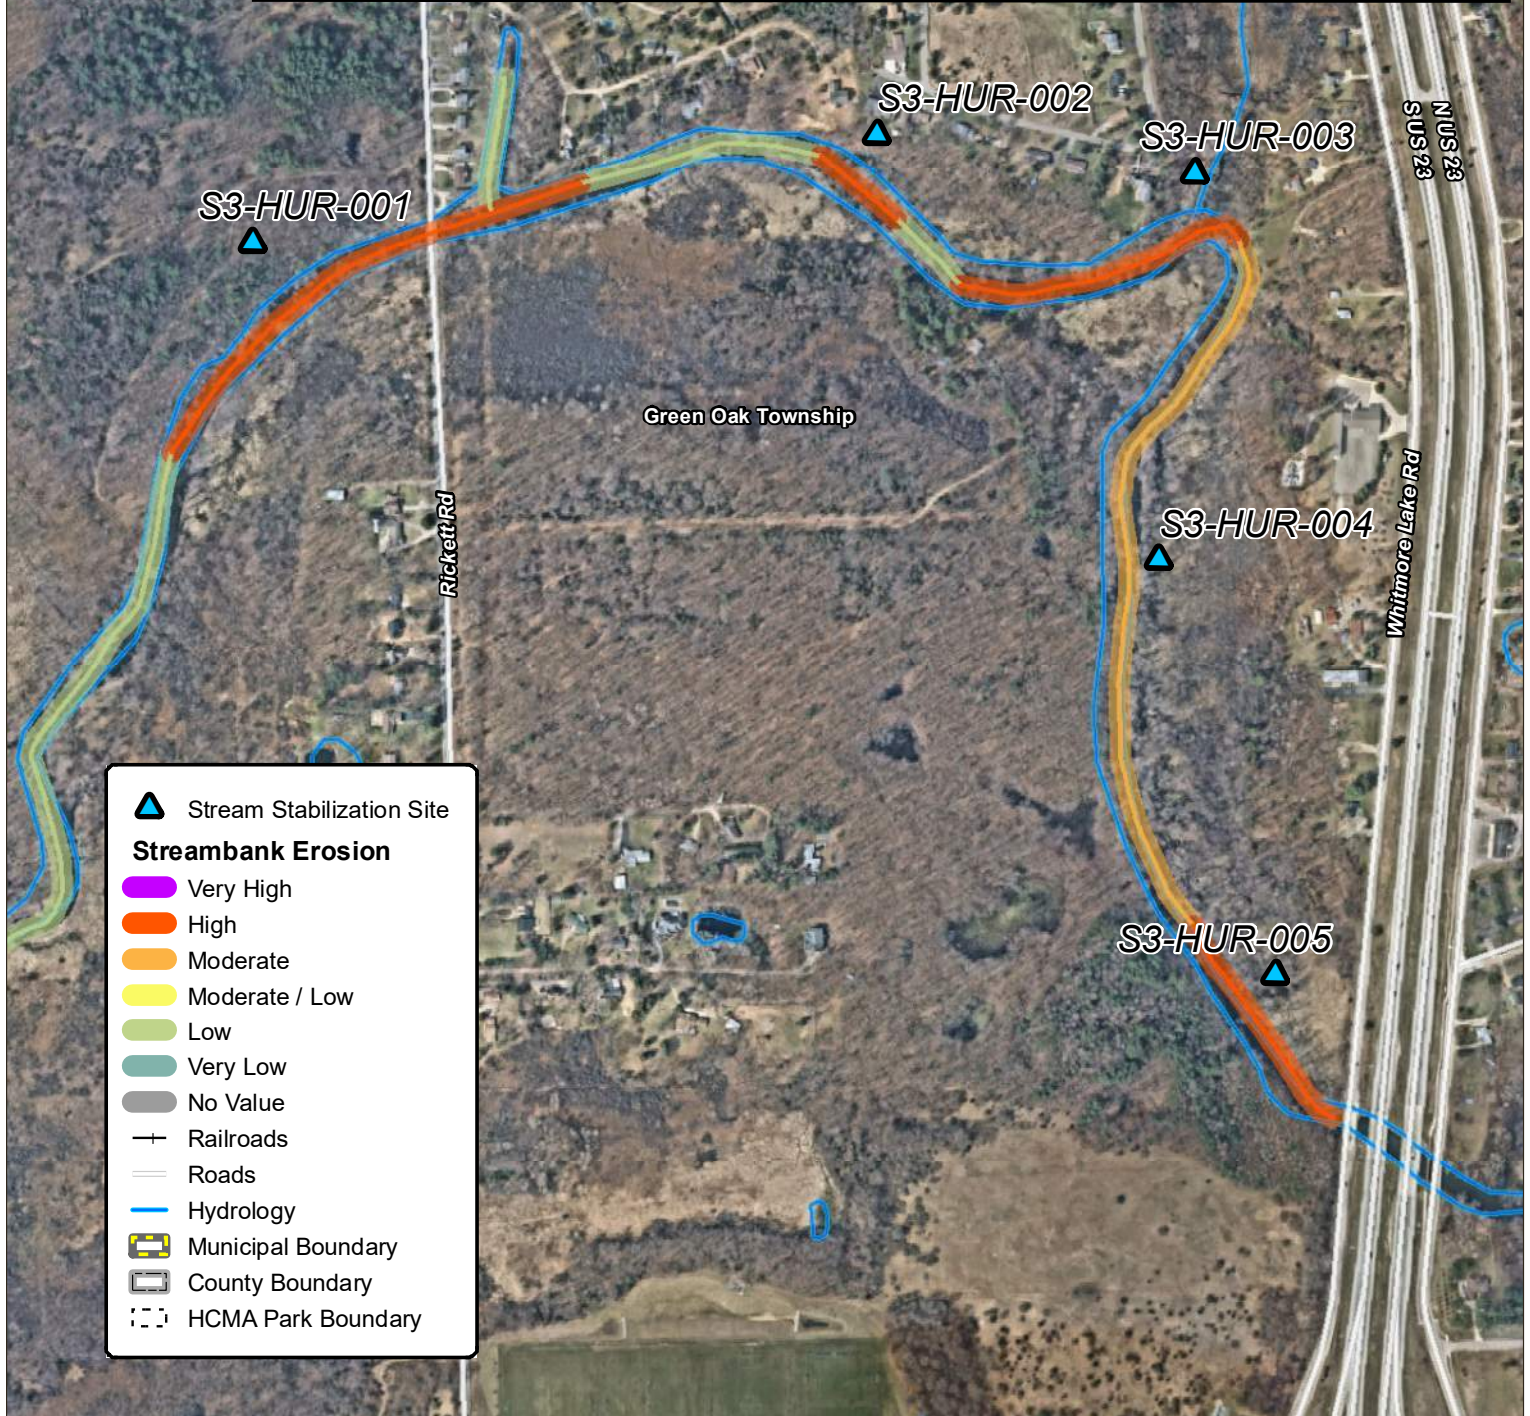
S3-HUR-001

Length: 1,579.56 ft

Recommended Treatment: Soil Lifts with Live Stakes

Construction Cost: \$1,071,000

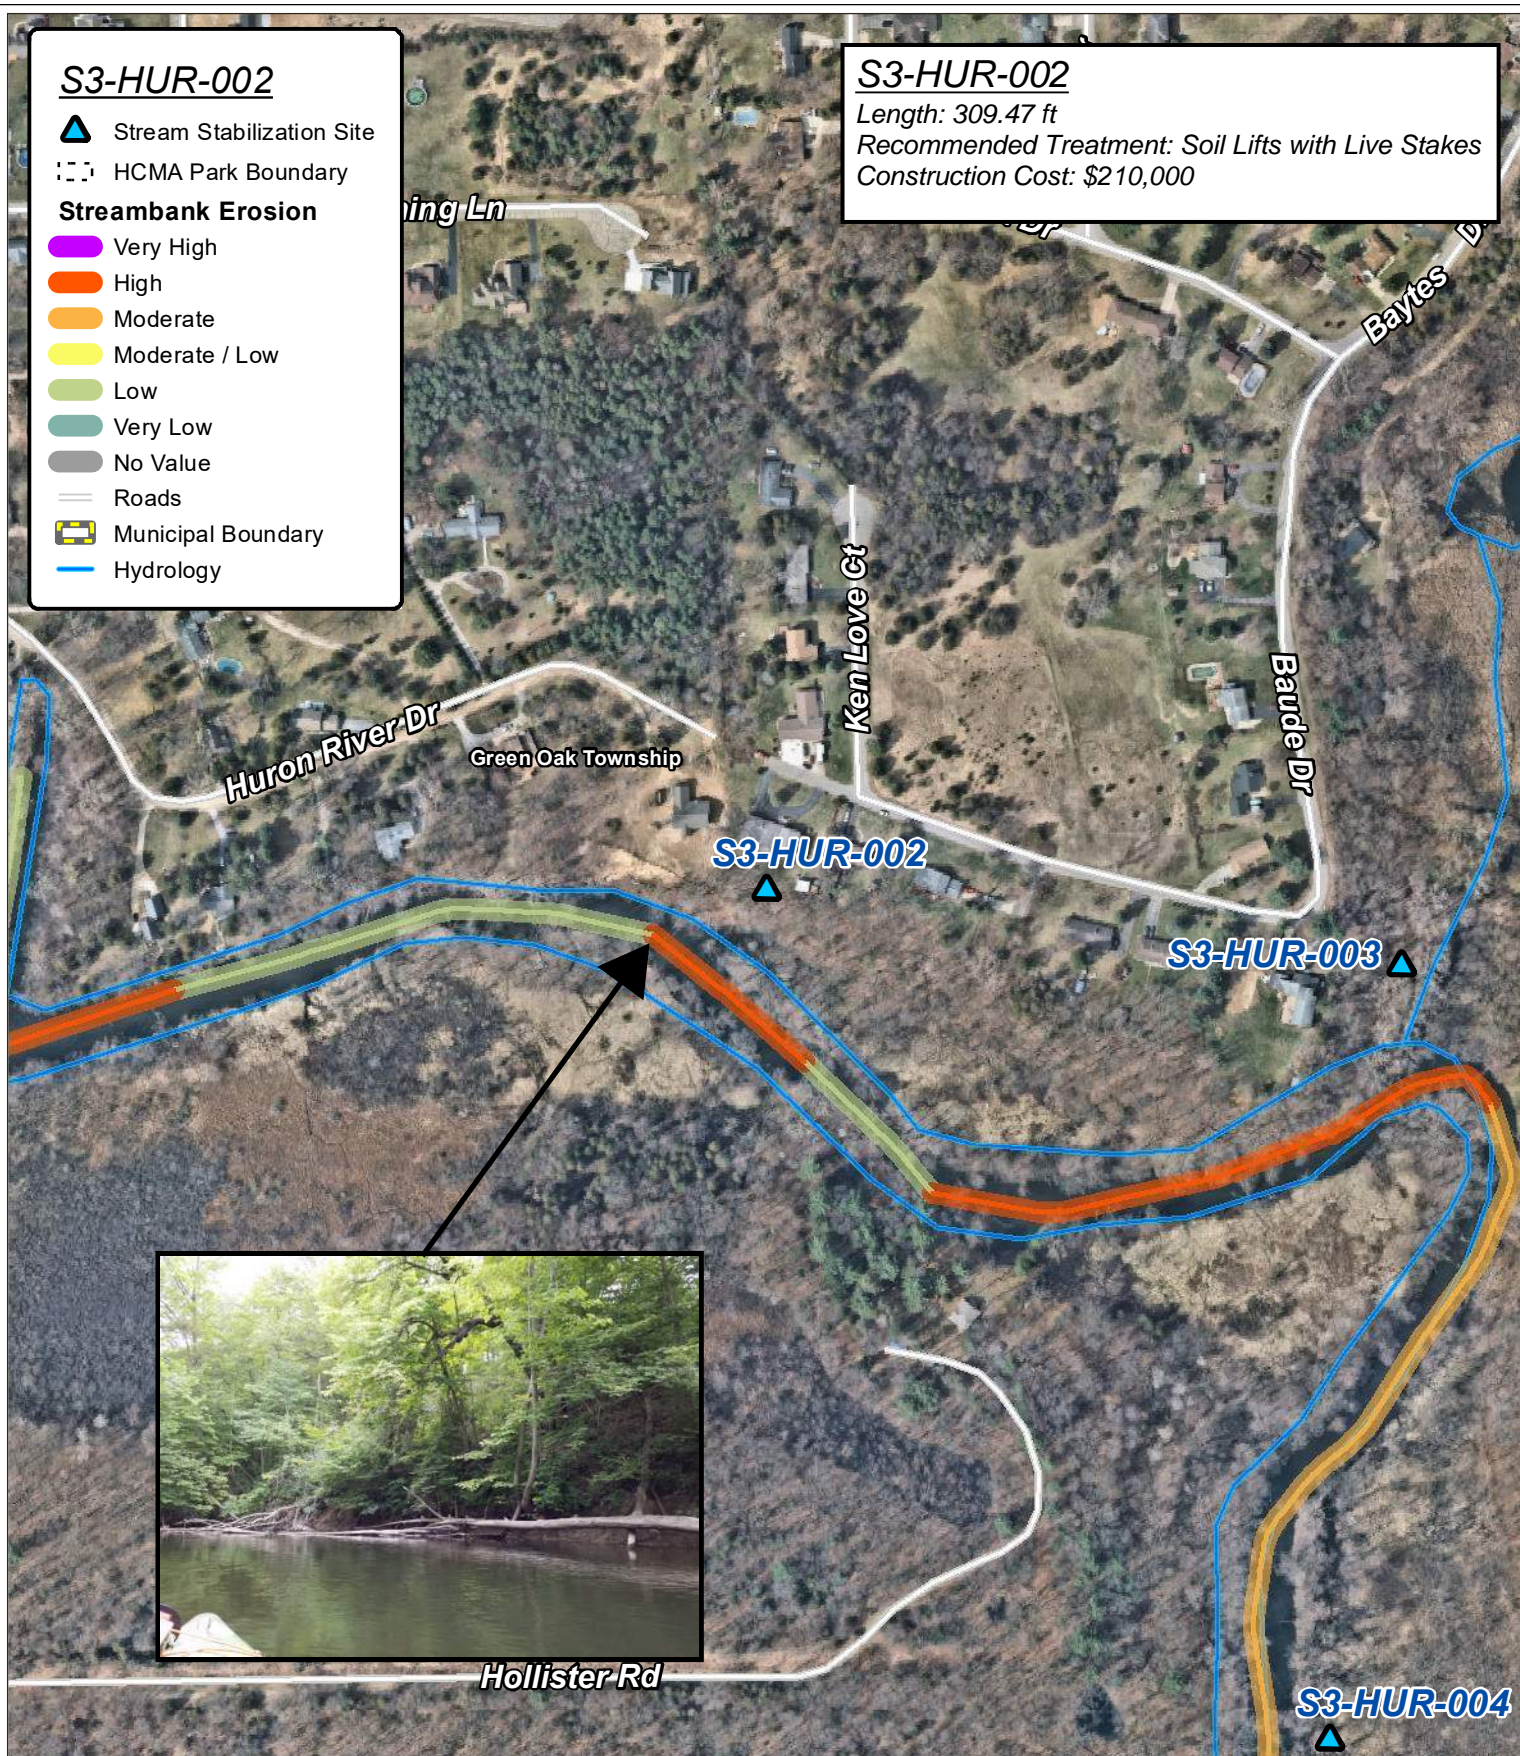
S3-HUR-002

Length: 309.47 ft

Recommended Treatment: Soil Lifts with Live Stakes

Construction Cost: \$210,000

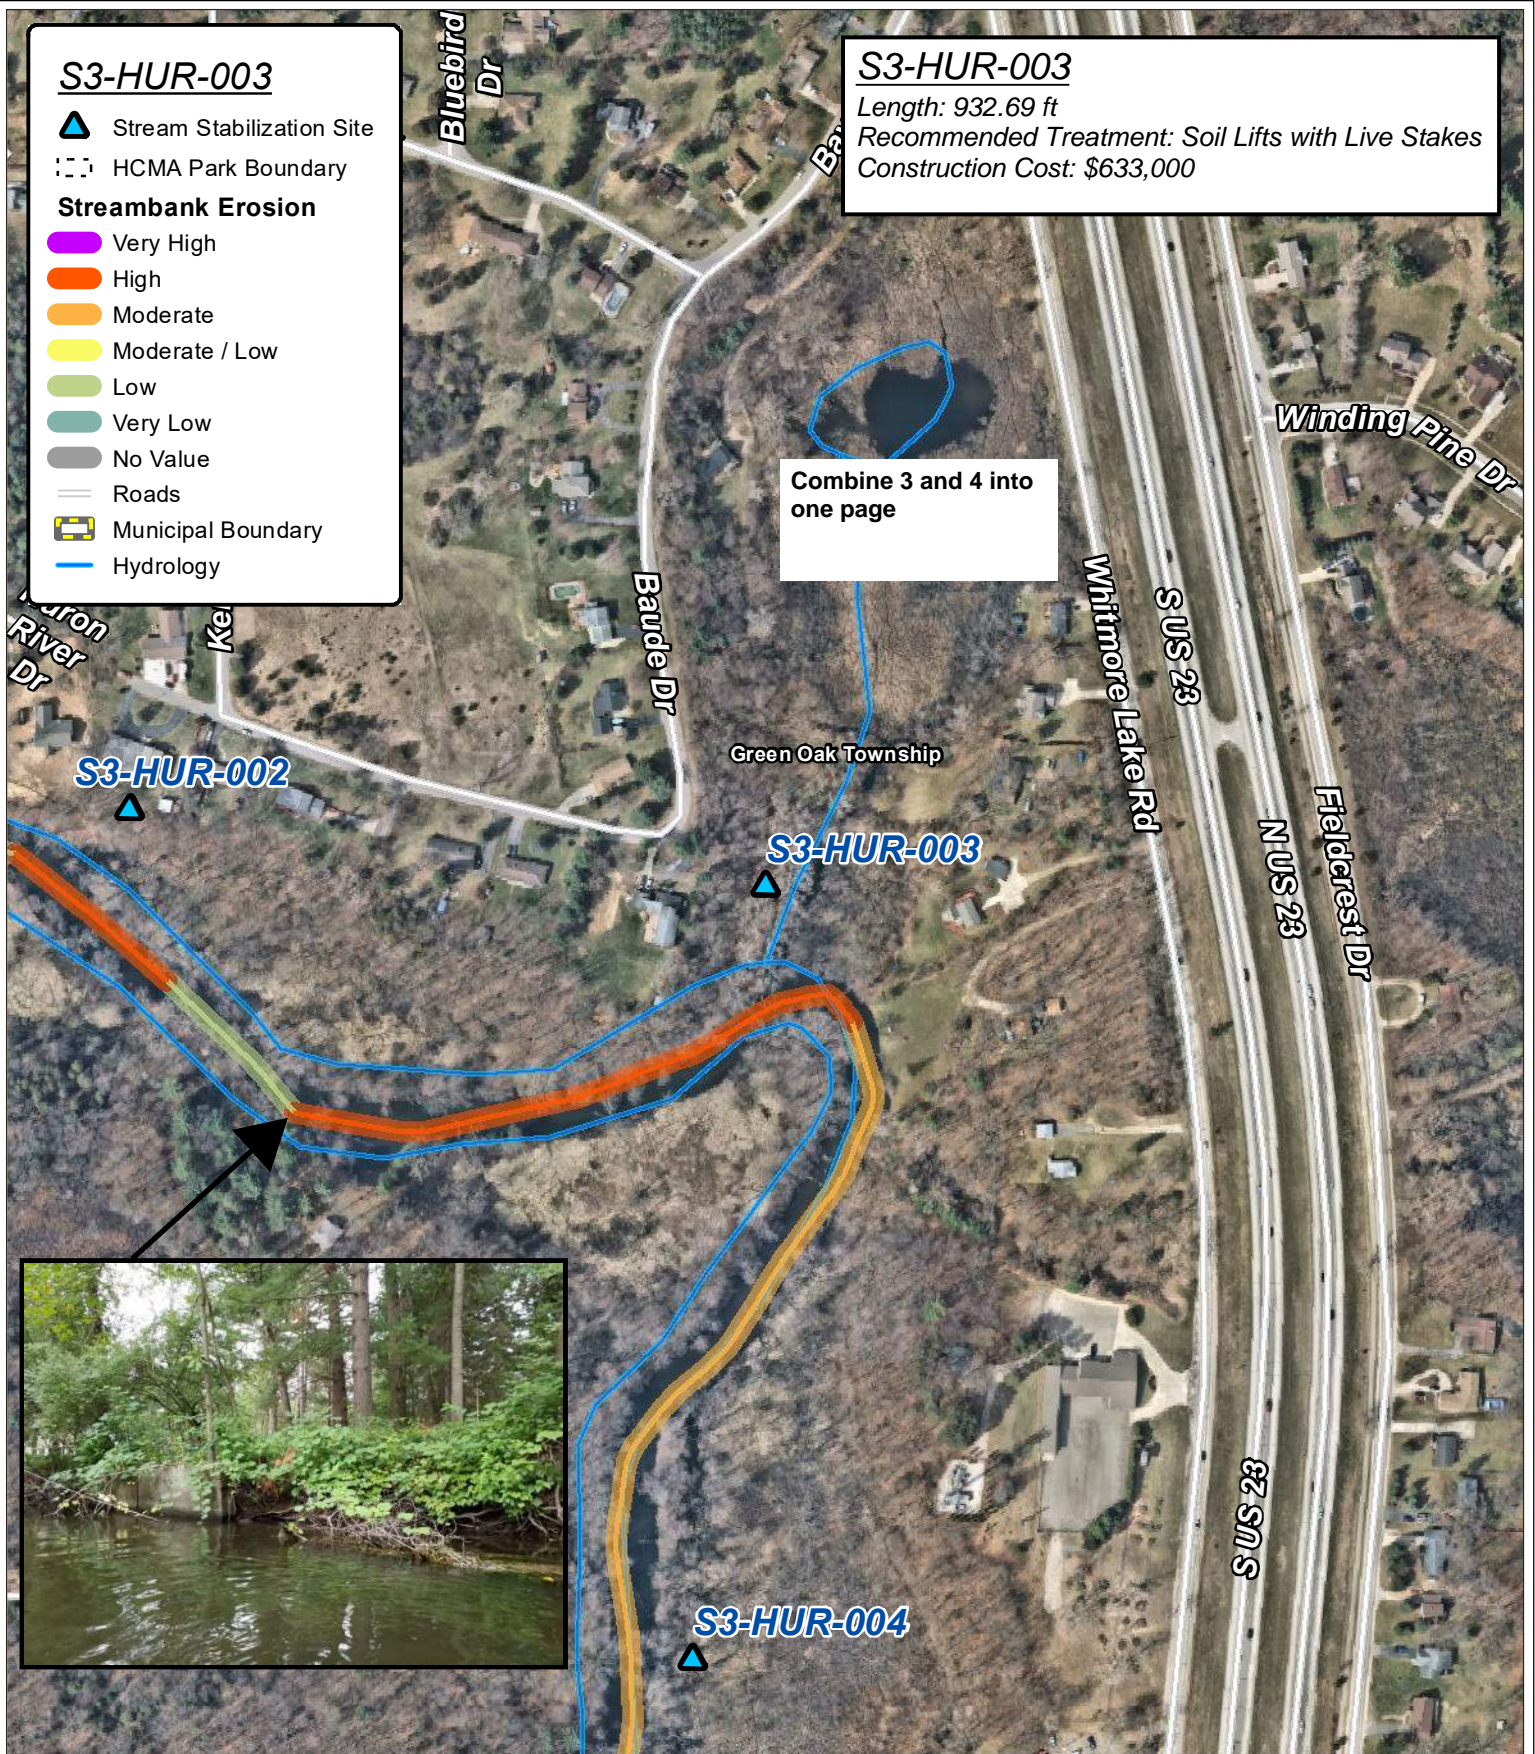
S3-HUR-003

Length: 932.69 ft

Recommended Treatment: Soil Lifts with Live Stakes

Construction Cost: \$633,000

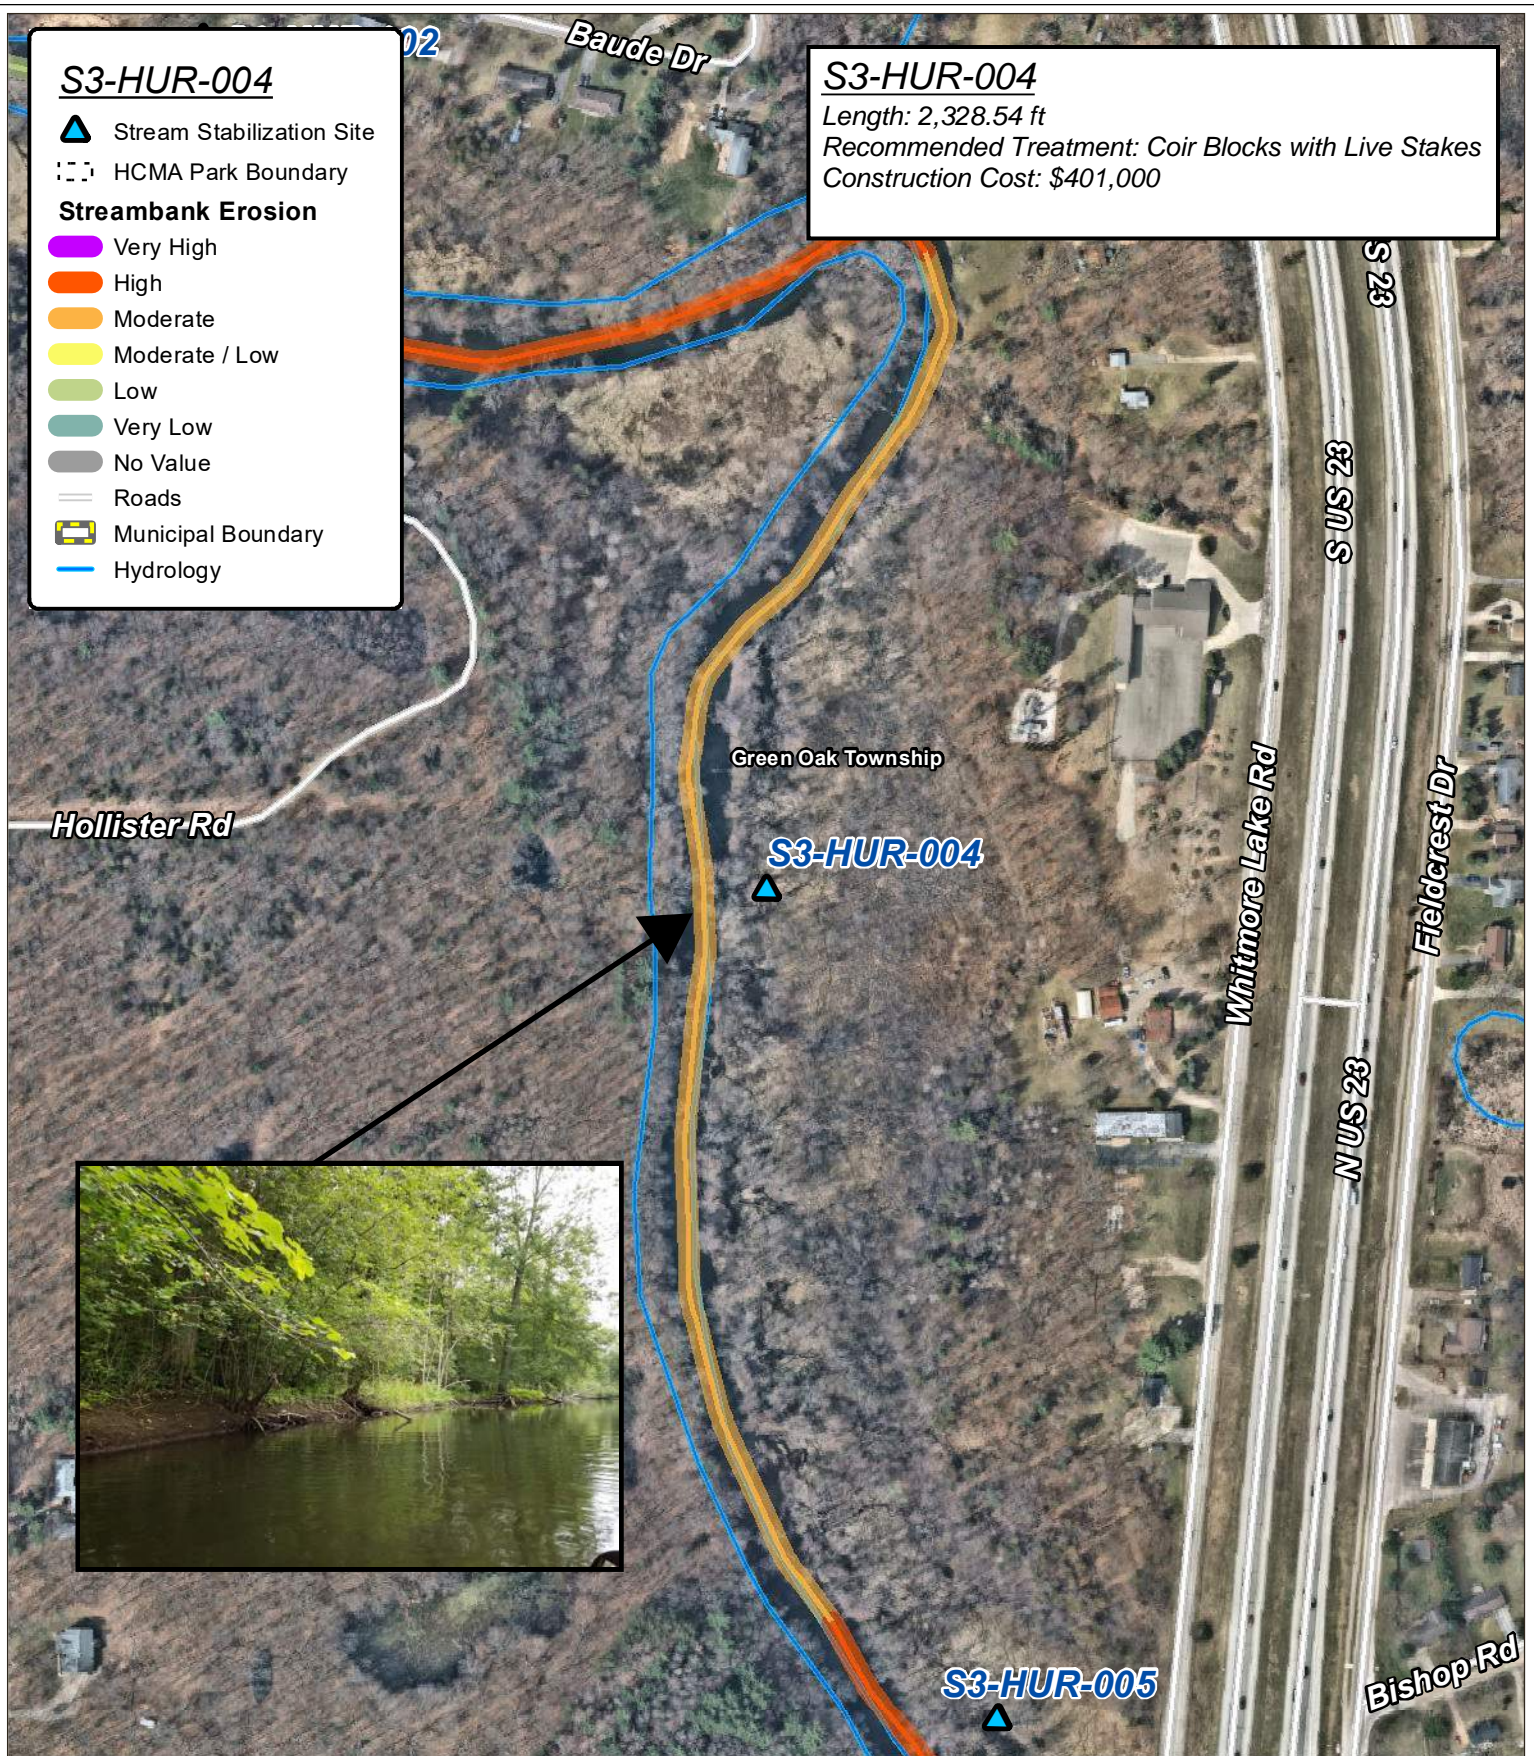
S3-HUR-004

Length: 2,328.54 ft

Recommended Treatment: Coir Blocks with Live Stakes

Construction Cost: \$401,000

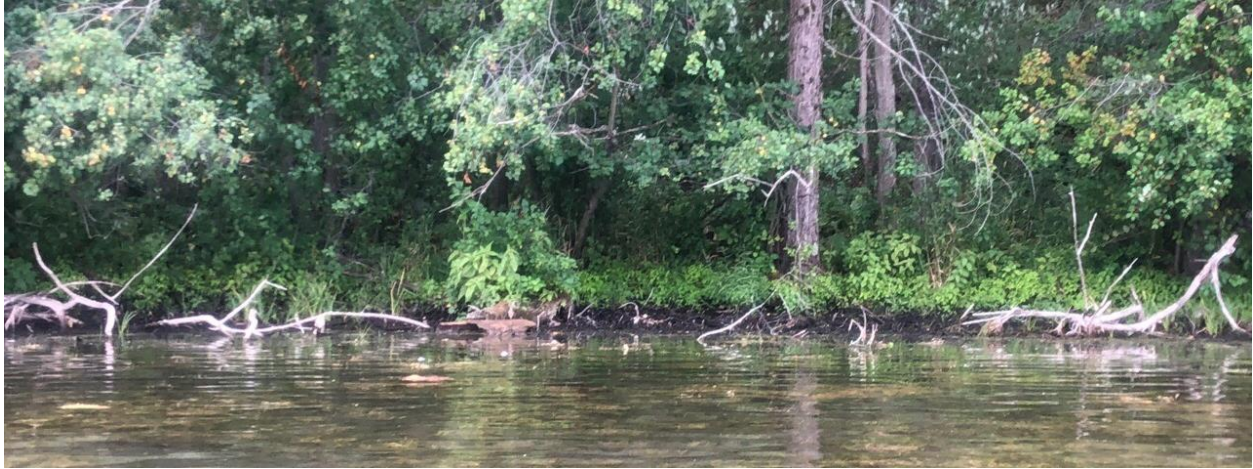
Minor slumping in Huron Meadows Metropark.

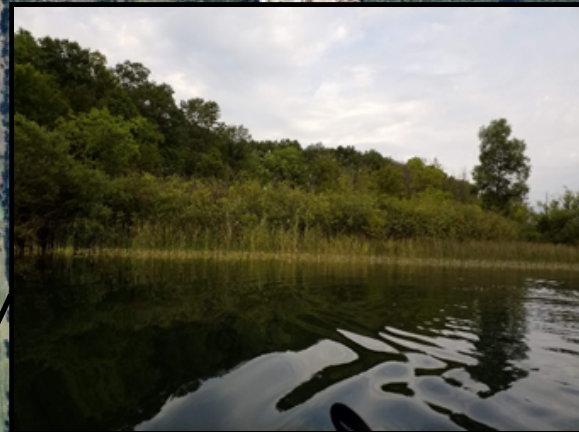
SLR-HUR-001

Area is a high quality wetland and its diversity is threatened by the small amount of invasive species found here.

Recommended Treatment: Detail E
