Kensington Metropark Stormwater Management Plan

September 2019

Kensington Metropark Stormwater Structure Recommendations

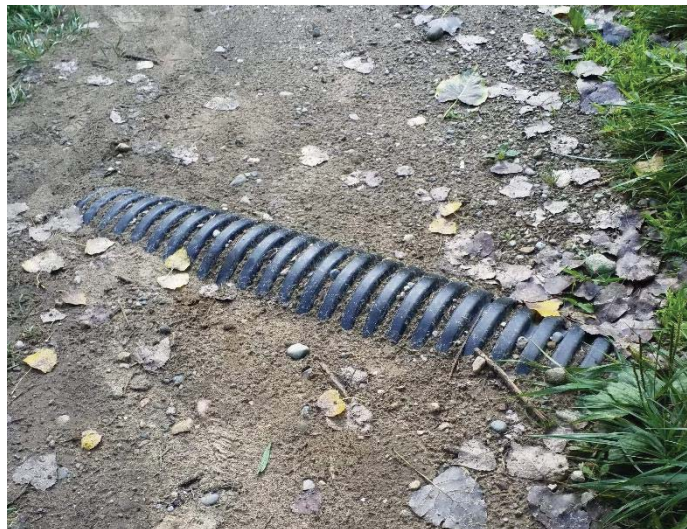
Left: Failing culvert in Kensington Metropark. Right: Proportion of culverts in each condition category.

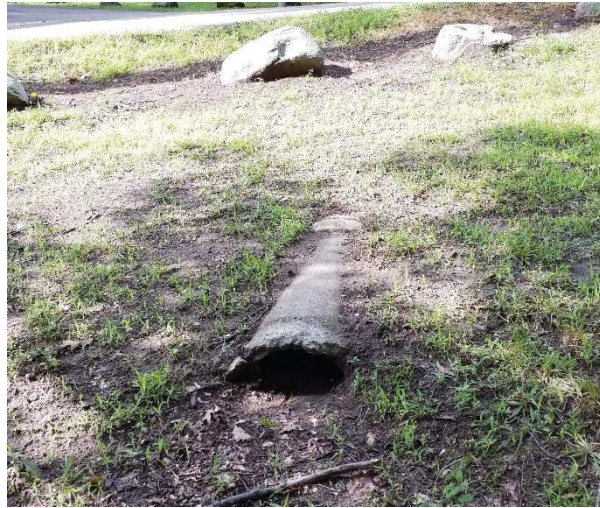
Proportion of outfalls in each condition category. Right: Blocked outfall in failing condition in Kensington Metropark.

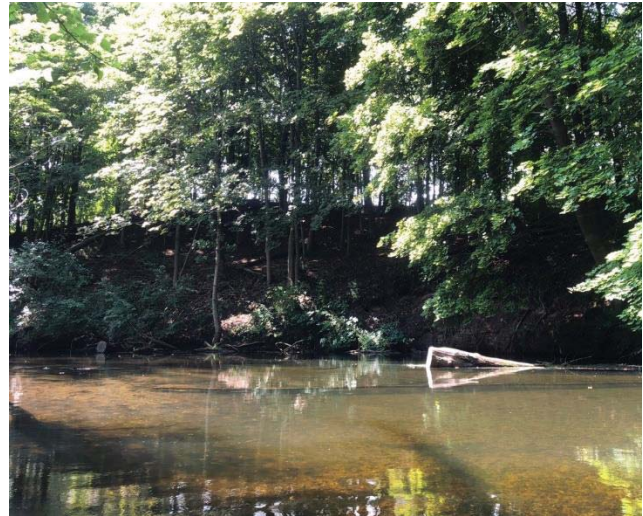
Erosion Condition	Feet of Streambank (miles)	Cost of Restoration
Very High	0.0 (0.0)	
High	2,436 (0.46)	\$598,000
Moderate	5,805 (1.10)	
Low	7,003 (1.33)	
Very Low	802 (0.15)	
Total:	16,047 (3.03)	\$598,000

Left: Proportion of stream bank in each erosion severity category. Right: High erosion on a bank in Kensington Metropark.

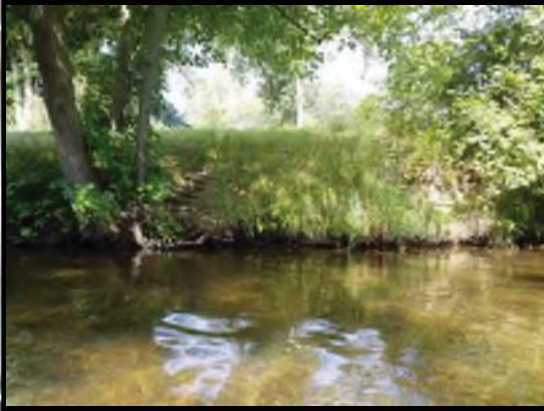
S3-KEN-001

Length: 987.51 ft

Recommended Treatment: Coir Block with Live Stakes

Construction Cost: \$170,000

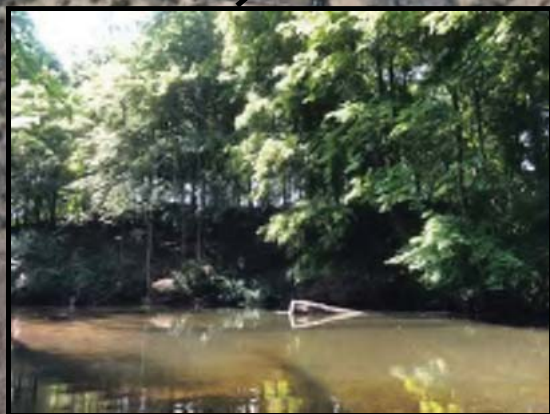
S3-KEN-002

Length: 351.27 ft

Recommended Treatment: Soil Lifts with Live Stakes

Construction Cost: \$239,000

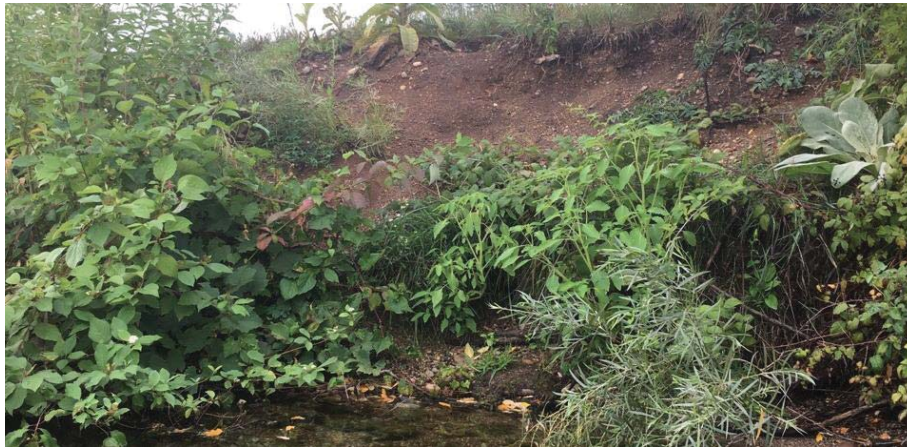
Major slumping in Kensington Metropark.

Erosion Condition	Length of Shoreline (ft)
Major	9,503.1
Minor	86,153.4
None	52,464.2
Total:	148,120.7
Restoration Cost:	\$151,777
