HURON-CLINTON  
metroparks

# Lake Erie Metropark Stormwater Management Plan

September 2019

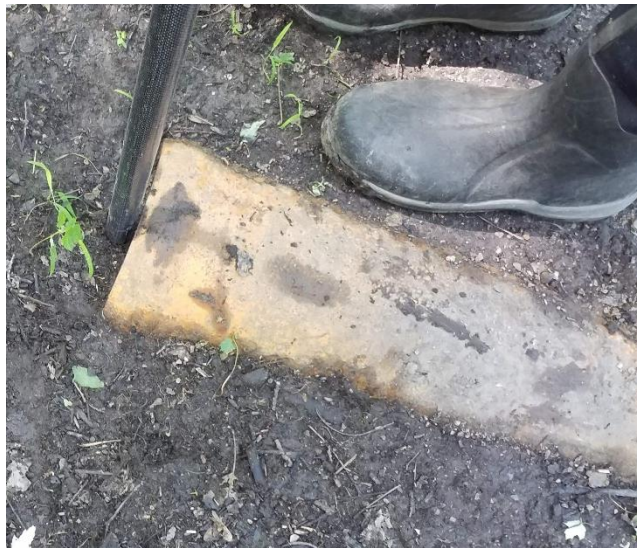
*Left: Failing culvert in Lake Erie Metropark. Right: Proportion of culverts in each condition category.*

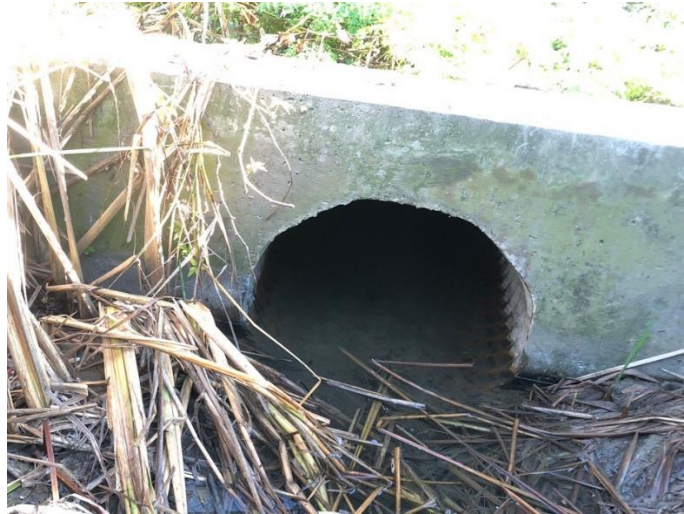
*Left: Proportion of outfalls in each condition category. Right: Outfall in moderate condition in Lake Erie Metropark.*

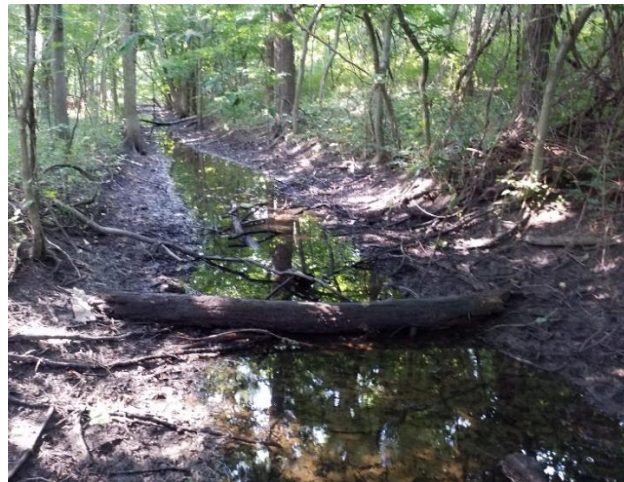
Left: Proportion of stream in each erosion severity category. Right: Moderate erosion on a small stream in Lake Erie Metropark.

\*No restoration recommended at this time.

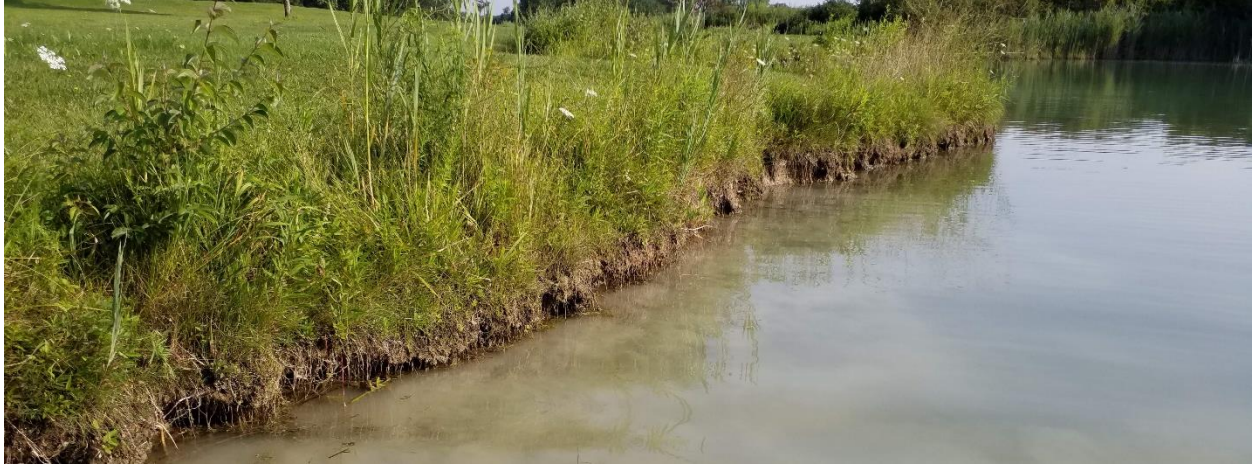
*Major slumping in Lake Erie Metropark.*

Lake Erie Metropark has a large proportion of shoreline. Recommended restoration activity is largely invasive species related, with some shoreline stabilization plantings.

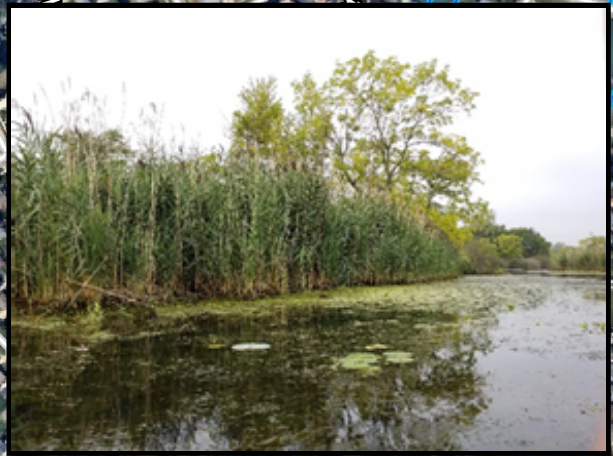
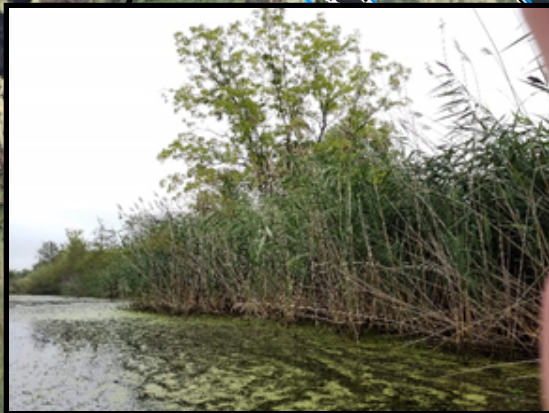
**SLR-LE-015**

Length: 774 Ft

Recommended Treatment: E

SLR-LE-015	774	E (Invasive Species Removal)	\$3,000/acre	NA
SLR-LE-008	650.00	A+E (Tree Removal, Excavation, Plant Restoration, and Invasive Species Removal)	\$21	\$13,650
