HURON-CLINTON
metroparks

Lake St. Clair Metropark
Stormwater Management Plan

September 2019

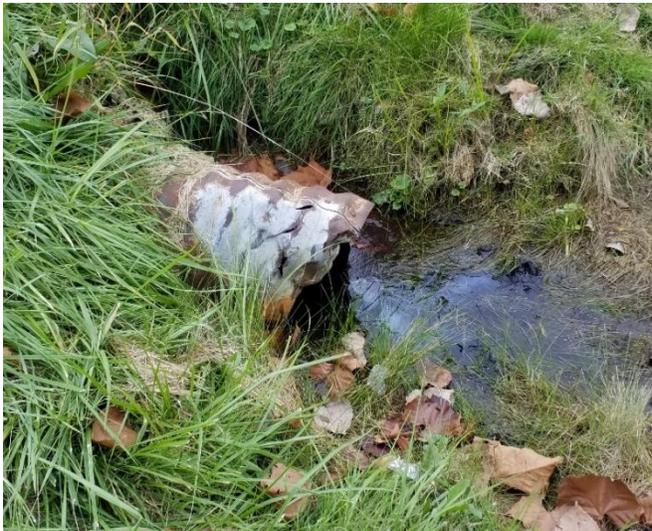
Left: Failing culvert in Lake St. Clair Metropark. Right: Proportion of culverts in each condition category.

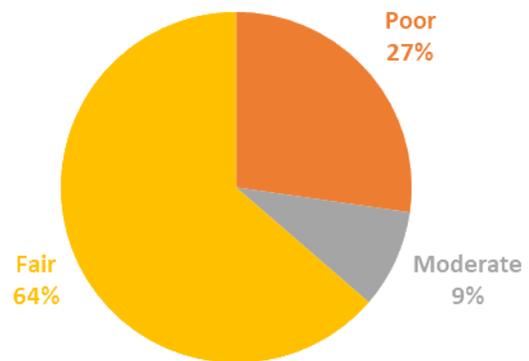
Left: Proportion of outfalls in each condition category. Right: Blocked outfall in poor condition in Lake St. Clair Metropark.

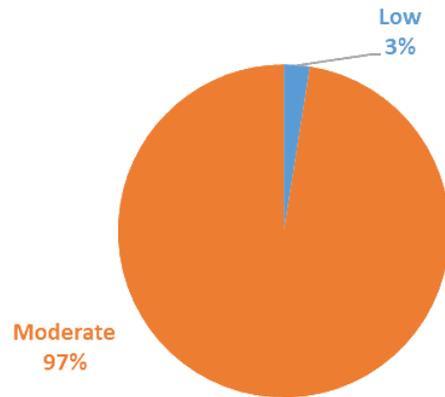
Left: Proportion of stream in each erosion severity category. Right: Low erosion on a small stream in Lake St. Clair Metropark.

*No restoration recommended at this time.

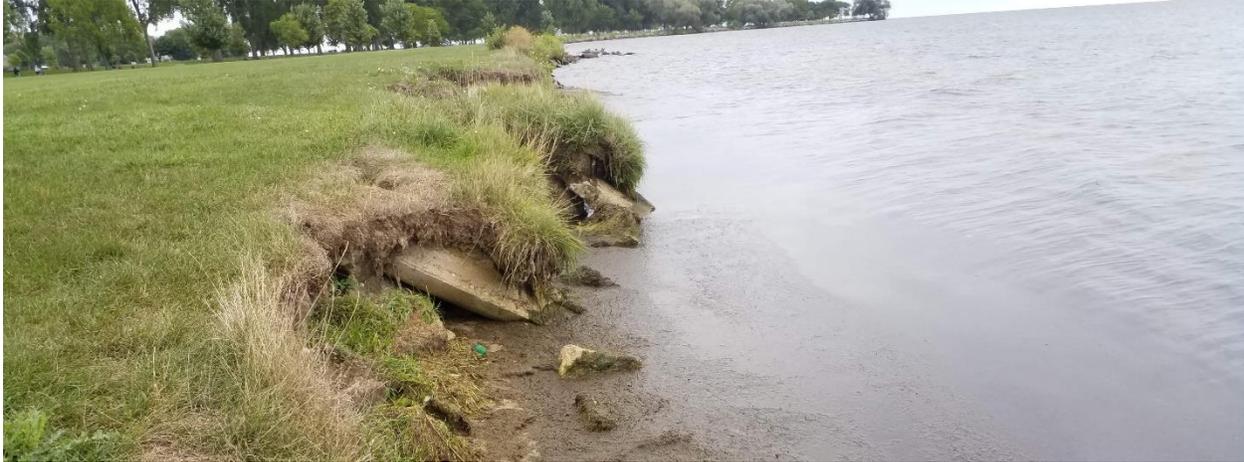
Minor slumping in Lake St. Clair Metropark.

Lake St. Clair Metropark has a large proportion of shoreline. Recommended restoration activity is largely invasive species related, with some shoreline stabilization plantings.
