HURON-CLINTON
metroparks

Lower Huron Metropark Stormwater Management Plan

September 2019

Prepared by: **OHM**

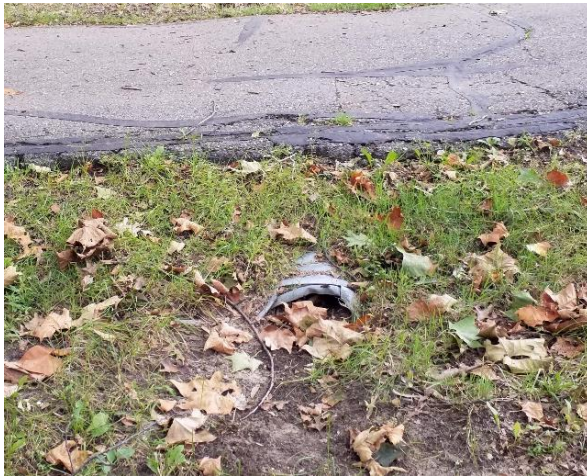
Left: Failing culvert in Lower Huron. Right: Proportion of culverts in each condition category.

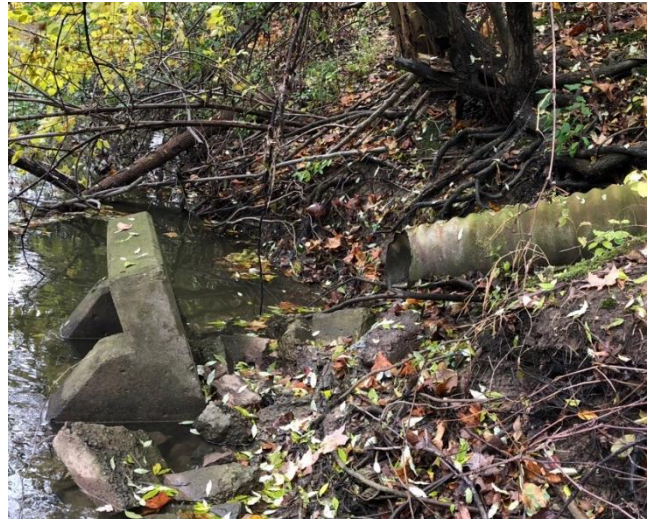
Left: Proportion of outfalls in each condition category. Right: Failing outfall completely falling apart.

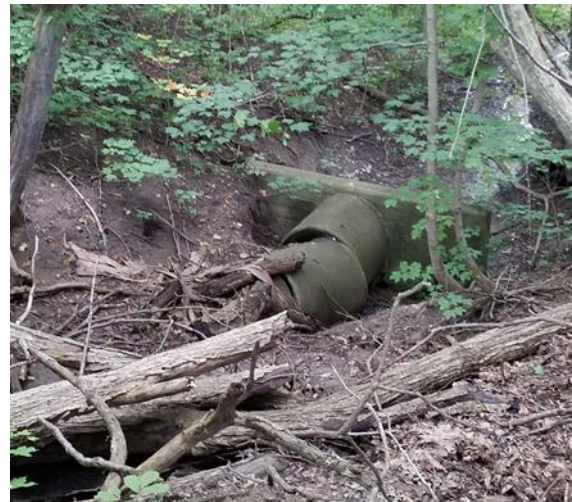
Left: Proportion of stream in each erosion category. Right: High erosion damaging Lower Huron Metropark culvert.

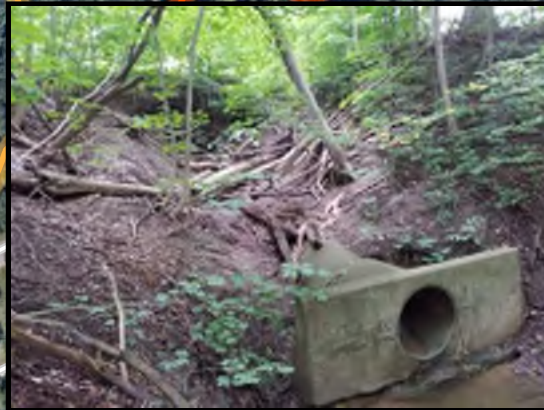
S3-LOW-008 **CRITICAL**

**INFRASTRUCTURE IMPACTED
BY VERY HIGH EROSION
INDICATES CRITICAL CONDITION**

Recommended Treatment: Soil Lifts with Live Stakes

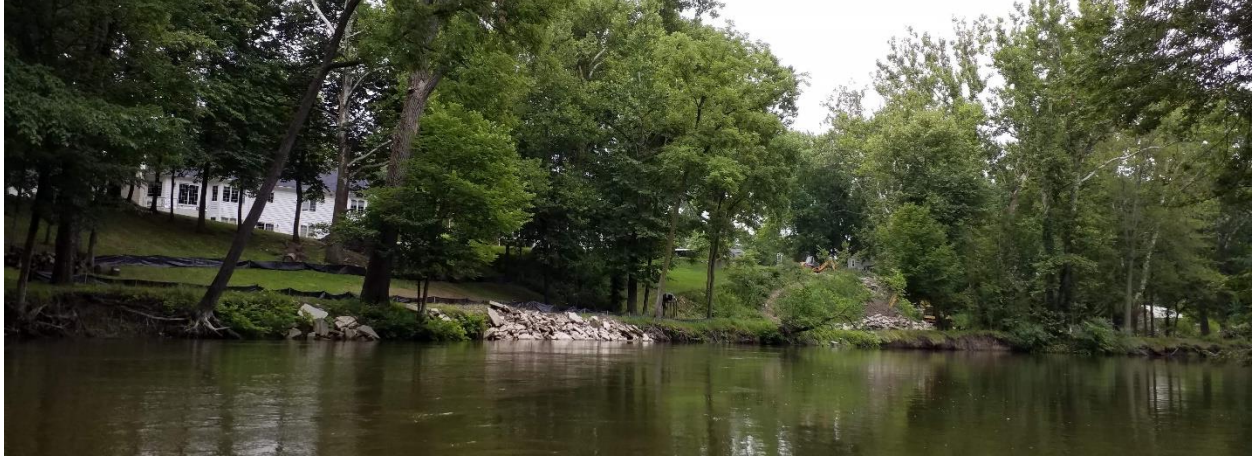
Minor slumping in Lower Huron Metropark.

The shoreline in Lower Huron is composed of several small lakes and ponds. No restoration activity is recommended at this time.
