Oakwoods Metropark Stormwater Management Plan

September 2019

Oakwoods Metropark Stormwater Structure Recommendations

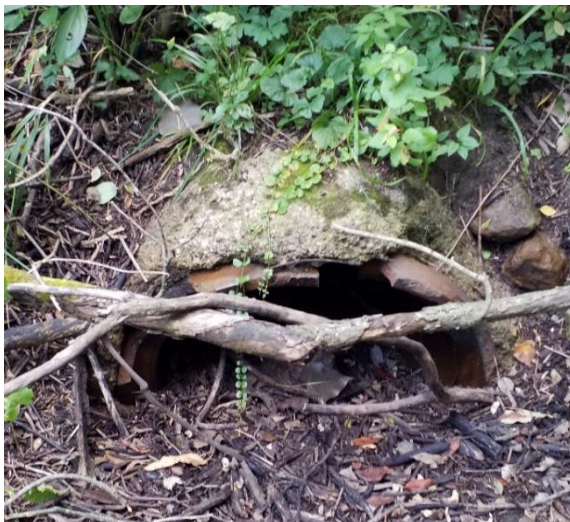
Left: Failing culvert in Oakwoods. Right: Proportion of culverts in each condition category.

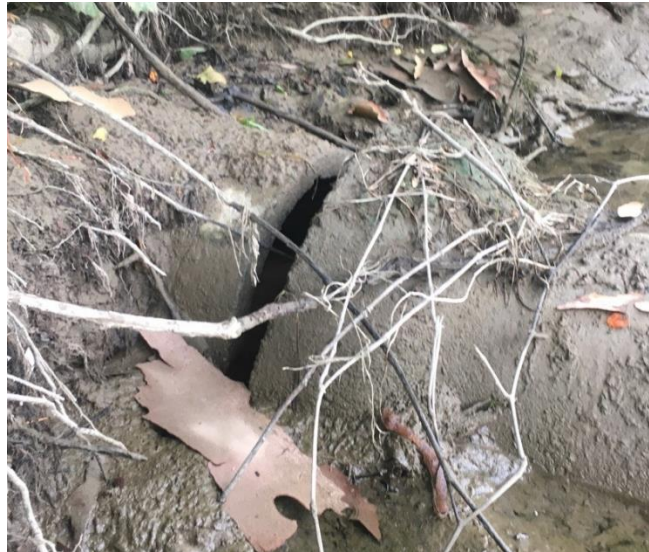
Left: Proportion of outfalls in each condition category. Right: Detached outfall in failing condition in Oakwoods Metropark.

Outfall ID	Diameter (in)	Condition	Maintenance Need	Cost Opinion
SDC-OAK-010	6	Failing	Replacement	\$5,000
SDC-OAK-004*	18	Poor	Replacement	\$7,500
Total:				\$12,500

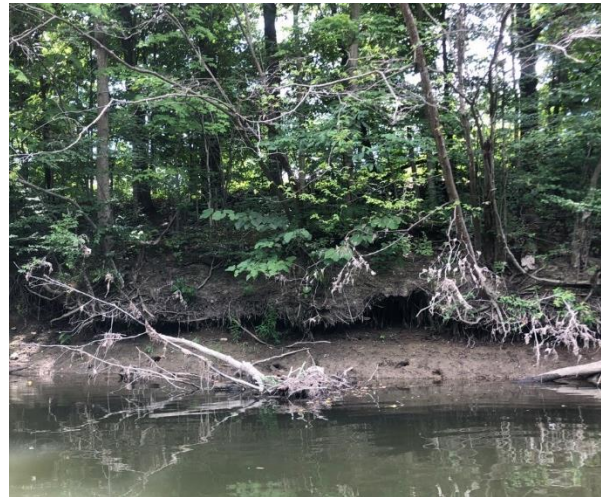
Left: Proportion of stream bank in each erosion severity category. Right: Severe erosion on bank in Oakwood Metropark.

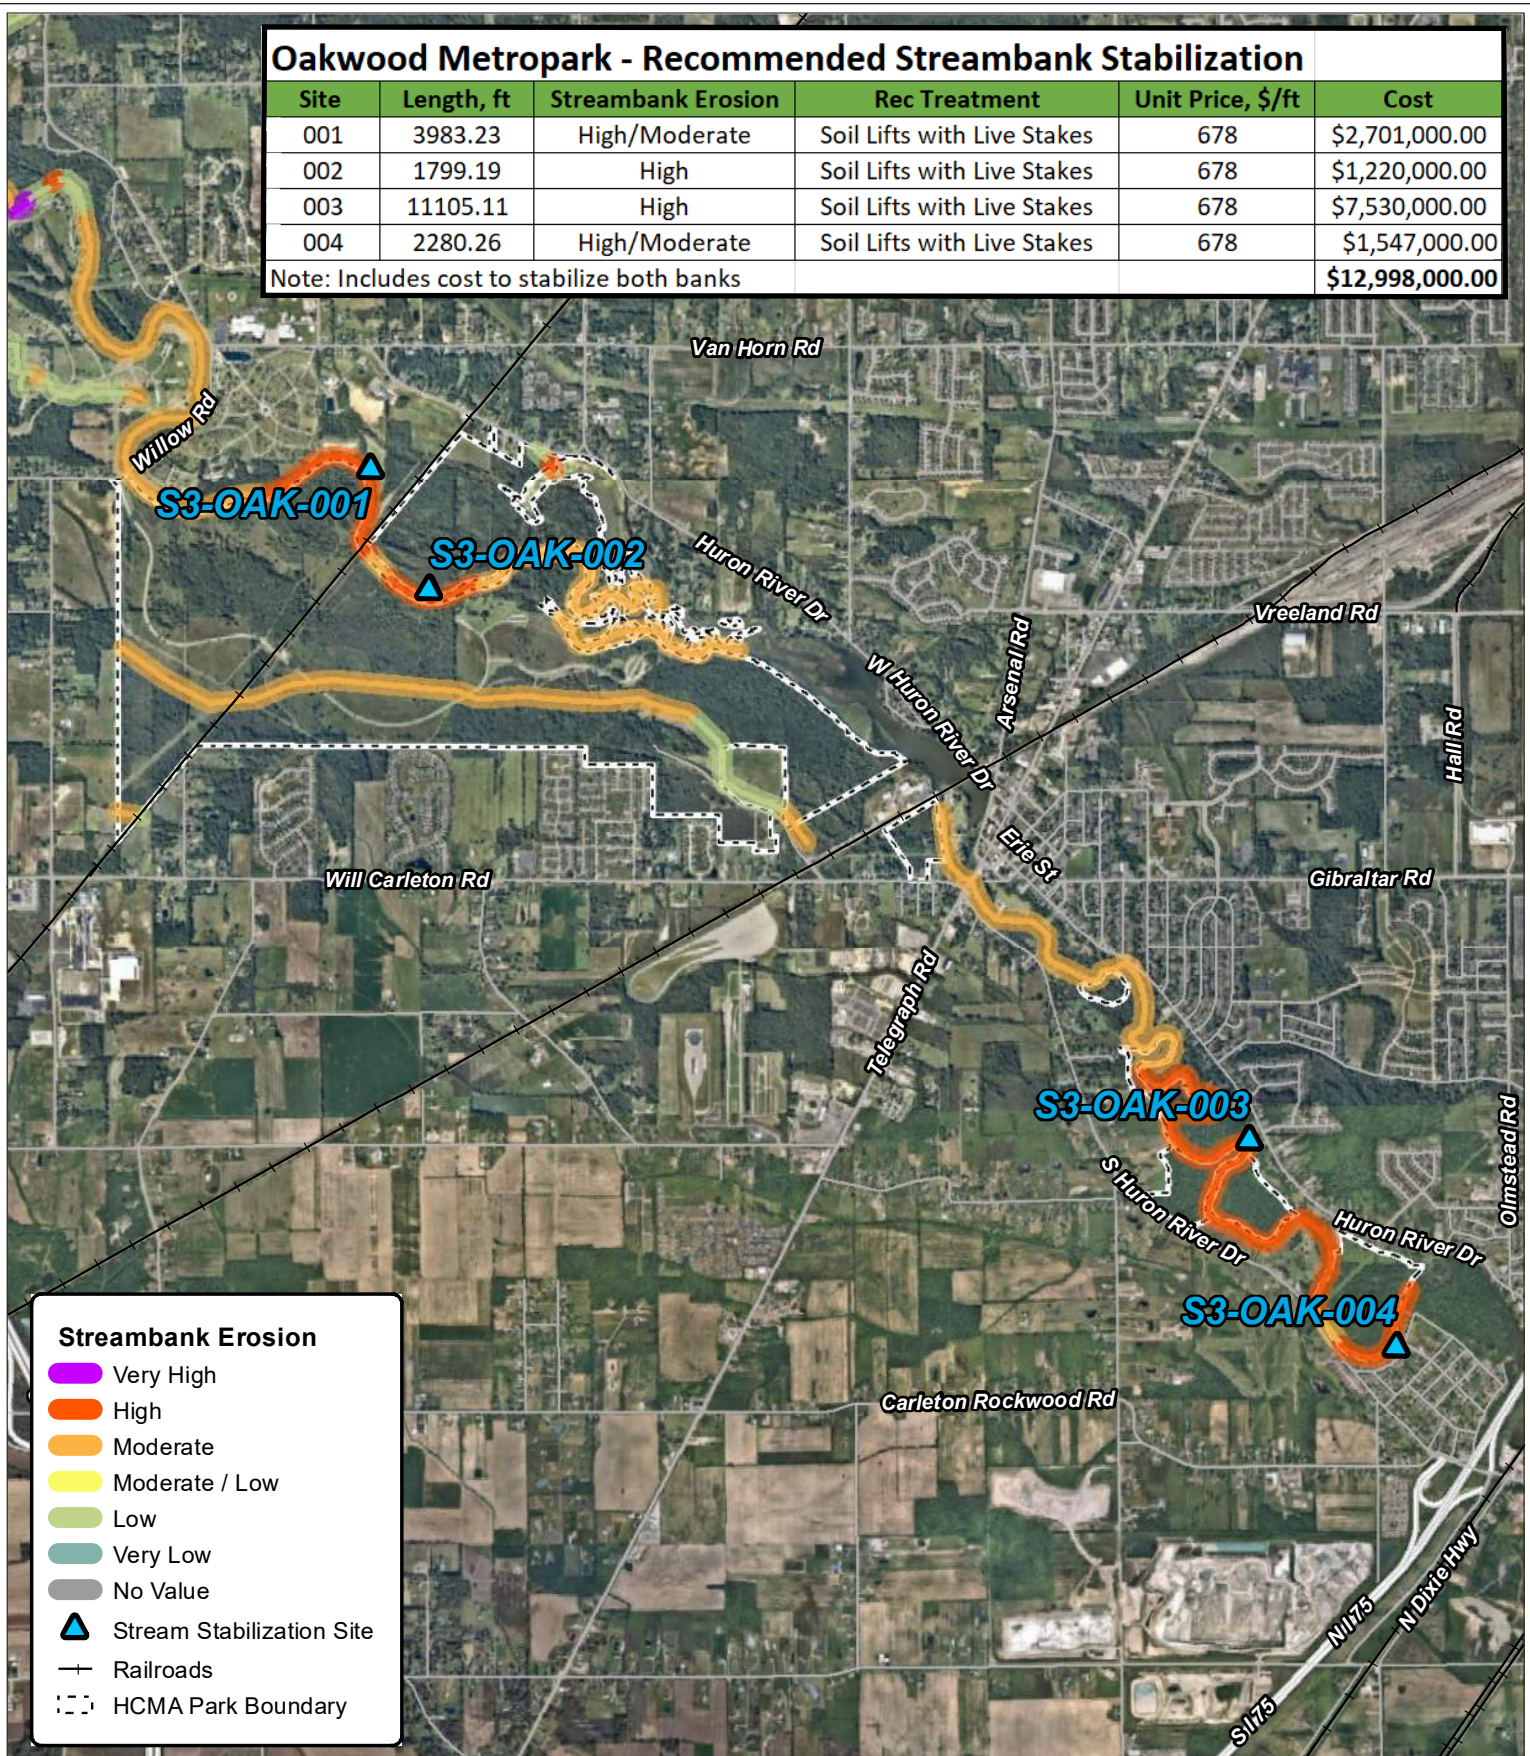
S3-OAK-001

Length: 3,983.23 ft

Recommended Treatment: Soil Lifts with Live Stakes

Construction Cost: \$2,700,630

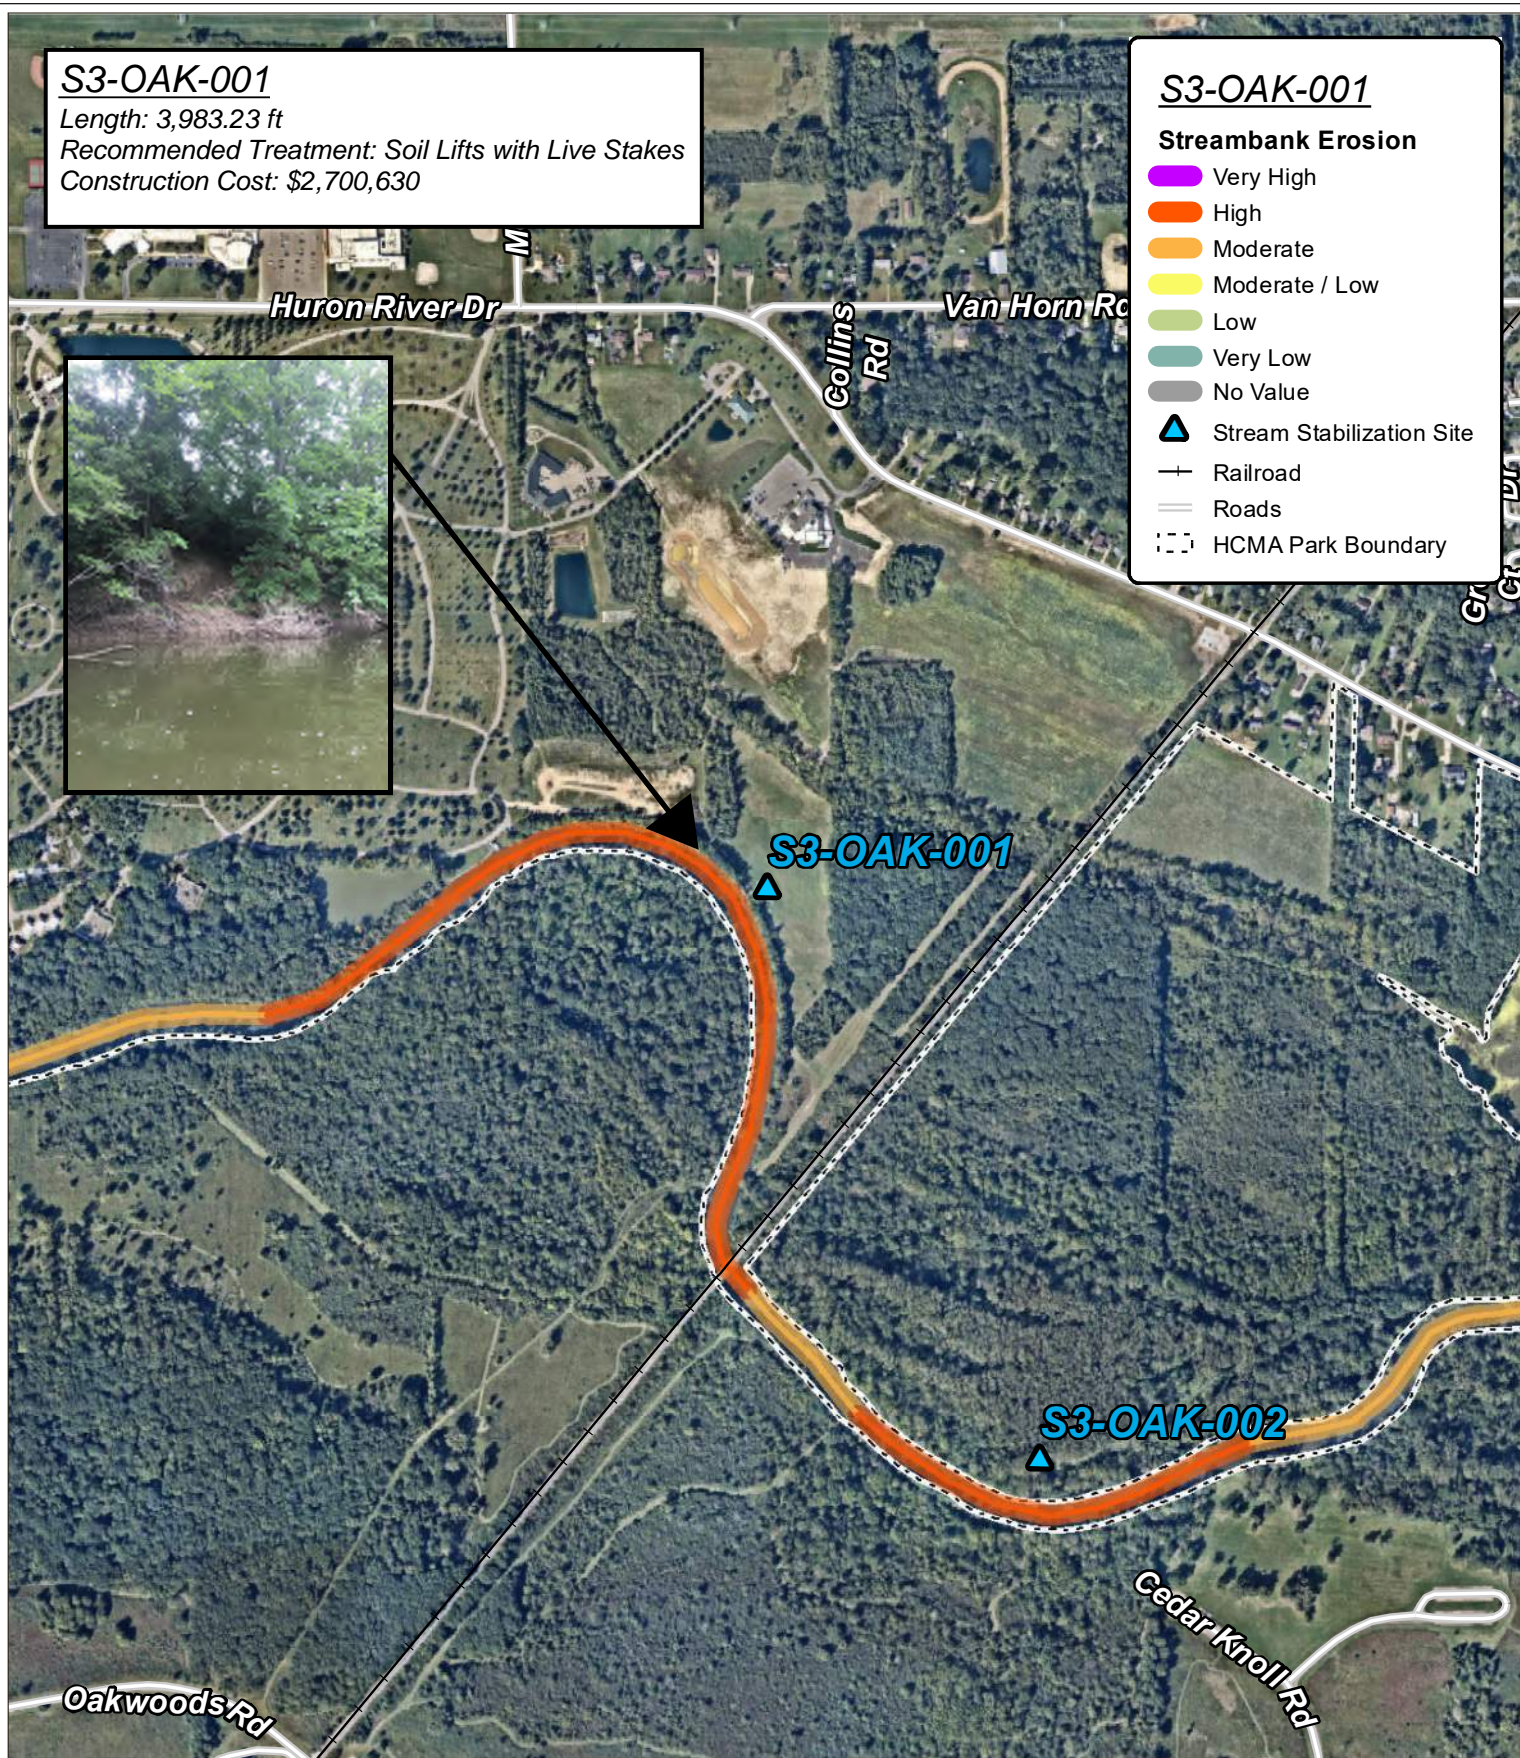
S3-OAK-002

Length: 1799.19 ft

Recommended Treatment: Soil Lifts with Live Stakes

Construction Cost: \$1,219,851

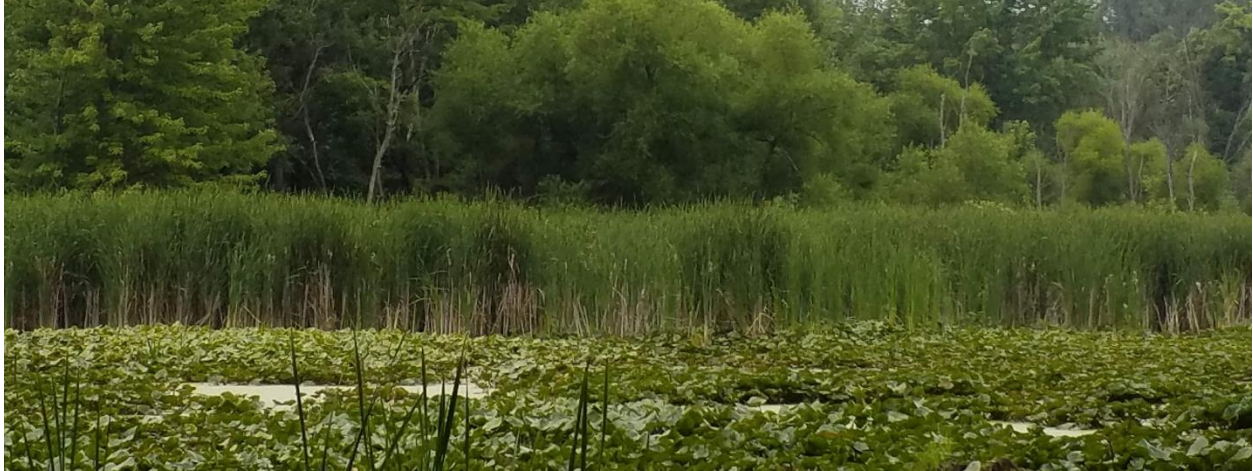
Freshwater marsh with no slumping in Oakwoods Metropark.
