Stony Creek Metropark Stormwater Management Plan

September 2019

Stony Creek Metropark Stormwater Structure Recommendations

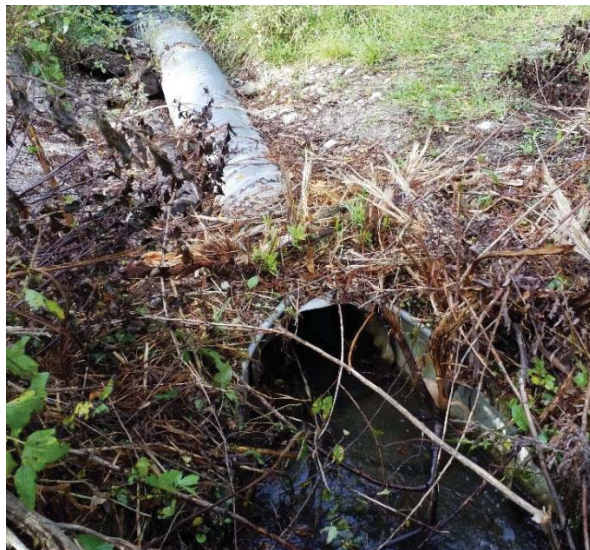
Left: Failing culvert in Stony Creek Metropark. Right: Proportion of culverts in each condition category.

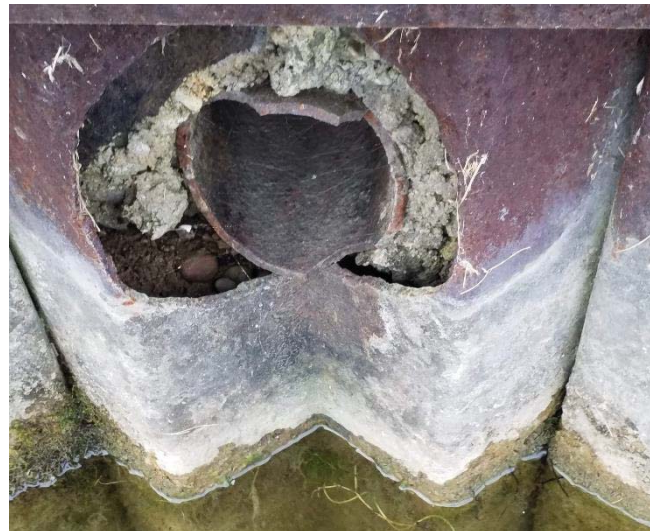
Left: Proportion of outfalls in each condition category. Right: Outfall in seawall in poor condition in Stony Creek Metropark.

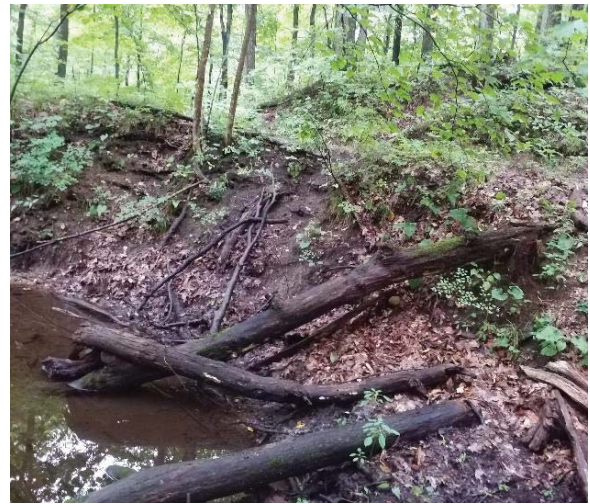
Left: Proportion of stream bank in each erosion category. Right: High erosion near a hiking trail in Stony Creek Metropark.

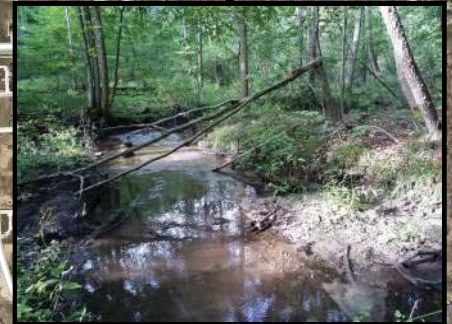
S3-STO-004 **CRITICAL**

Length: 710.65 ft

**INFRASTRUCTURE IMPACTED
BY VERY HIGH EROSION
INDICATES CRITICAL CONDITON**

Recommended Treatment: Soil Lifts with Live Stakes

Construction Cost: \$482,000

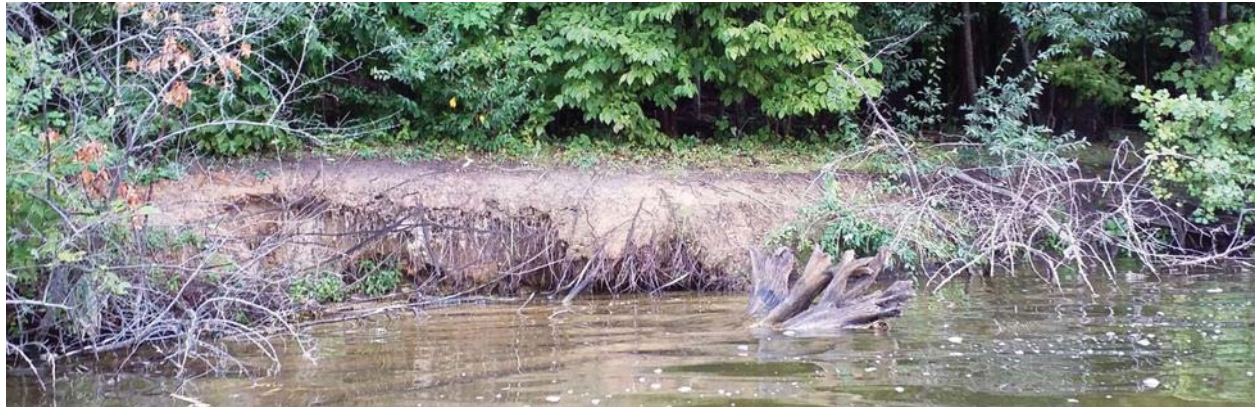
Major slumping in Stony Creek Metropark.
