HURON-CLINTON  
**metroparks**

# Willow Metropark Stormwater Management Plan

September 2019

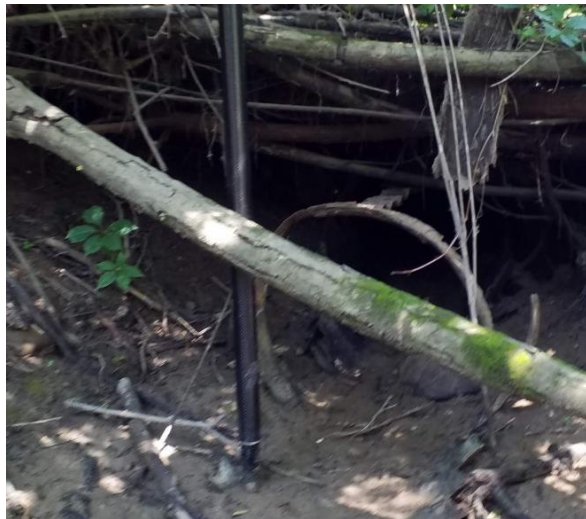
*Left: Failing culvert in Willow. Right: Proportion of culverts in each condition category.*

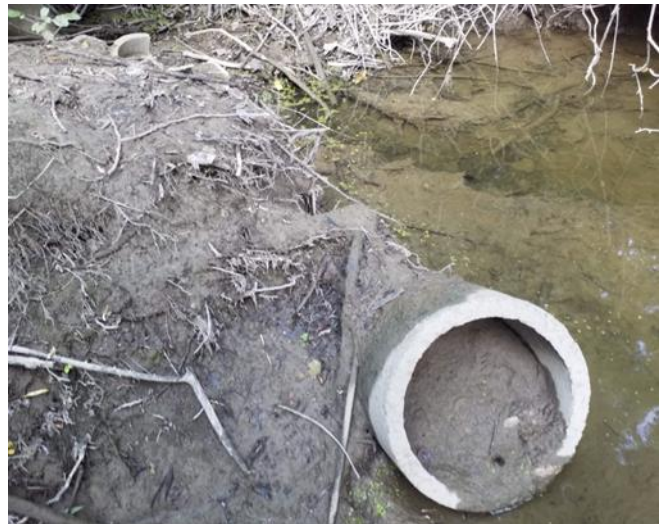
Left: Proportion of outfalls in each condition category. Right: Severely damaged outfall in failing condition in Willow.

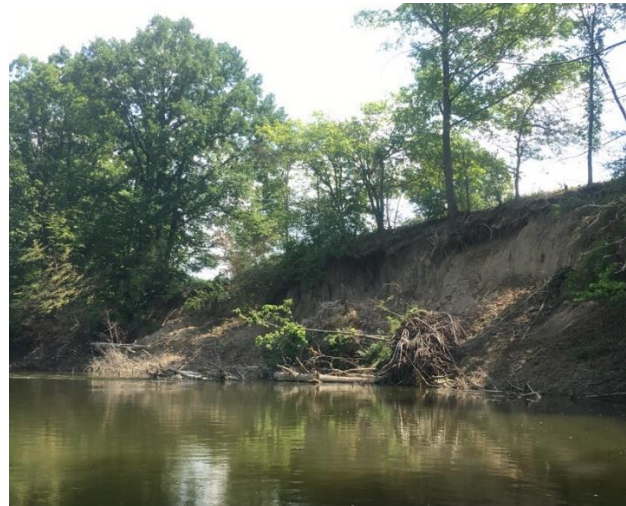
*Left: Proportion of stream in each erosion category. Right: High erosion on a bank next to a path in Willow Metropark.*

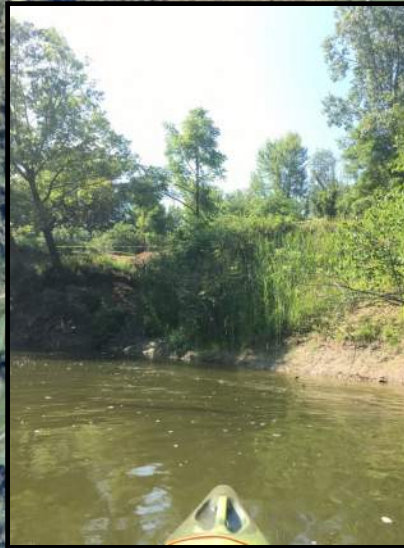
### S3-WIL-003

### Site-003 **CRITICAL**

Length: 5,104.15 ft

**INFRASTRUCTURE IMPACTED  
BY VERY HIGH EROSION  
INDICATES CRITICAL CONDTION**

Recommended Treatment: Soil Lifts with Live Stakes

Construction Cost: \$3,461,000

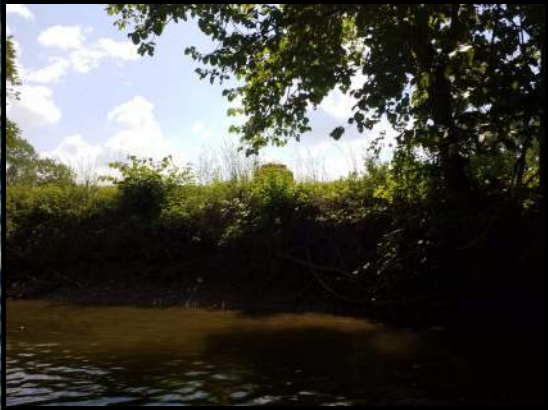
### Site-004 **CRITICAL**

Length: 336.76 ft

Recommended Treatment: Soil Lifts with Live Stakes  
Construction Cost: \$229,000

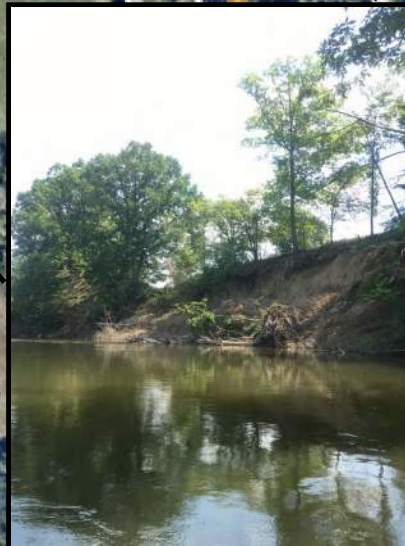
**INFRASTRUCTURE IMPACTED  
BY VERY HIGH EROSION  
INDICATES CRITICAL CONDITION**

### Site-005 **CRITICAL**

Length: 92.10 ft

Recommended Treatment: Soil Lifts with Live Stakes  
Construction Cost: \$63,000

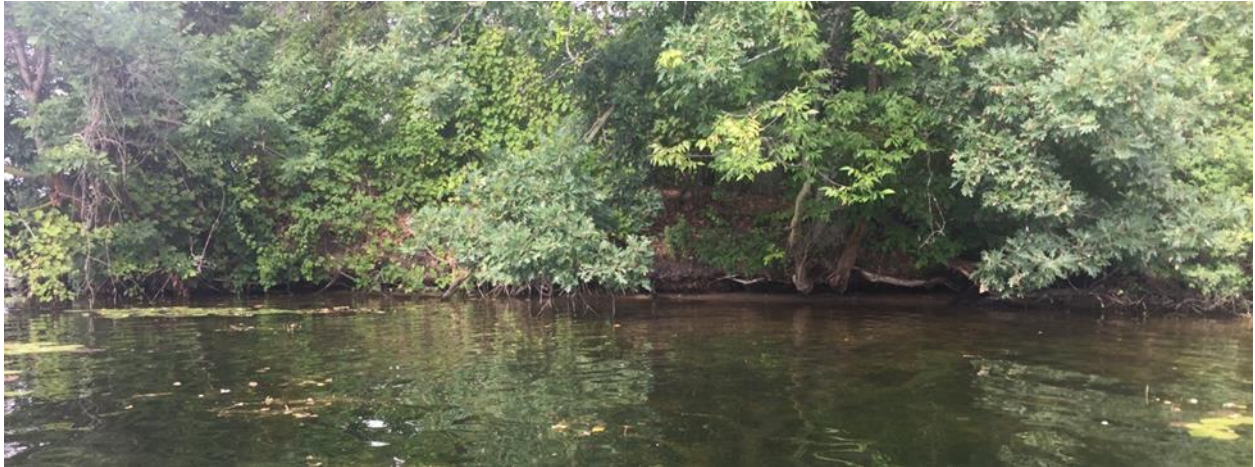
*Minor slumping in Willow Metropark.*

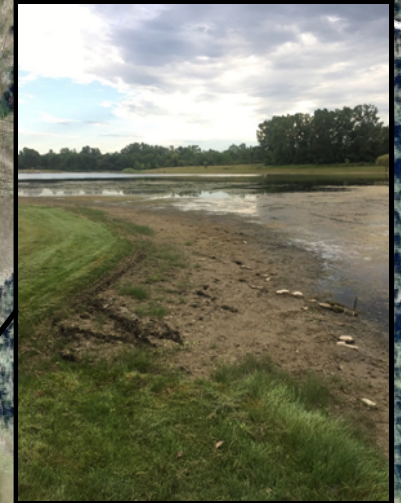
### SLR-WIL-001

### Site-001

Length: 307.86 Ft

Recommended Treatment: Detail D

Construction Cost: \$ 2,463
