# Wolcott Mill Metropark Stormwater Management Plan

September 2019

## Wolcott Mill Metropark Stormwater Structure Recommendations

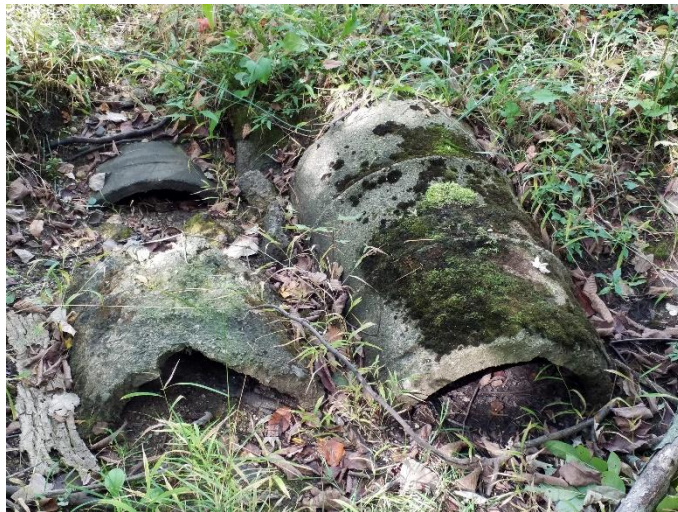
Left: Failing culvert in Wolcott Mill Metropark. Right: Proportion of culverts in each condition category.

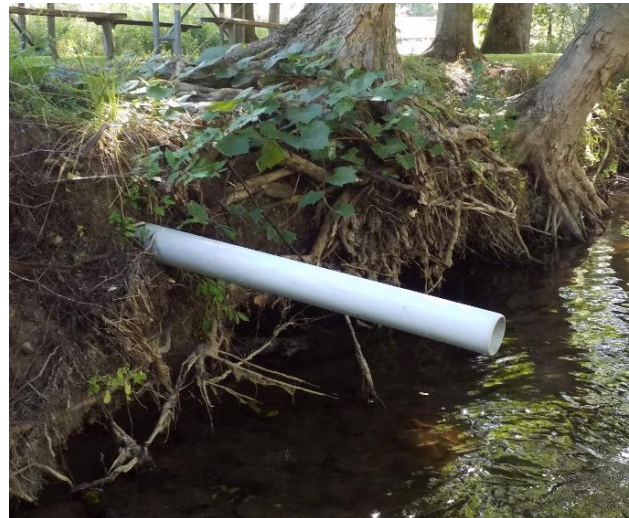
Left: Proportion of outfalls in each condition category. Right: Outfall in moderate condition in Wolcott Mill Metropark.

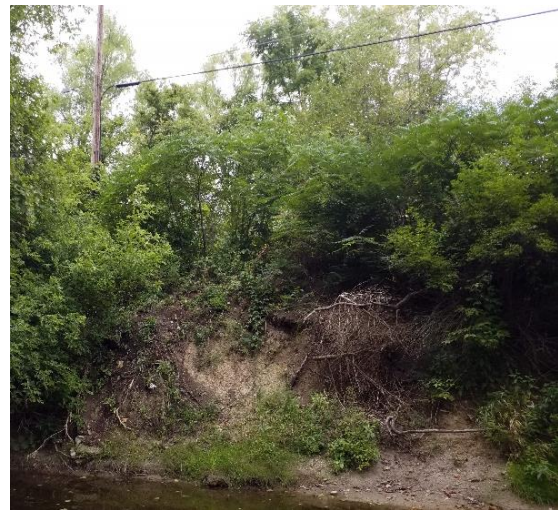
*Left: Proportion of stream in each erosion category. Right: High erosion endangering a power pole in Wolcott Mill Metropark.*

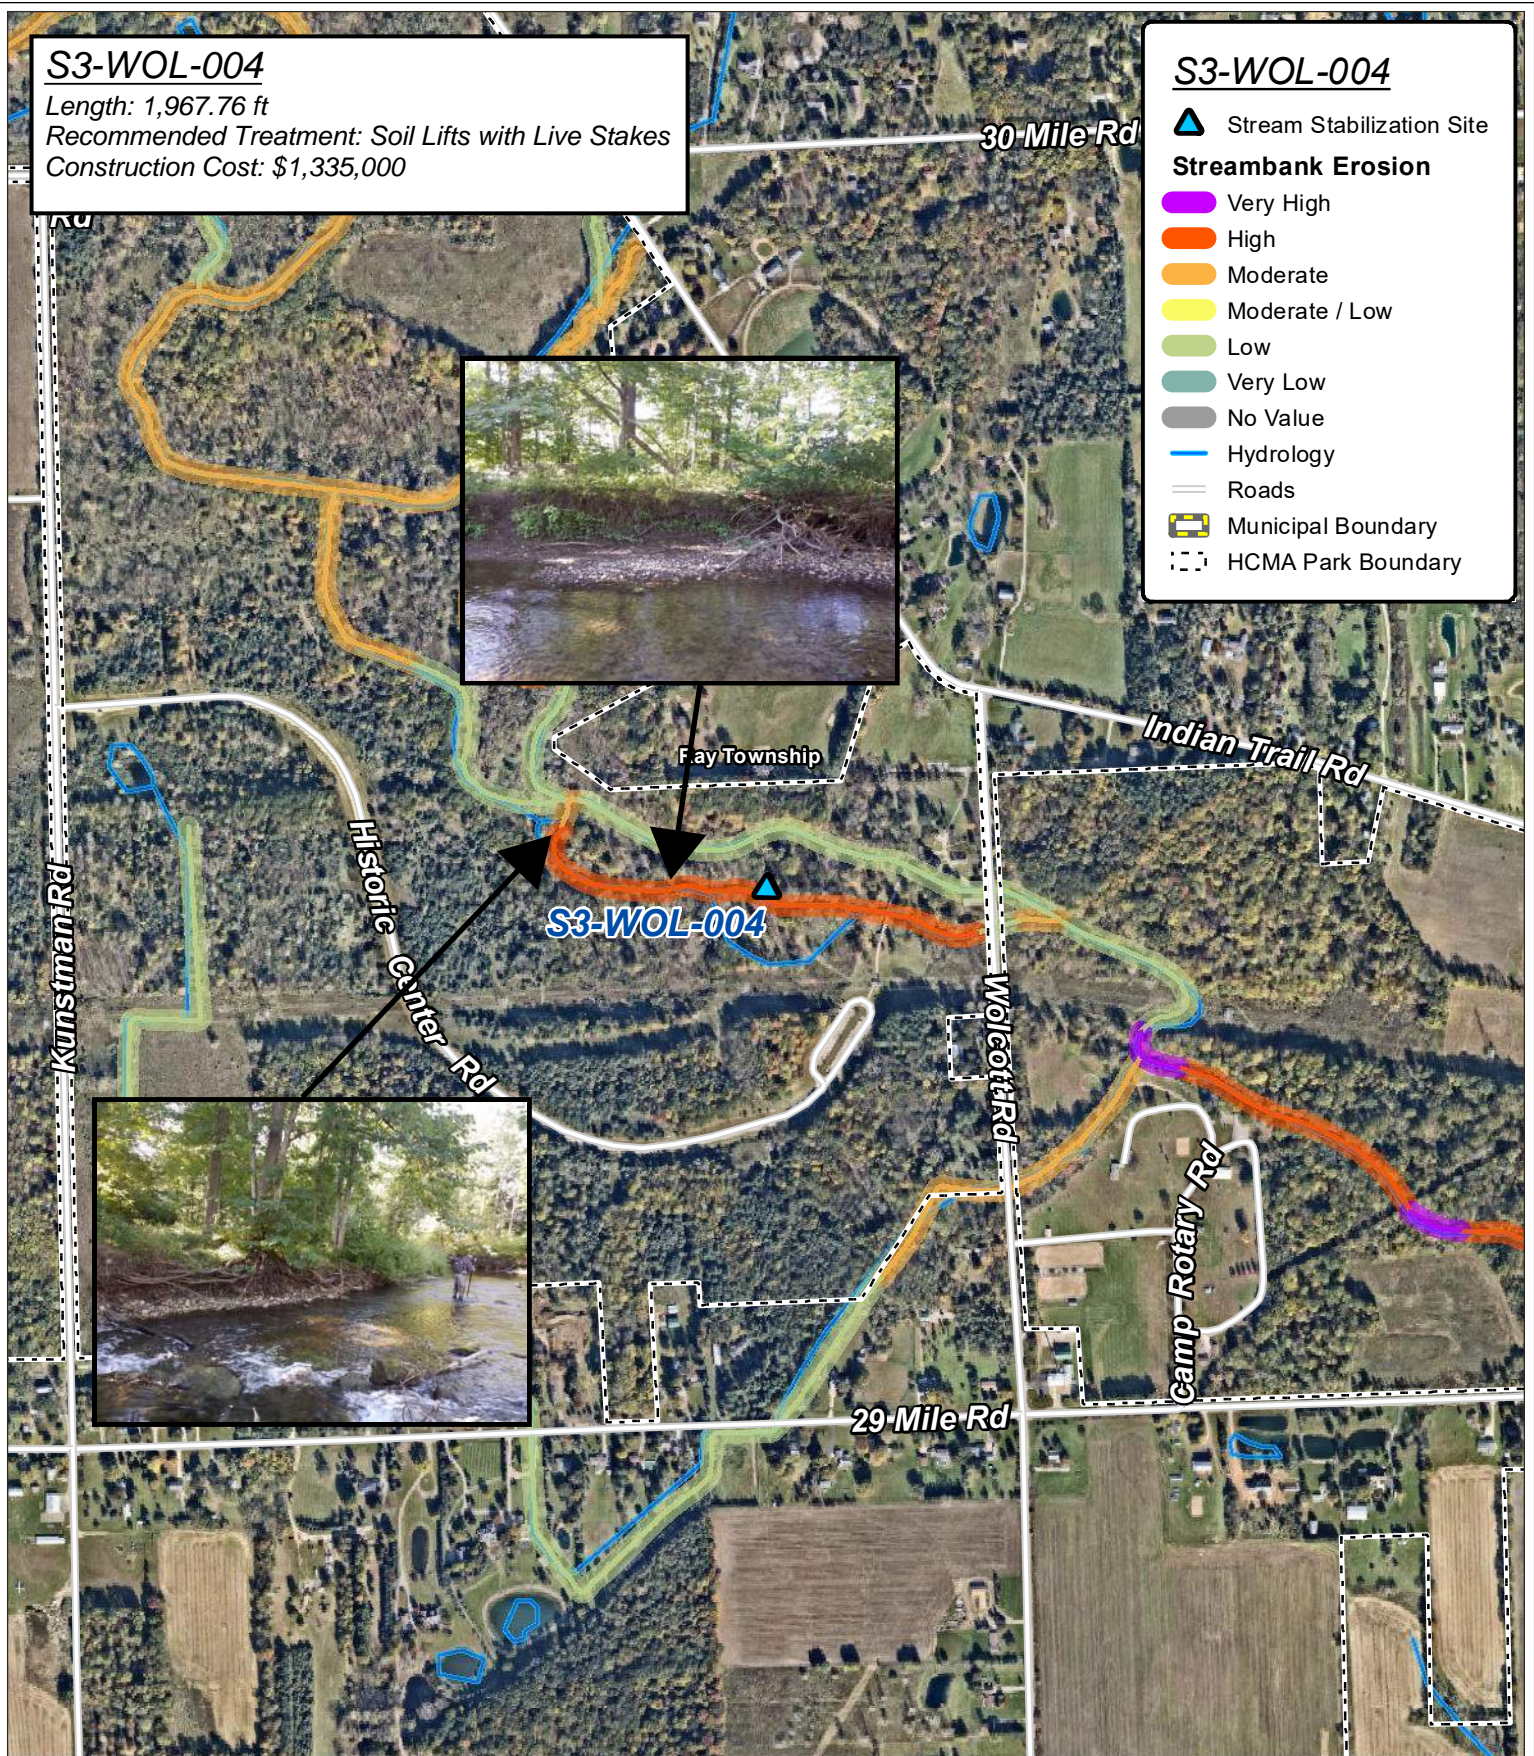
**S3-WOL-004**

Length: 1,967.76 ft

Recommended Treatment: Soil Lifts with Live Stakes

Construction Cost: \$1,335,000

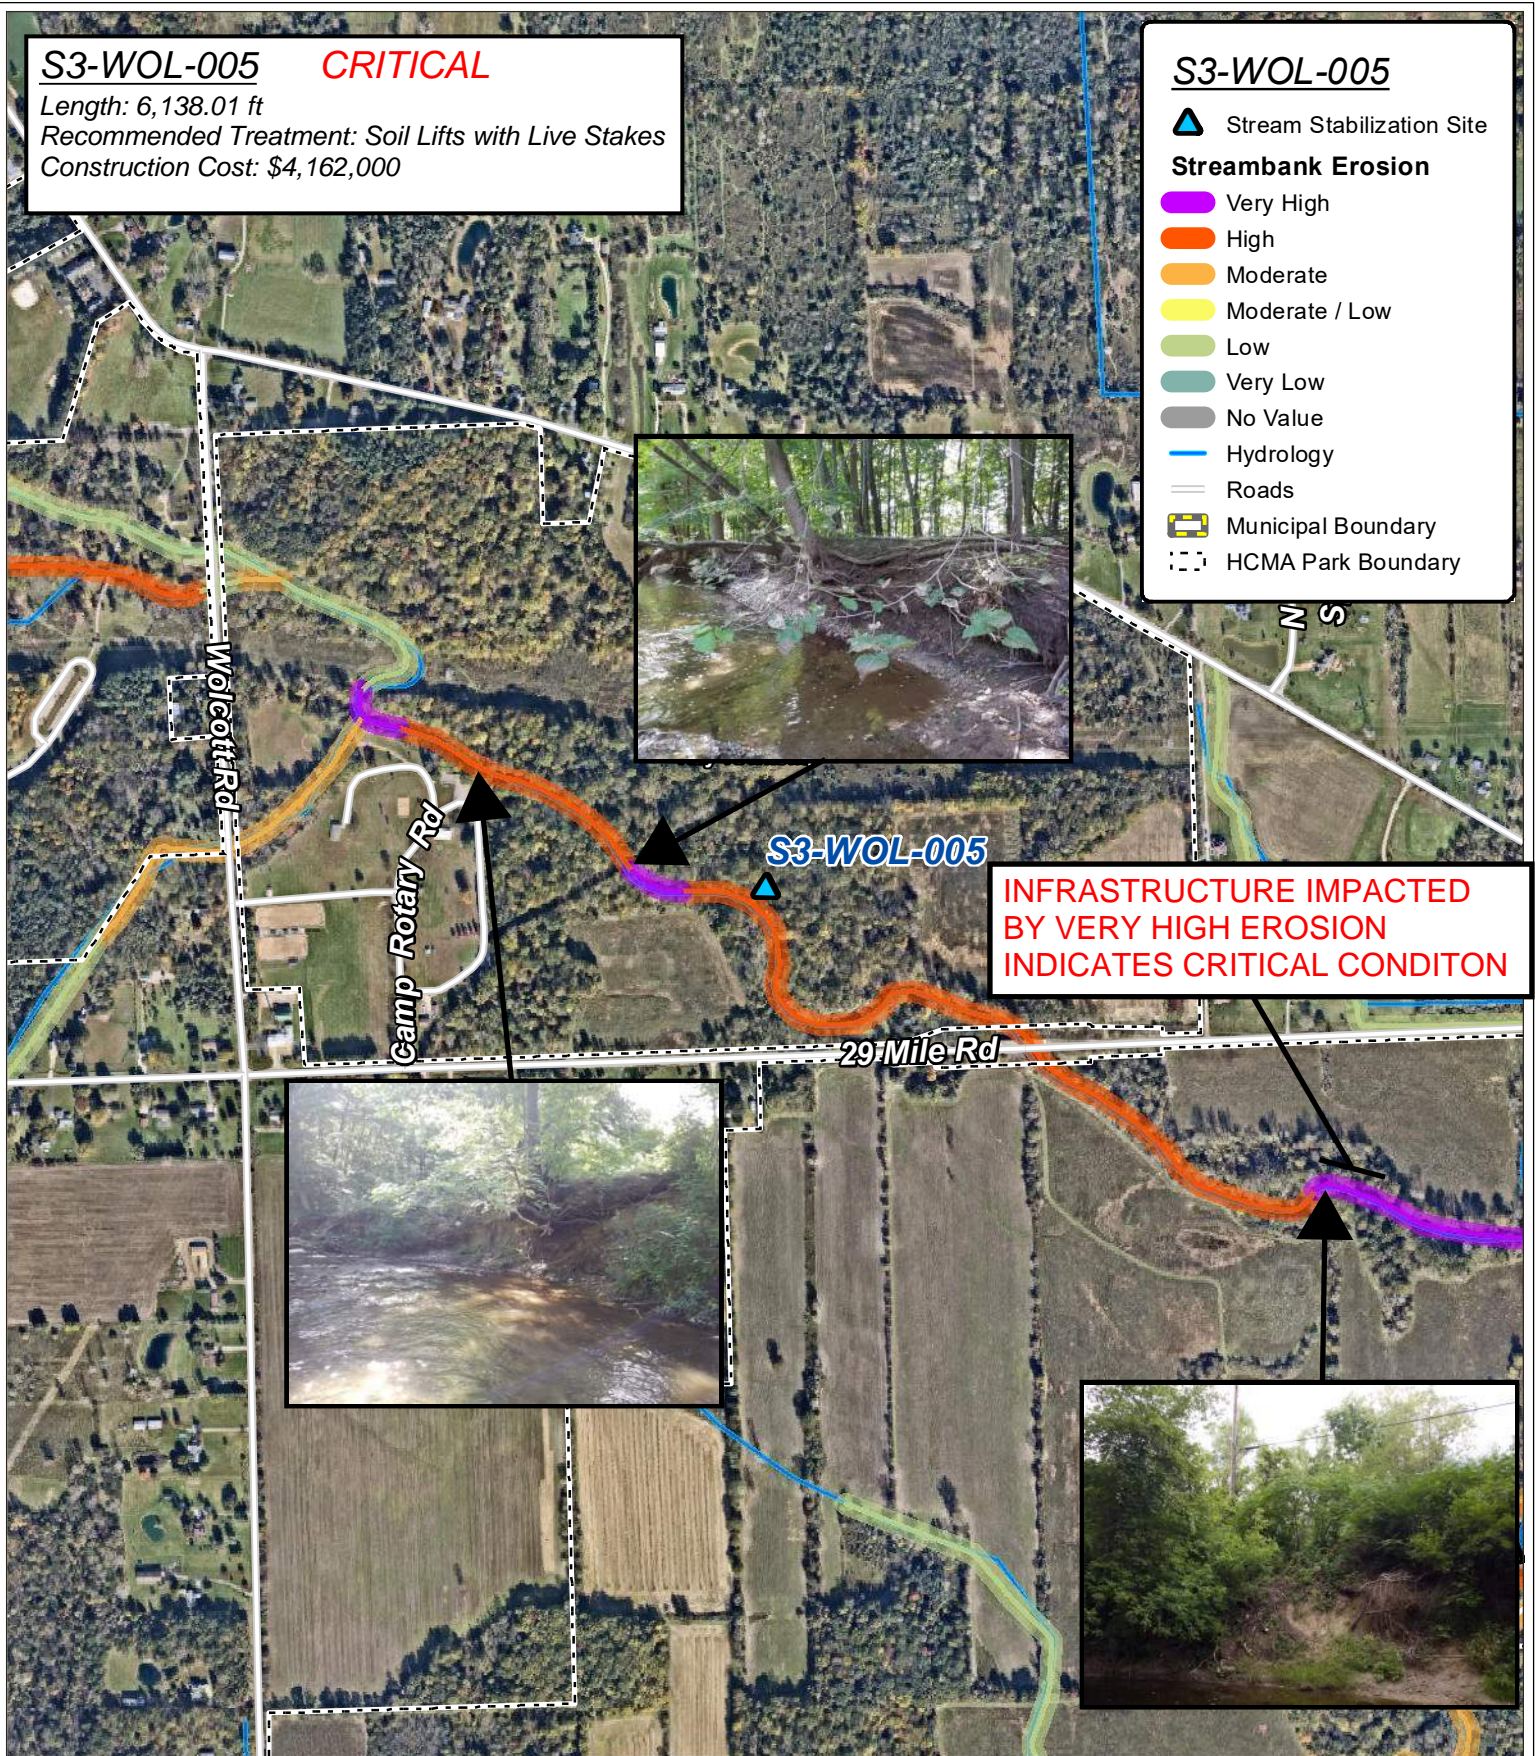
**S3-WOL-005**

**CRITICAL**

Length: 6,138.01 ft

Recommended Treatment: Soil Lifts with Live Stakes

Construction Cost: \$4,162,000

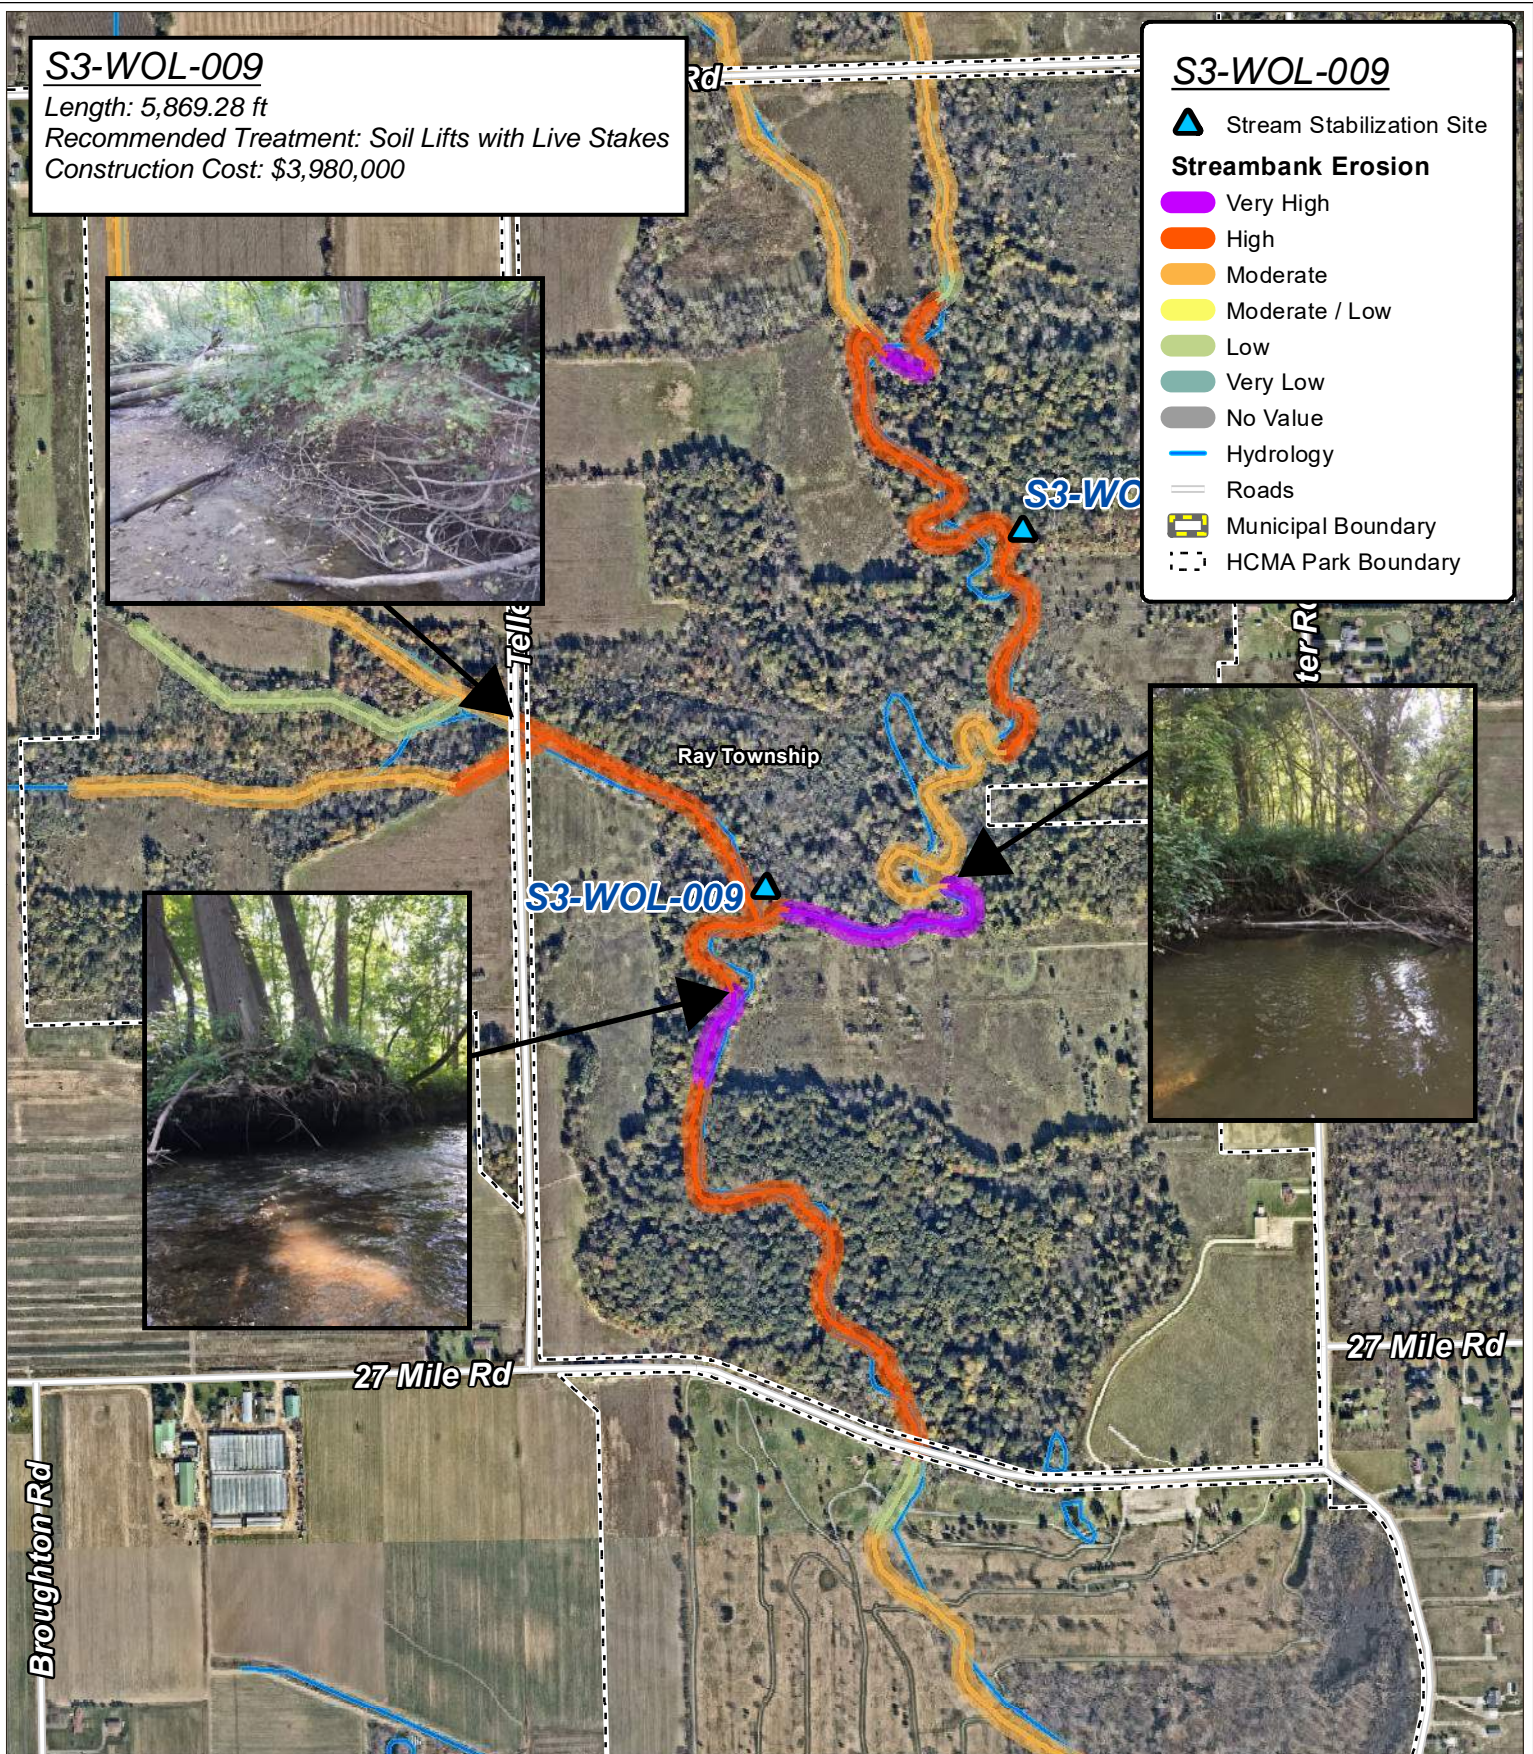
**S3-WOL-009**

Length: 5,869.28 ft

Recommended Treatment: Soil Lifts with Live Stakes

Construction Cost: \$3,980,000

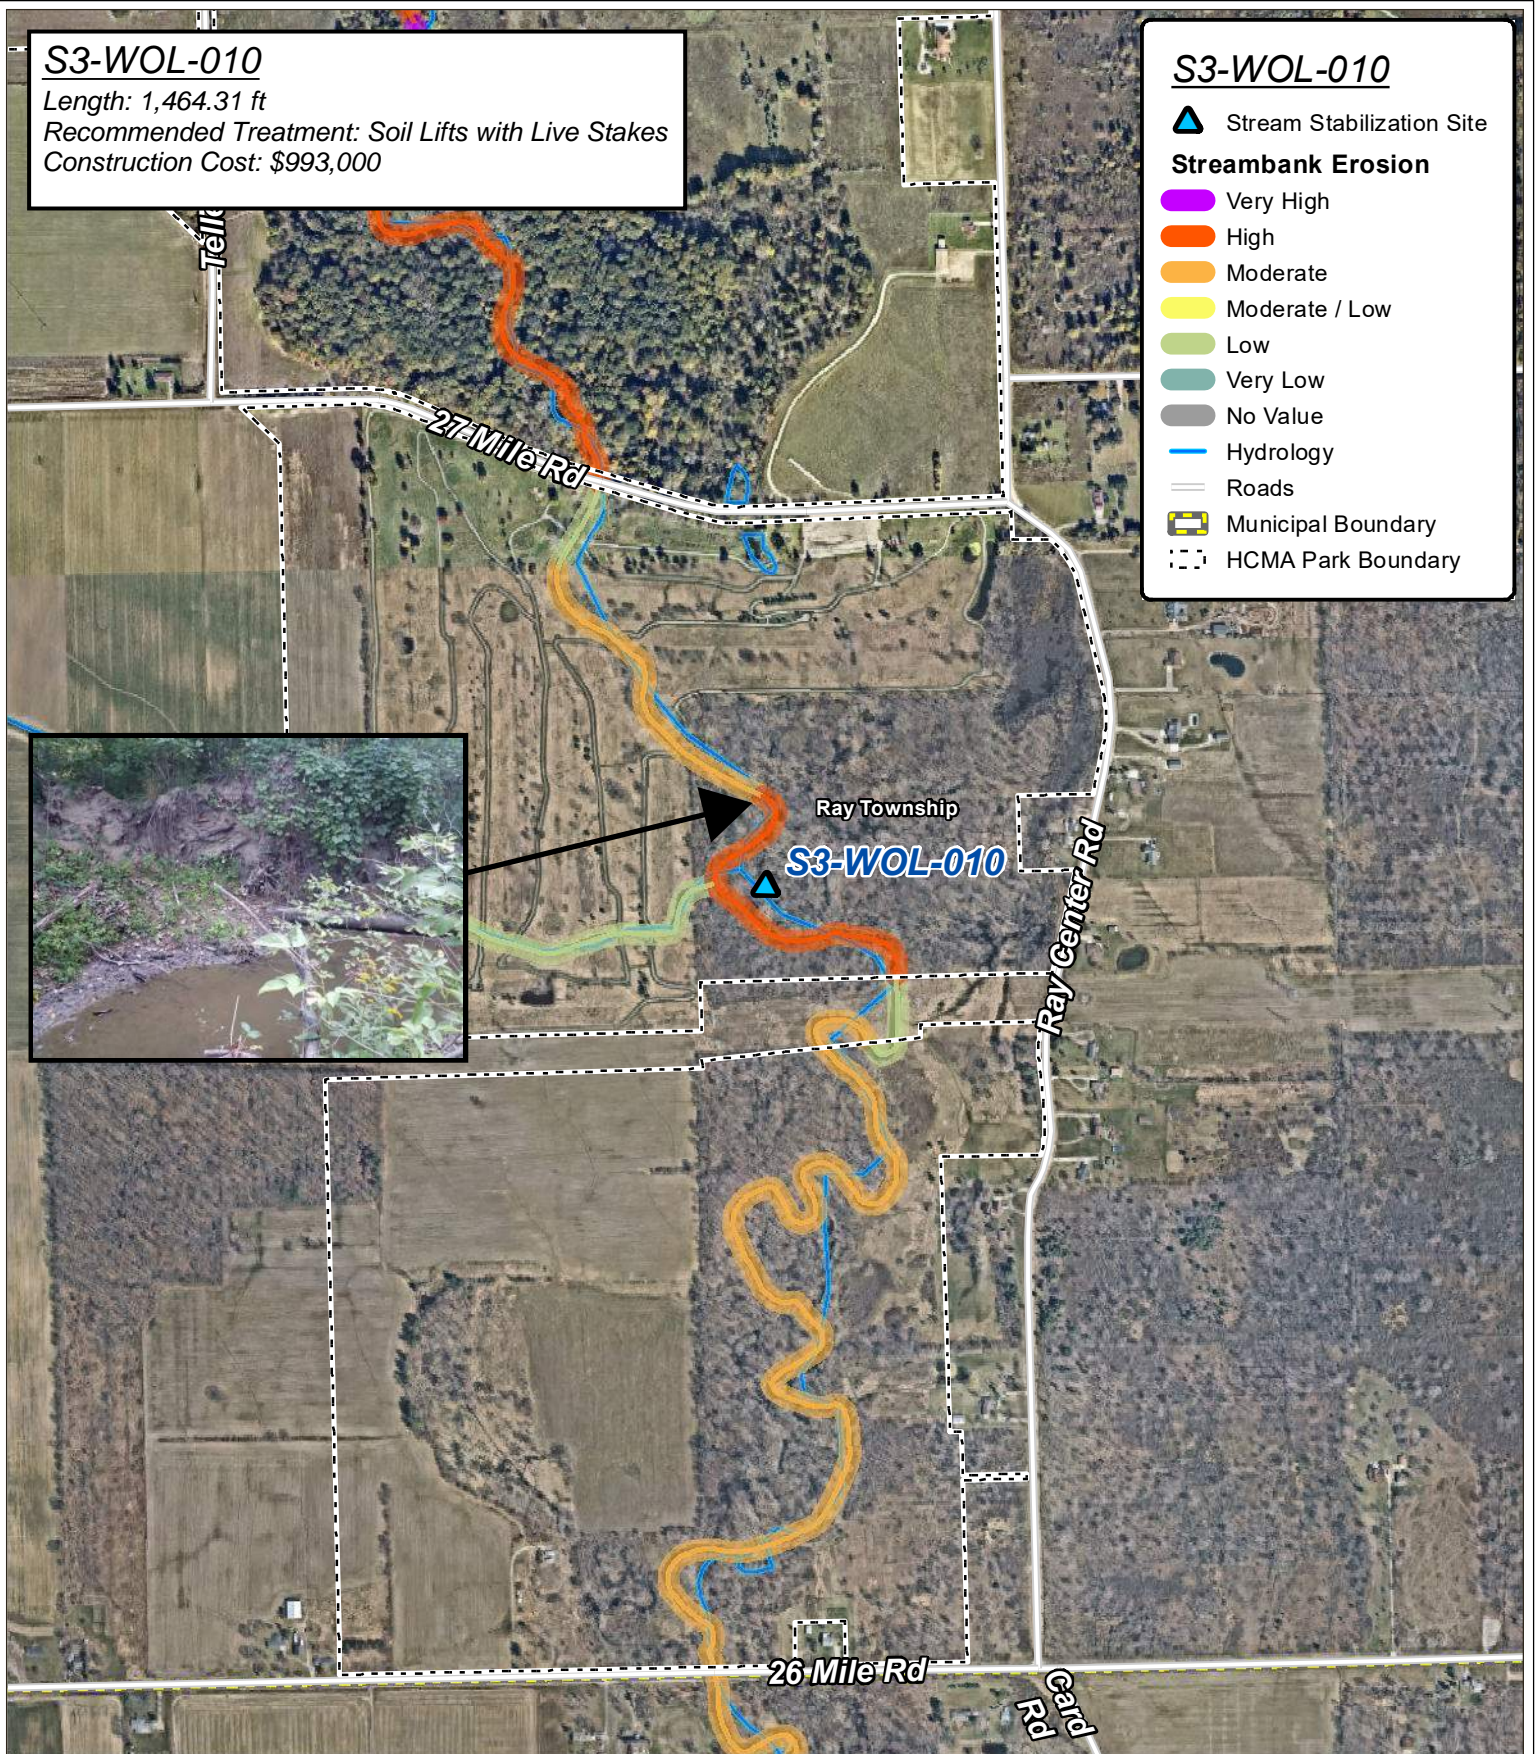
## S3-WOL-010

Length: 1,464.31 ft

Recommended Treatment: Soil Lifts with Live Stakes

Construction Cost: \$993,000

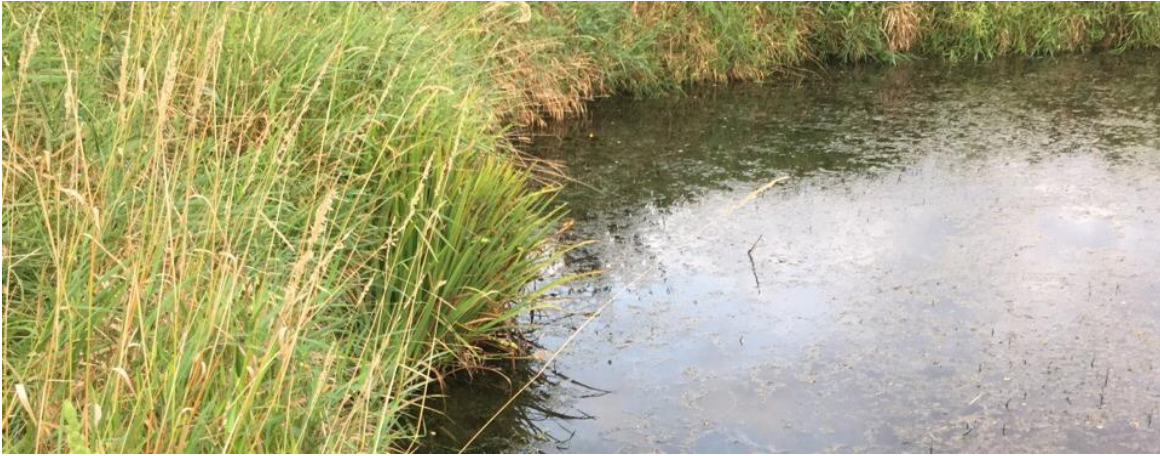
*Minor slumping in Wolcott Mill Metropark.*

All shoreline in Wolcott Mill Metropark consists of vegetated low banks. No shoreline in this park is currently in need of restoration.
