SUBJECT: Flat Rock Dam, Dam ID No. 556; Wayne County

**DAM SAFETY INSPECTION REPORT
FLAT ROCK DAM – DAM ID NO. 556
HURON RIVER
WAYNE COUNTY – SW 1/4 SECTION 31, T 04S, R 10E**

FLAT ROCK DAM
WAYNE COUNTY
DAM ID NO. 556
APPENDIX B – INSPECTION PHOTOS

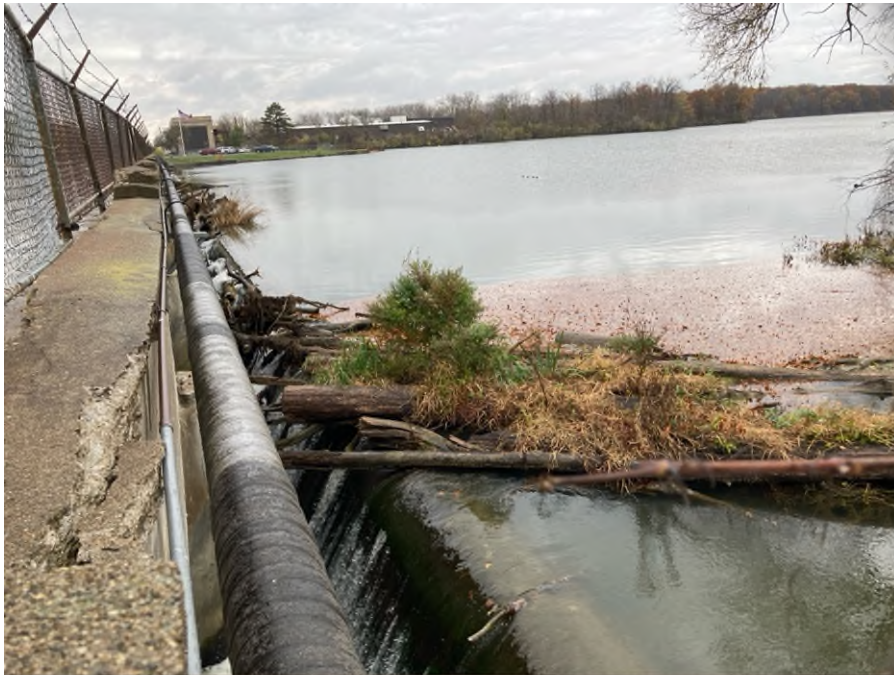
Photo #3: Principal Spillway Weir Wall.
Issue: Debris, Action: Maintenance.

- 1 **Debris (Action: Maintenance):** Remove debris. Complete action as soon as possible.
 - a Principal Spillway: Weir Wall
- 2 **Deteriorating Material (Action: Maintenance, Material: Concrete):** Remove the deteriorated concrete and install new concrete. Remove all deteriorated concrete, additional concrete may have to be removed to ensure the patch is a minimum of 3 inches thick. Roughen existing concrete surface to improve the patch bond. Install high strength concrete. Complete action by December 31, 2024.

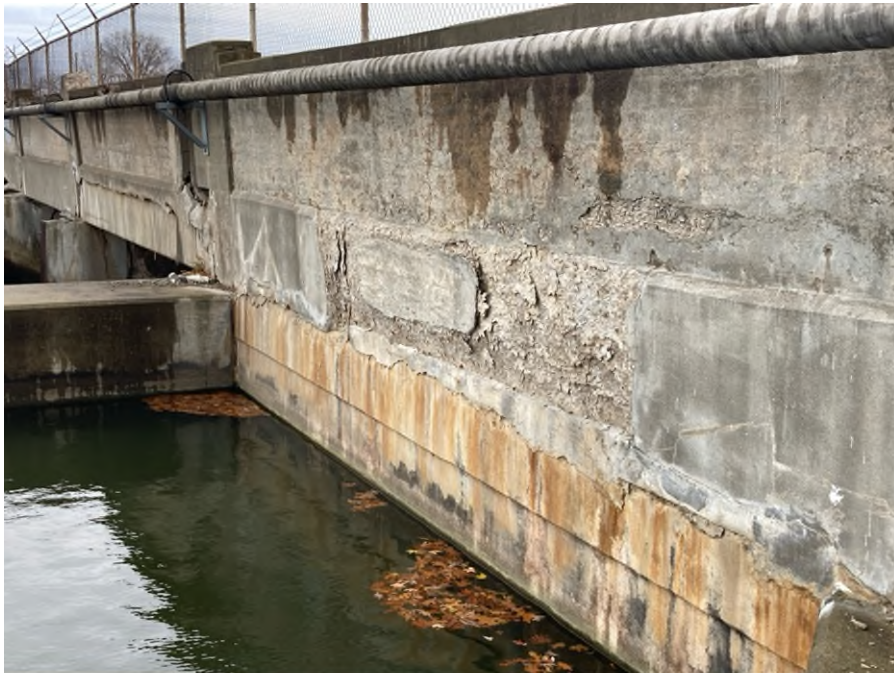
Photo #9: Principal Spillway Abutment Right Wall.
Issue: Deteriorating Material, Action: Maintenance.
Material: Concrete.

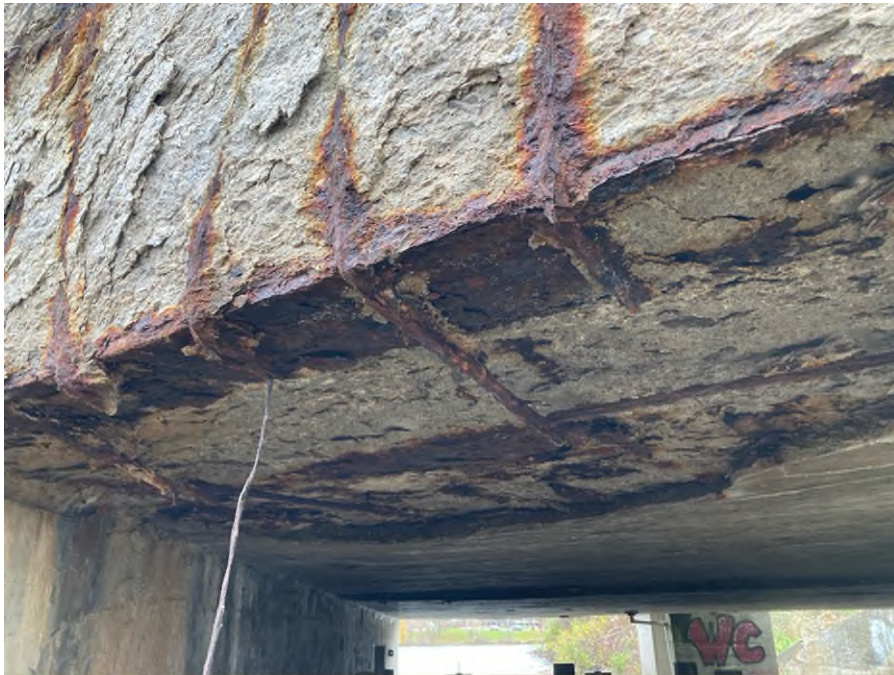
Photo #11: Principal Spillway Bridge.
Issue: Deteriorating Material, Action: Maintenance.
Material: Concrete.

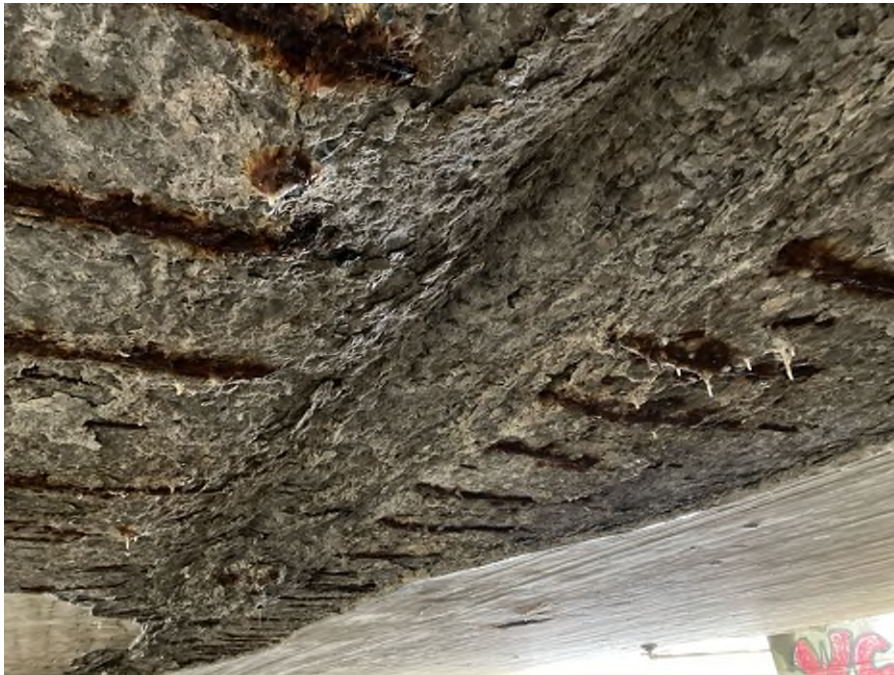
Photo #12: Principal Spillway Bridge.
Issue: Deteriorating Material, Action: Maintenance.
Material: Concrete.

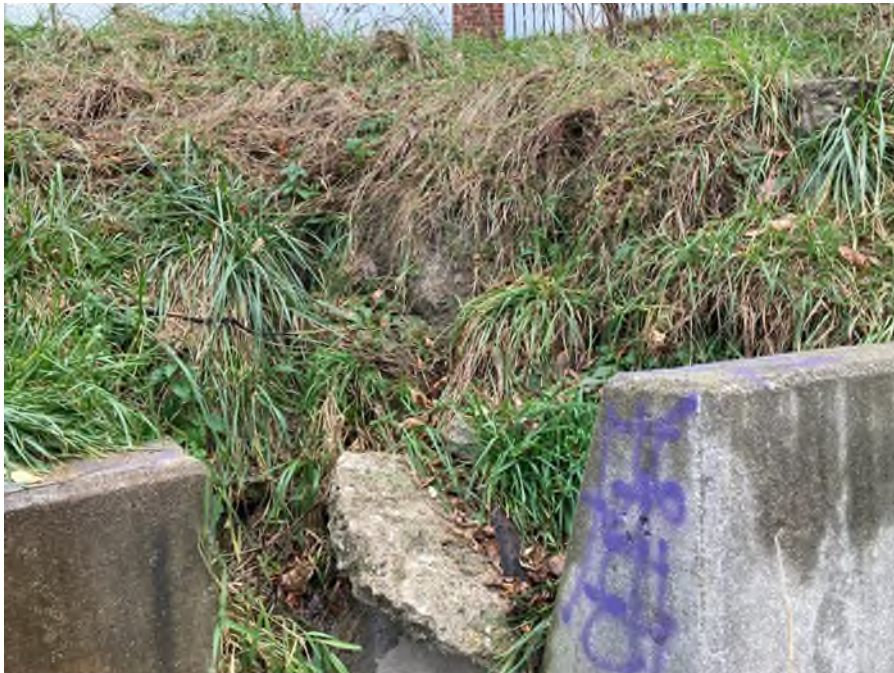
Photo #34: Embankment Downstream Slope. Right above storm sewer from Rhodes.
likely from seepage observed.
Issue: Depression, Action: Maintenance.

- a Principal Spillway: Abutment - Right Wall
 - b Principal Spillway: Bridge
- 3 **Depression (Action: Maintenance):** Reshape and stabilize area affected by depression. Remove vegetation and unsuitable fill material. Regrade the area to the original grade with material that matches the adjacent material. Install surface protection that matches the adjacent surface protection. After the depressions are filled the area should be monitored for another depression. If another depression is observed the Dam Safety Unit should be notified. Complete action by December 31, 2024.

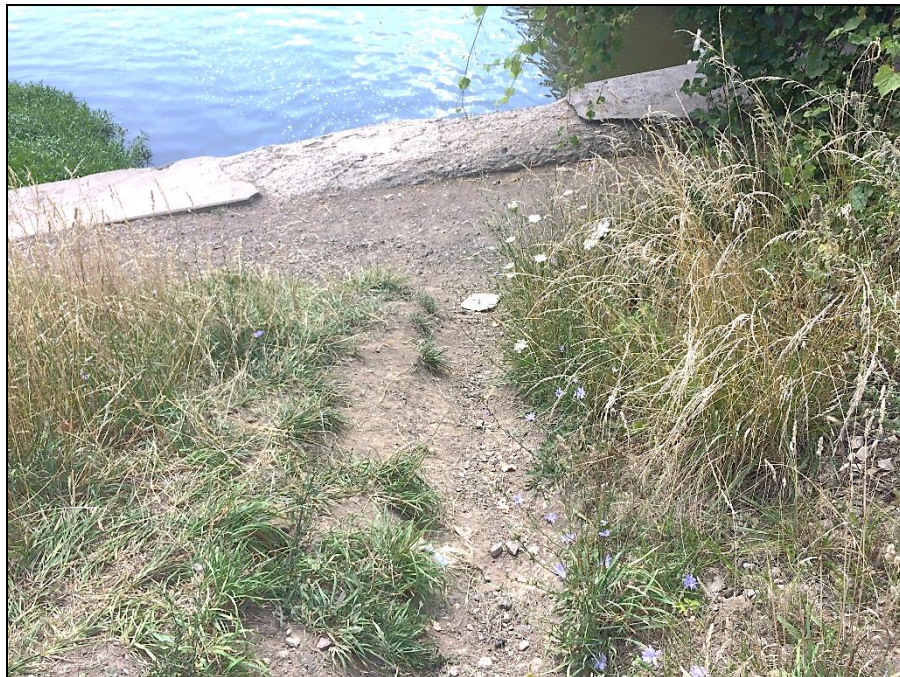
**Photograph 6 – Downstream face of left abutment viewed from left
Note the foot traffic erosion**

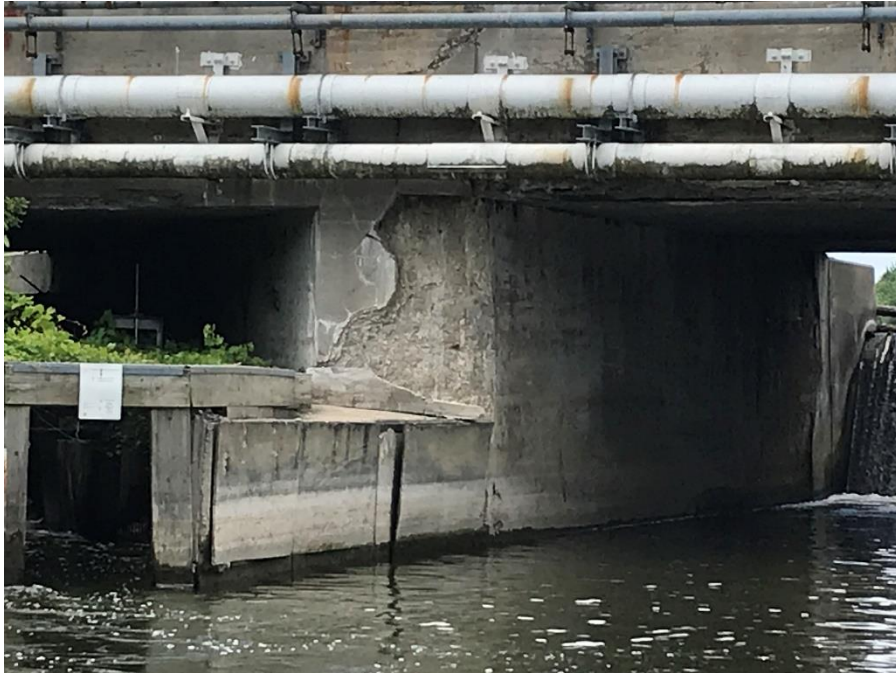
**Photograph 11 – Right downstream abutment wall
Note the spalling and delamination**

1. Continue to monitor the condition of both downstream concrete abutment walls of the principal spillway structure on a semi-annual basis. Implement repairs as necessary.
2. Remove all trees and brush from both earthen abutments. This recommendation has been repeated since the 2011 inspection report and should be completed as soon as reasonably possible. After clearing, both abutments should be mowed a minimum of two times per year to prevent further establishment of woody vegetation and to facilitate visual inspection.
3. Remove all vegetation from the left wall of the abandoned lock system. This recommendation is repeated from the 2014 and 2017 inspection reports and should be completed as soon as reasonably possible.
4. Backfill, compact, and seed the eroded areas along the downstream face of the left earthen abutment as soon as reasonably possible.

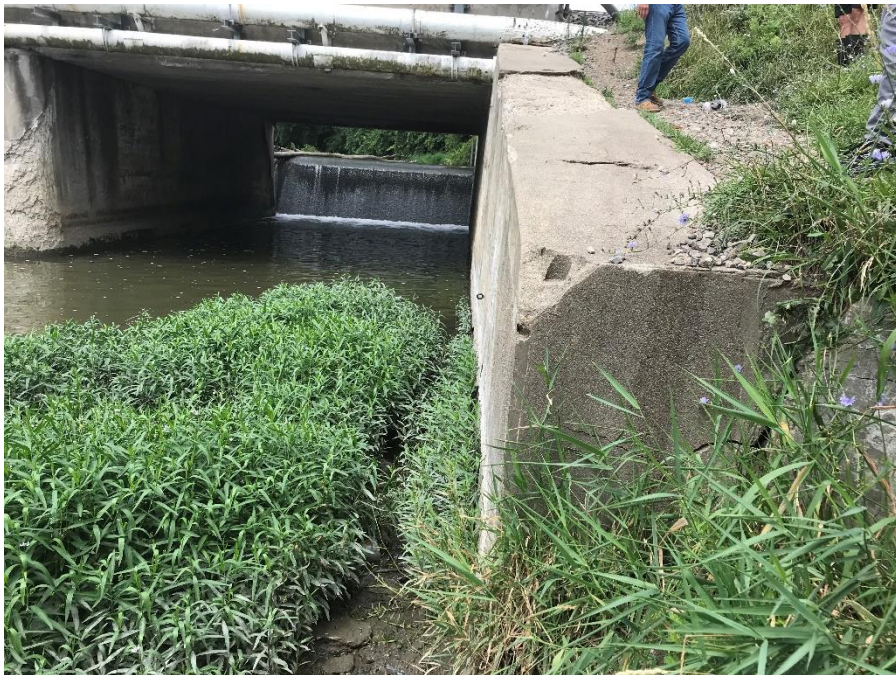
**Photograph 12 – Left downstream abutment wall
Note the spalling**

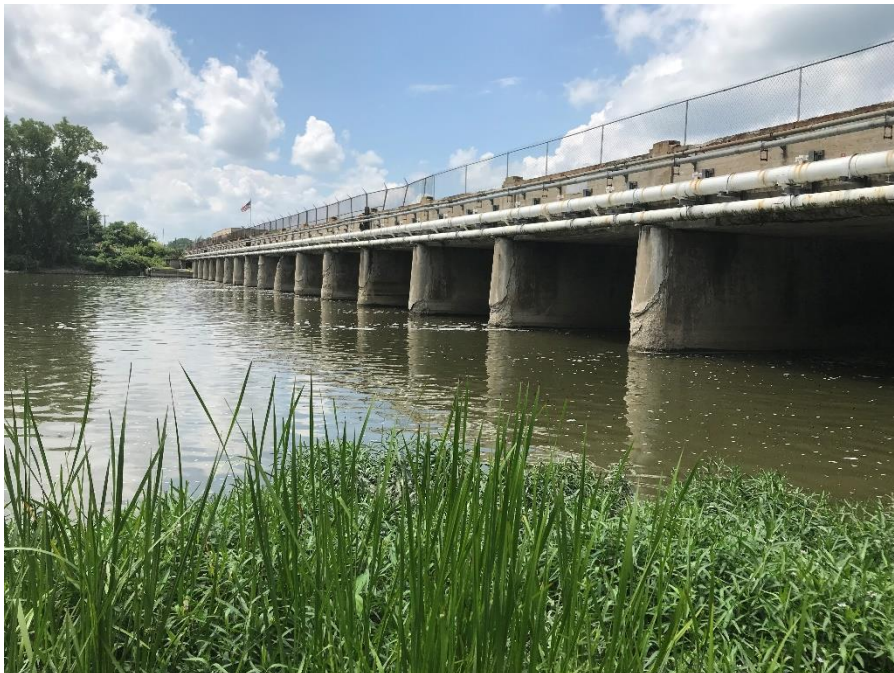
**Photograph 14 – Downstream face of bridge over spillway
Note the spalling and delamination of piers**

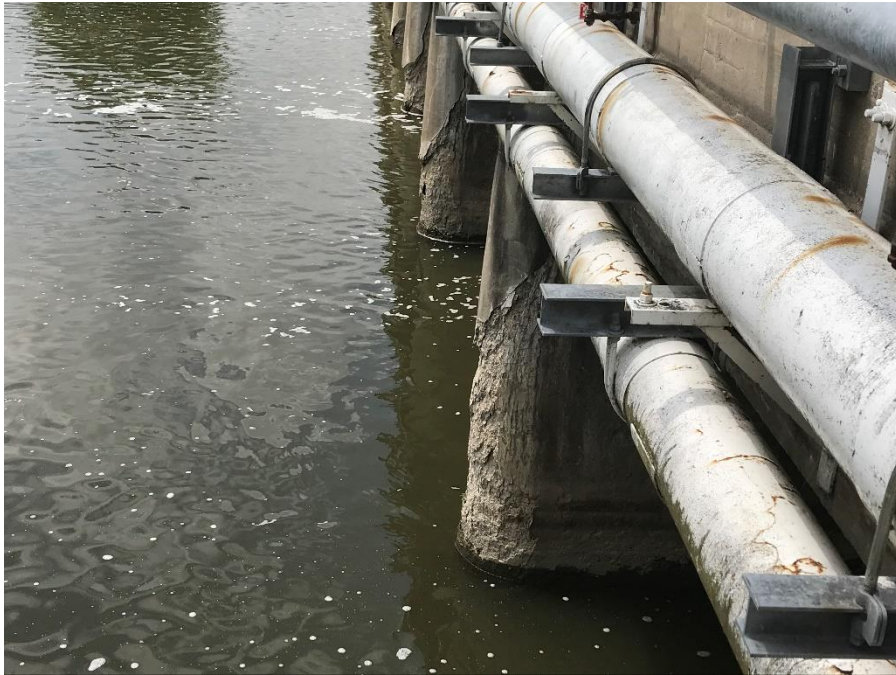
Photograph 15 – Typical pier spalling and delamination

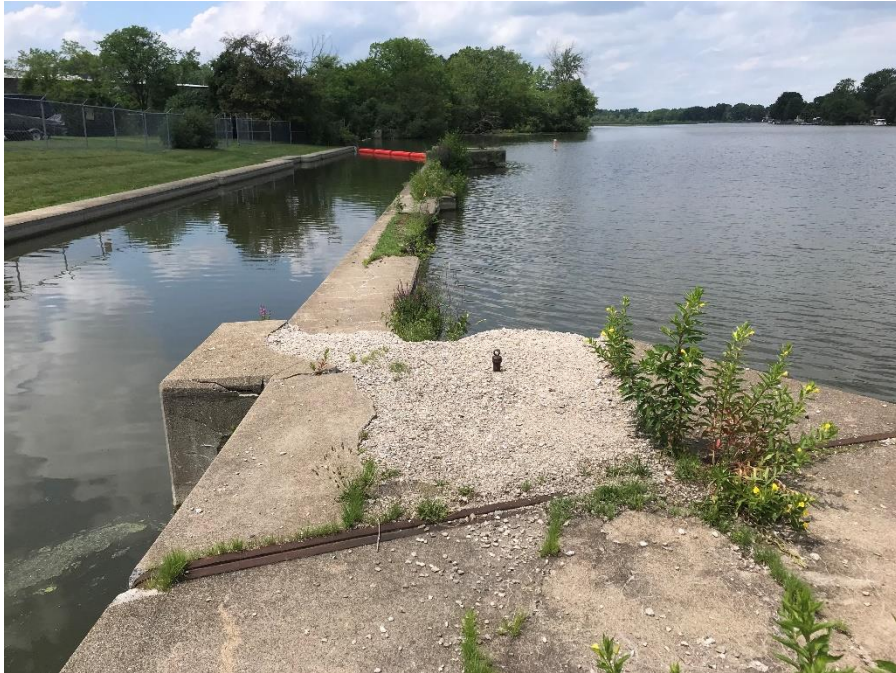
**Photograph 17 – Left abutment wall of abandoned lock
Note the spalling and cracking**

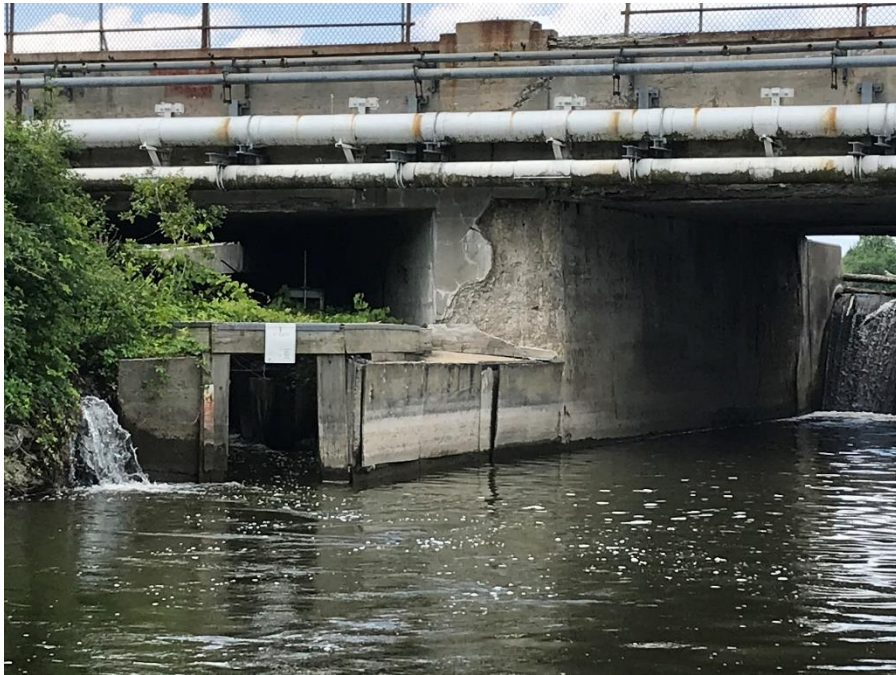
**Photograph 21 – DNR fish ladder outlet
Note the major leaking at right wall**

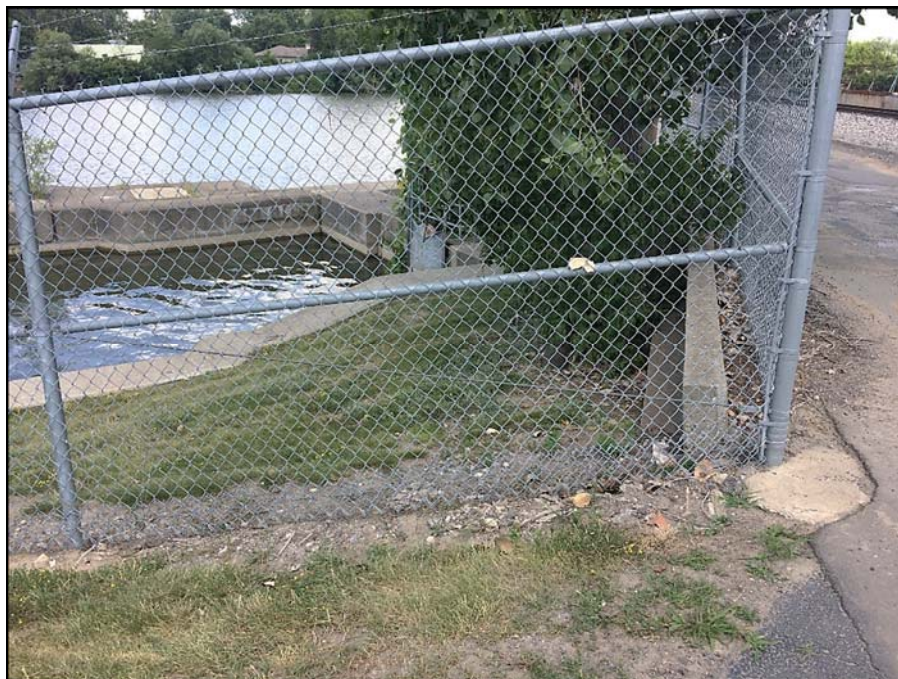
**Photograph 1 – Upstream face of right abutment viewed from right
Note the small trees and brush near the spillway structure**

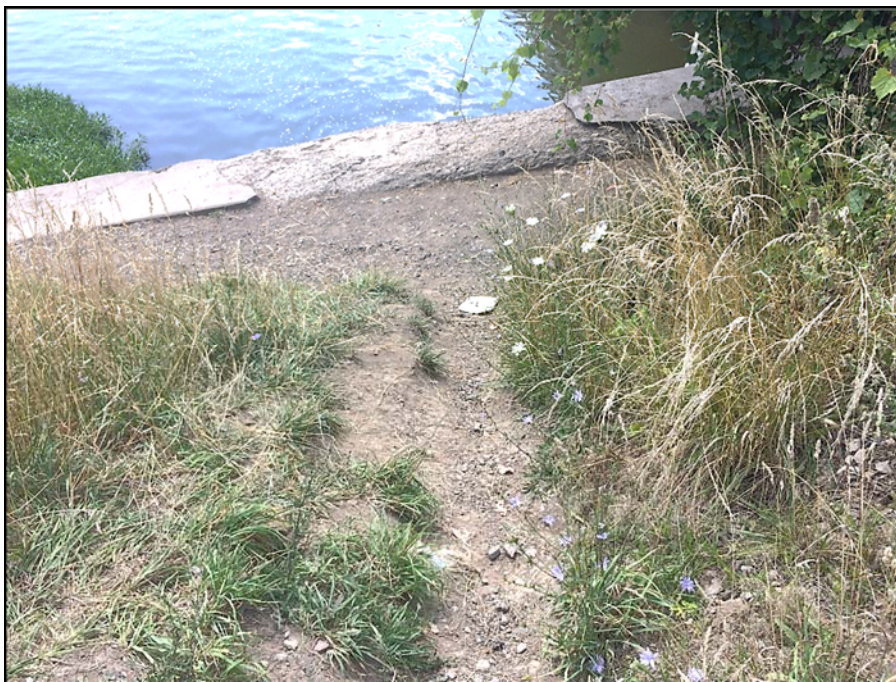
**Photograph 4 – Left abutment viewed from left
Note the foot traffic erosion**

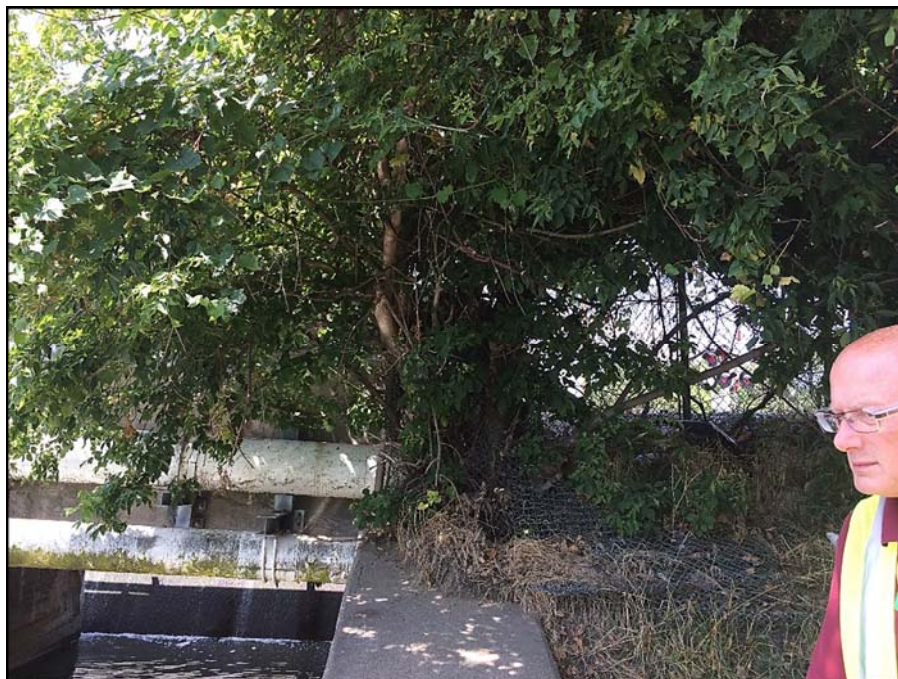
Photograph 5 – Trees growing from left abutment

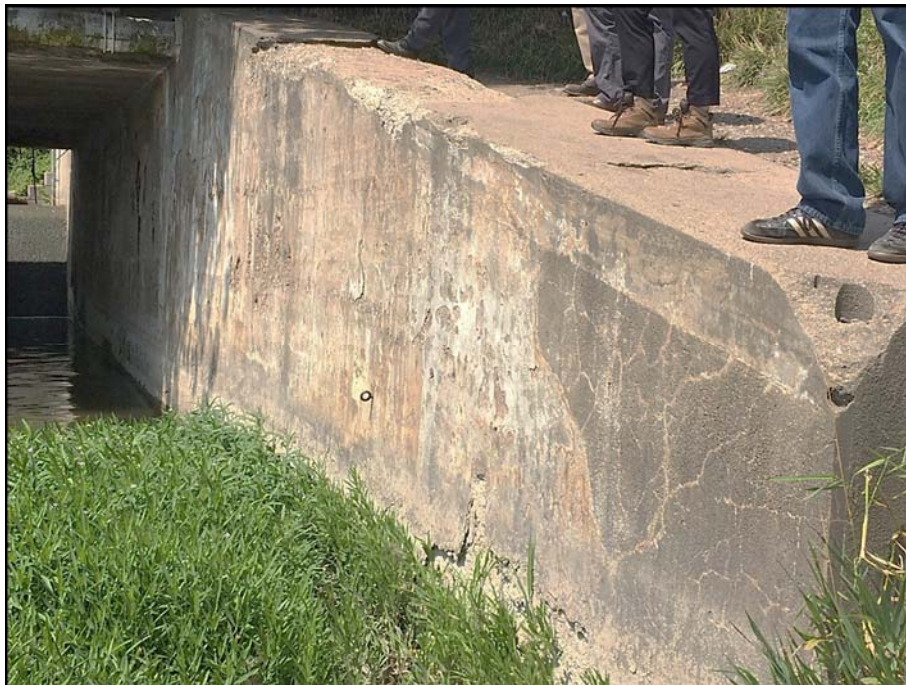
**Photograph 9 – Downstream left spillway abutment wall
Note the minor spalling and cracking**

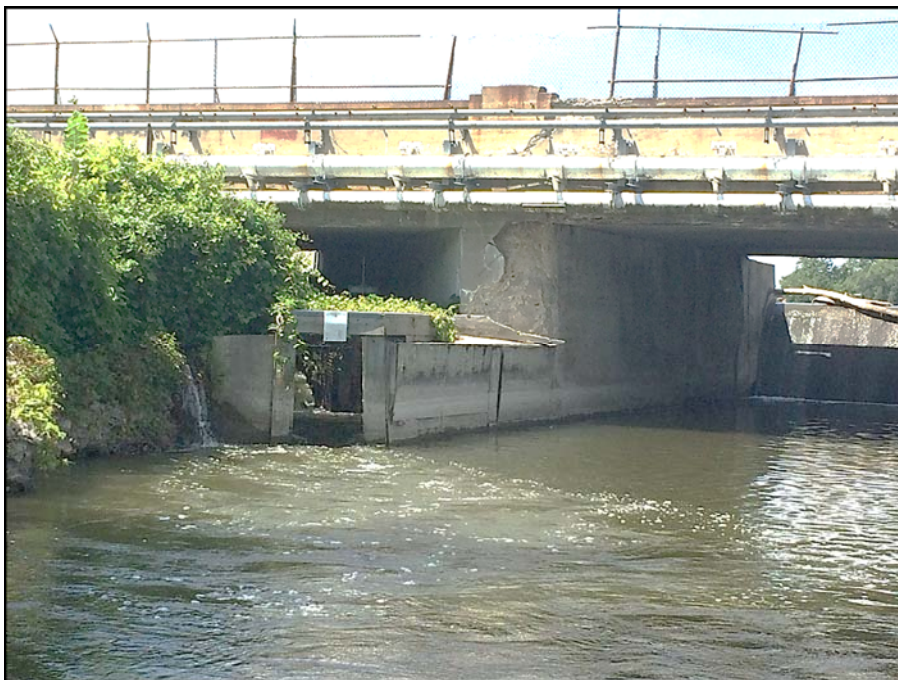
**Photograph 11 – Downstream right spillway abutment wall
Note the spalling and fish ladder outlet**

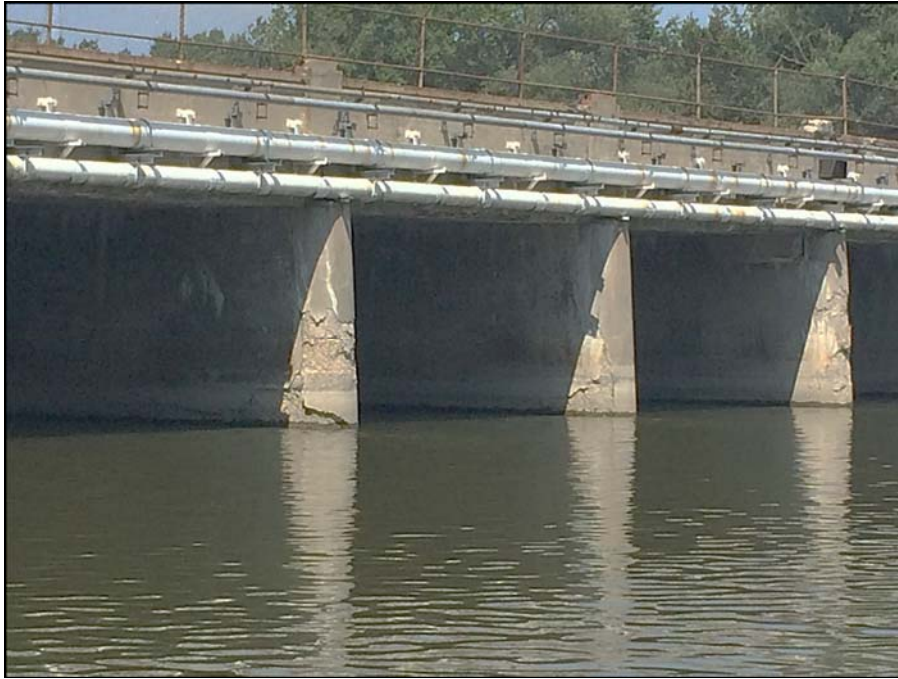
Photograph 13 – Typical spalling of bridge piers

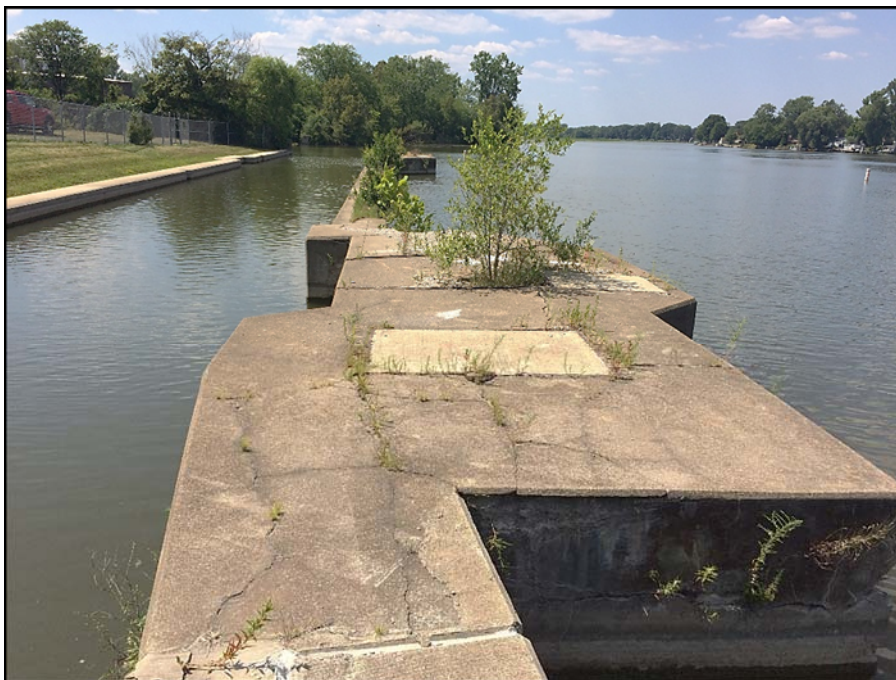
**Photograph 17 – Left wall of abandoned lock
Note that this is the original wall and shows
signs of deterioration**

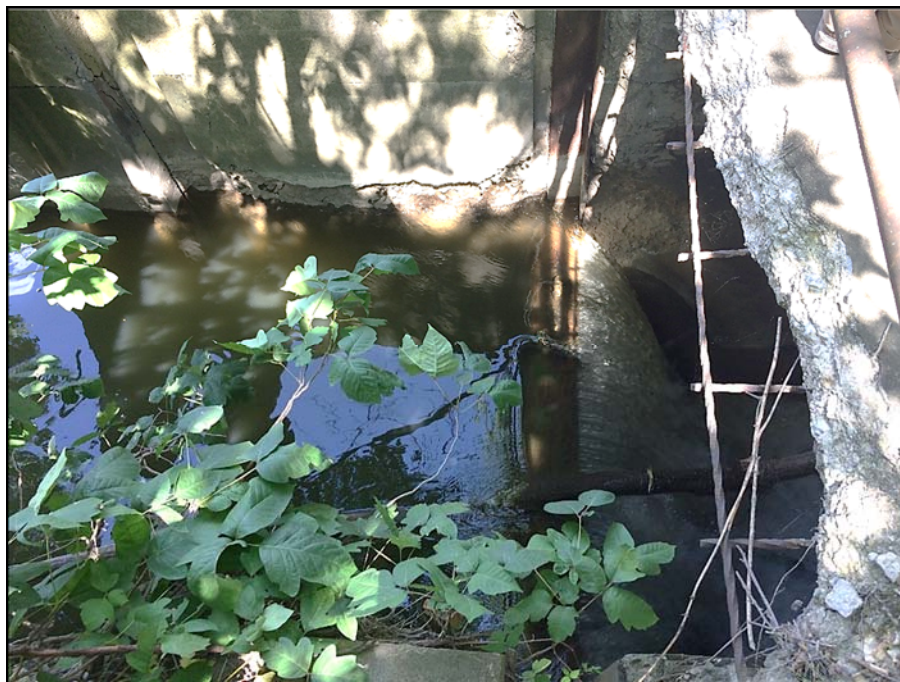
**Photograph 20 – Small powerhouse head gate viewed from right
Note the deteriorated concrete and exposed reinforcing
steel**

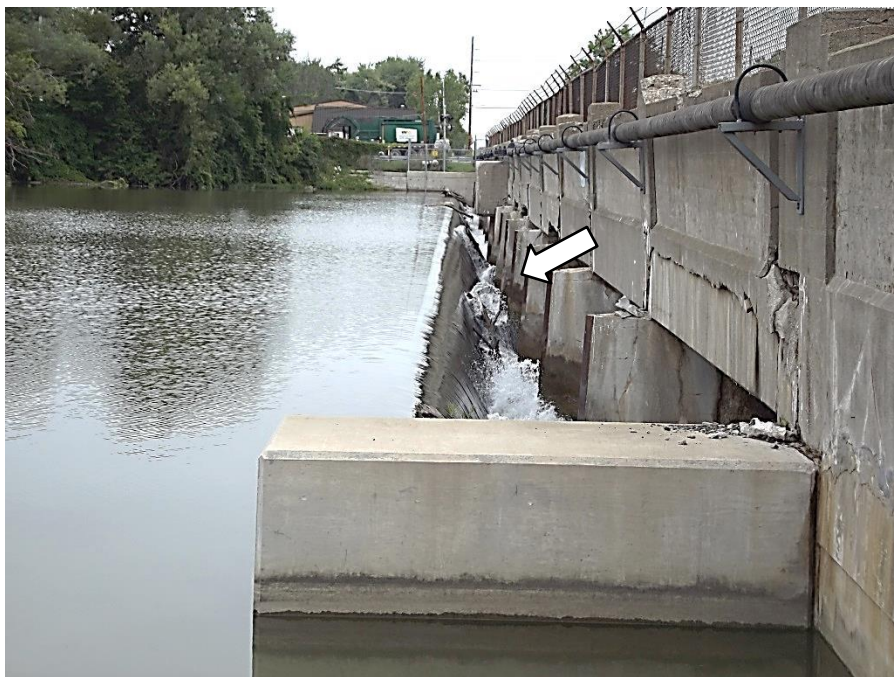
**Photograph 6 – Principal spillway crest viewed from right.
Note the minor debris build up.**

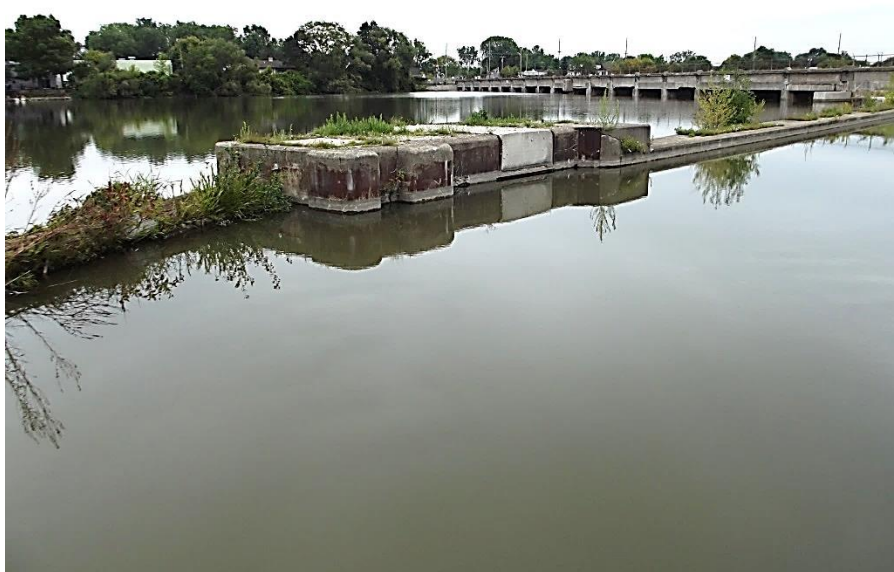
**Photograph 12 – Upstream portion of lock wall viewed from right.
Note the deteriorated concrete vegetation growing from cracks.**

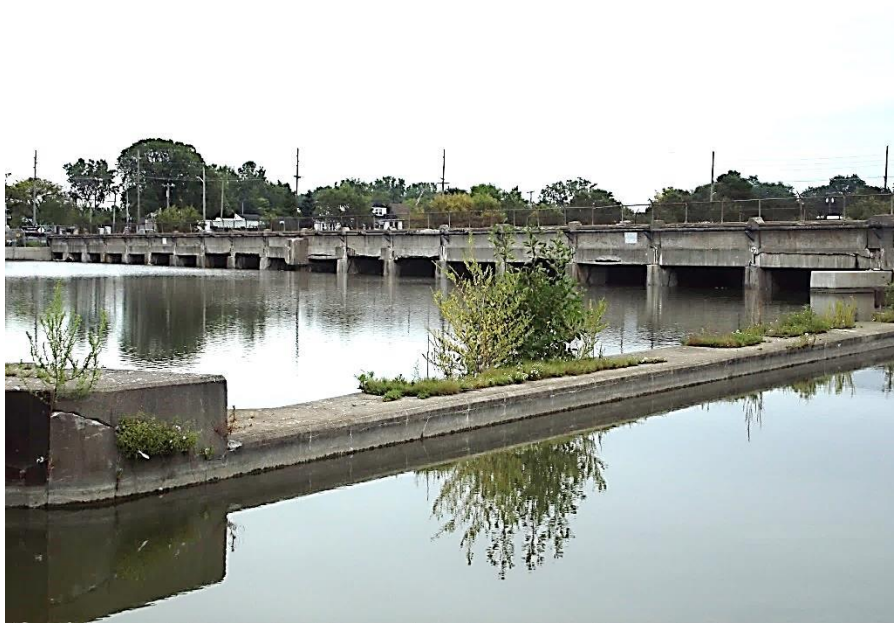
**Photograph 13 – Downstream portion of lock wall viewed from right.
Note the deteriorated concrete and vegetation growing from cracks.**
