HURON-CLINTON
metroparks

Delhi Metropark
Stormwater Management Plan

September 2019

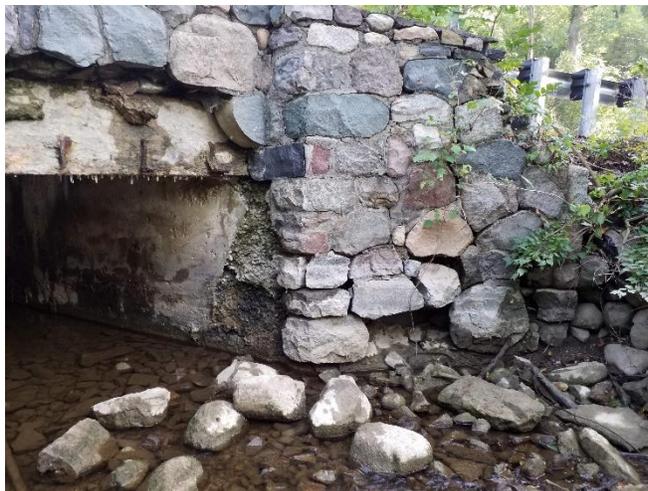
Left: Poor culvert in Delhi Metropark. Right: Proportion of culverts in each condition category.

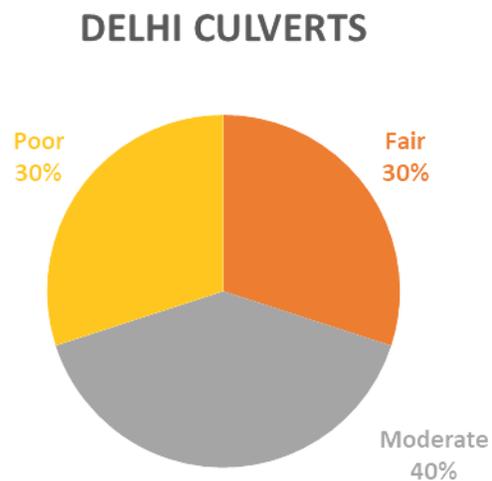
Culvert Rating	Number of Culverts	Culverts Needing Immediate Cleanout	Culverts Needing Future Cleanout	Culverts Needing Replacement or Repair
New	0	0	0	0
Fair	3	0	2	0
Moderate	4	3	0	0
Poor	3	2*	0	3
Failing	0	0	0	0
Total:	10	5*	2	3
Repair Cost:		\$870	\$157	\$52,095

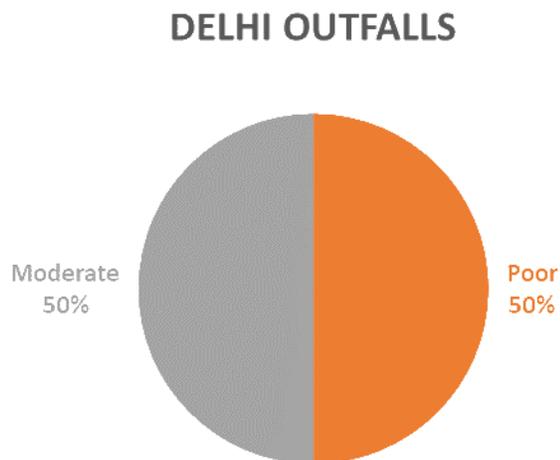
Outfall Rating	Number of Outfalls	Outfalls Needing Immediate Cleanout	Outfalls Needing Future Cleanout	Outfalls Needing Replacement or Repair
New	0	0	0	0
Fair	0	0	0	0
Moderate	1	0	0	0
Poor	1	1*	0	1
Failing	0	0	0	0
Total:	2	1	0	1
Repair Cost:		\$0	\$0	\$7,500

Left: Proportion of outfalls in each condition category. Right: Blocked outfall in poor condition.

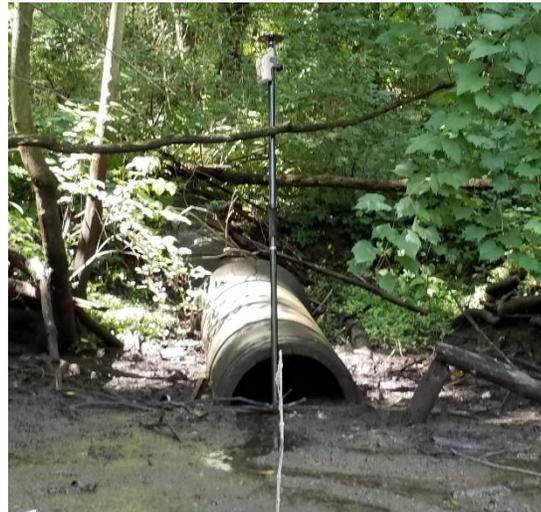
Outfall ID	Diameter (in)	Condition	Maintenance Need	Cost Opinion
SDC-DEL-001*	18	Poor	Replacement	\$7,500
Total:				\$7,500

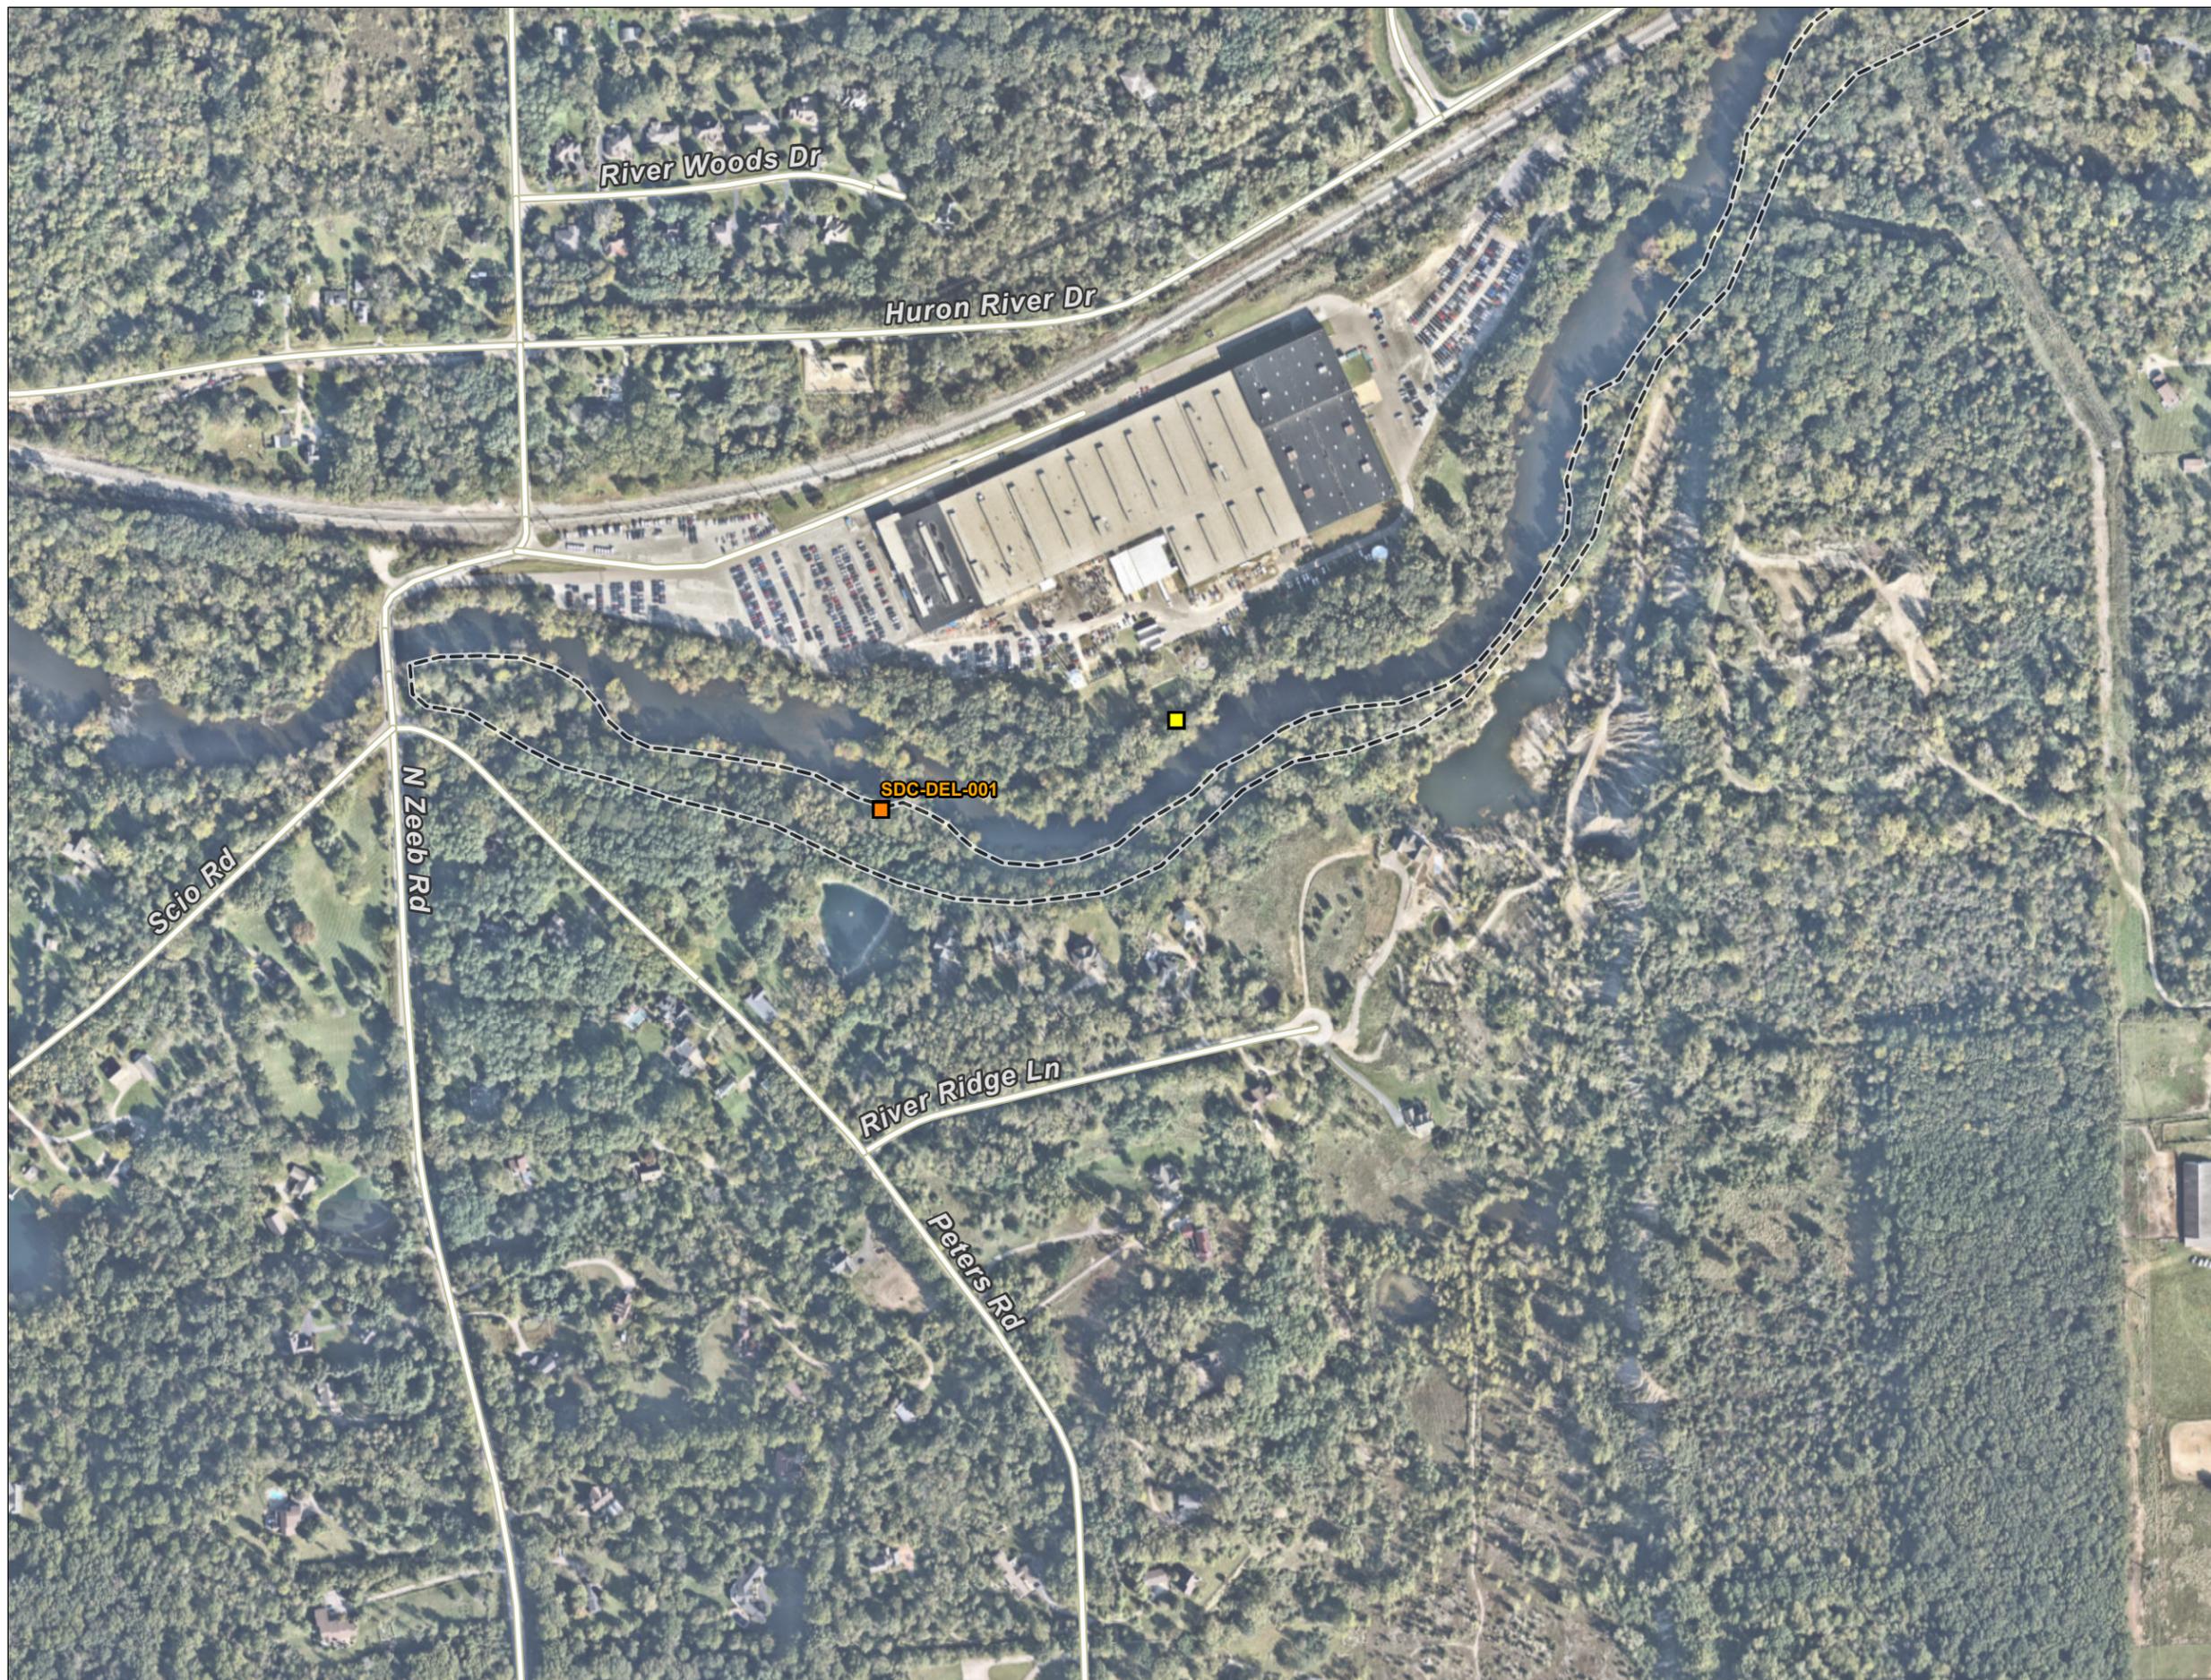
Map Sheet: 19 of 48

Stormwater Structure Ratings

Delhi Metropark

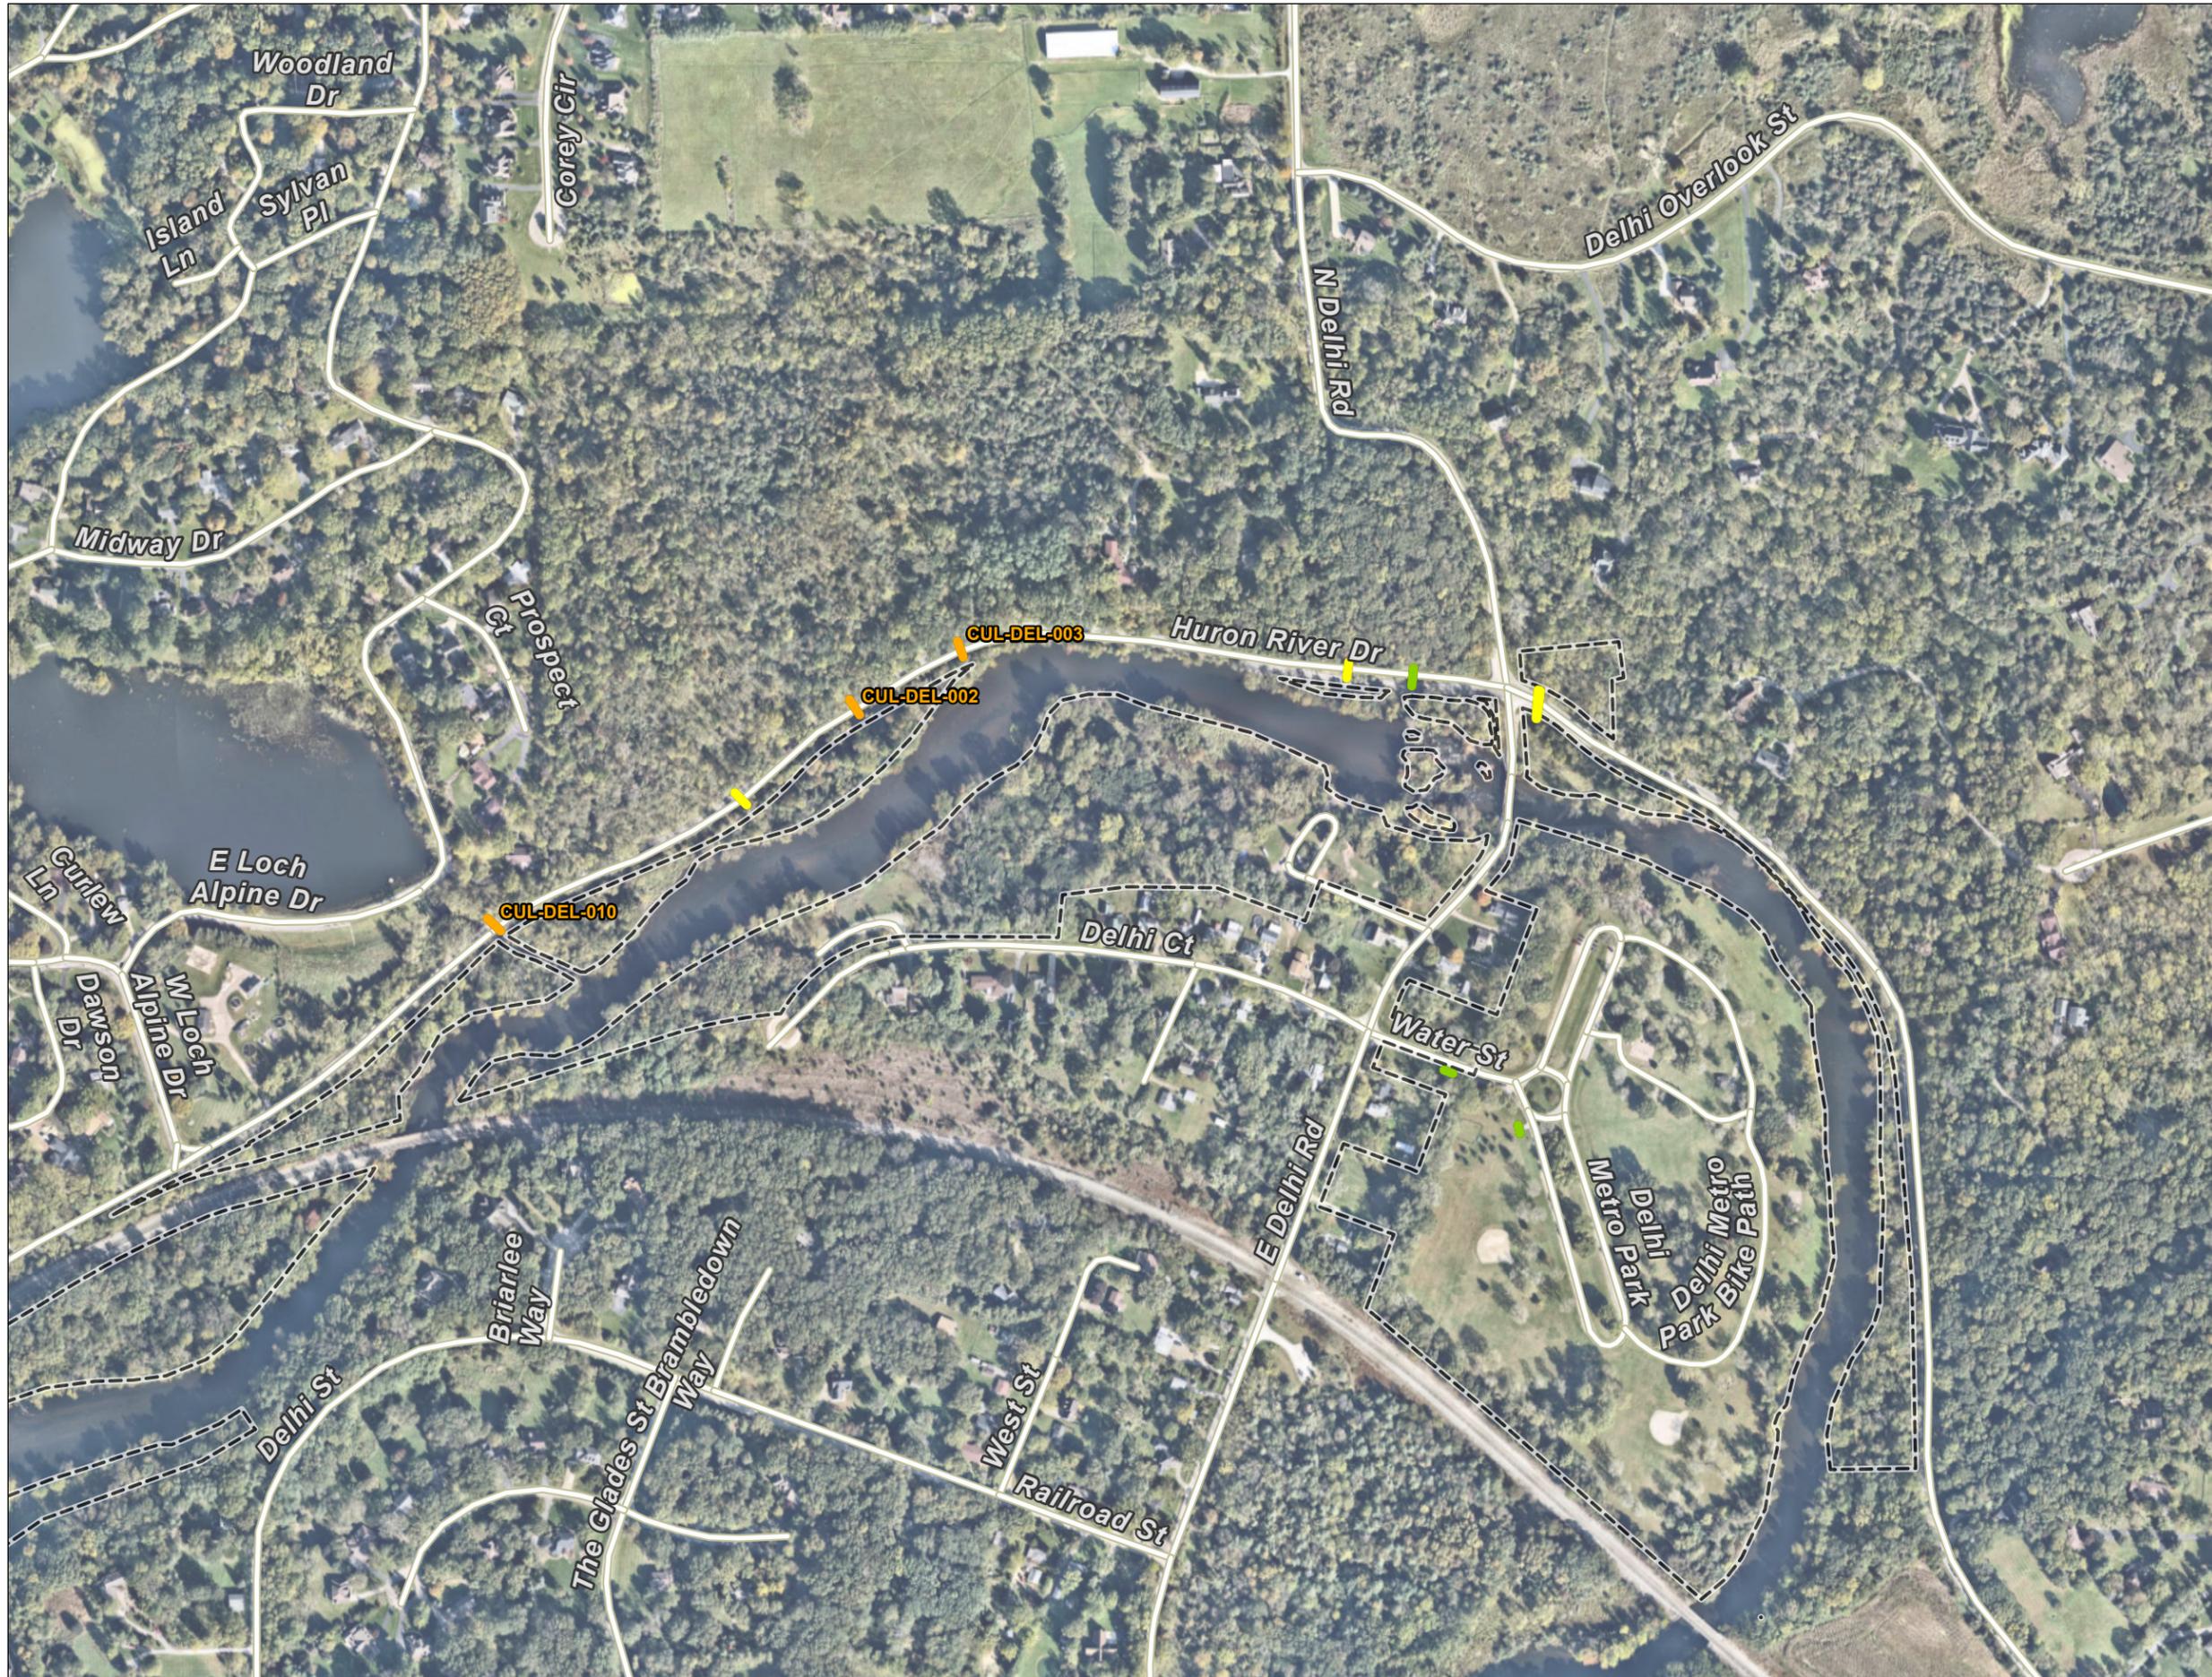
Map Sheet: 20 of 48

Stormwater Structure Ratings

Hudson Mills Metropark

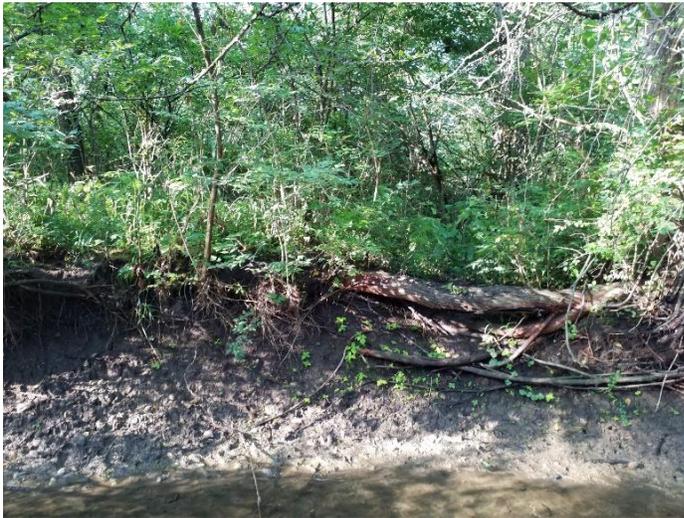
DELHI EROSION SEVERITY

Erosion Condition	Feet of Streambank (miles)	Cost of Restoration
Very High	0.0 (0.0)	
High	0.0 (0.0)	
Moderate	10,875 (2.06)	
Low	2,519 (0.48)	
Very Low	0.0 (0.0)	
Total:	13,394 (2.54)	\$0

Left: Proportion of stream bank in each erosion severity category. Right: Moderate erosion on a bank in Delhi Metropark.

Based on our assessment, we are recommending no streambank restoration within Delhi Metropark at this time.

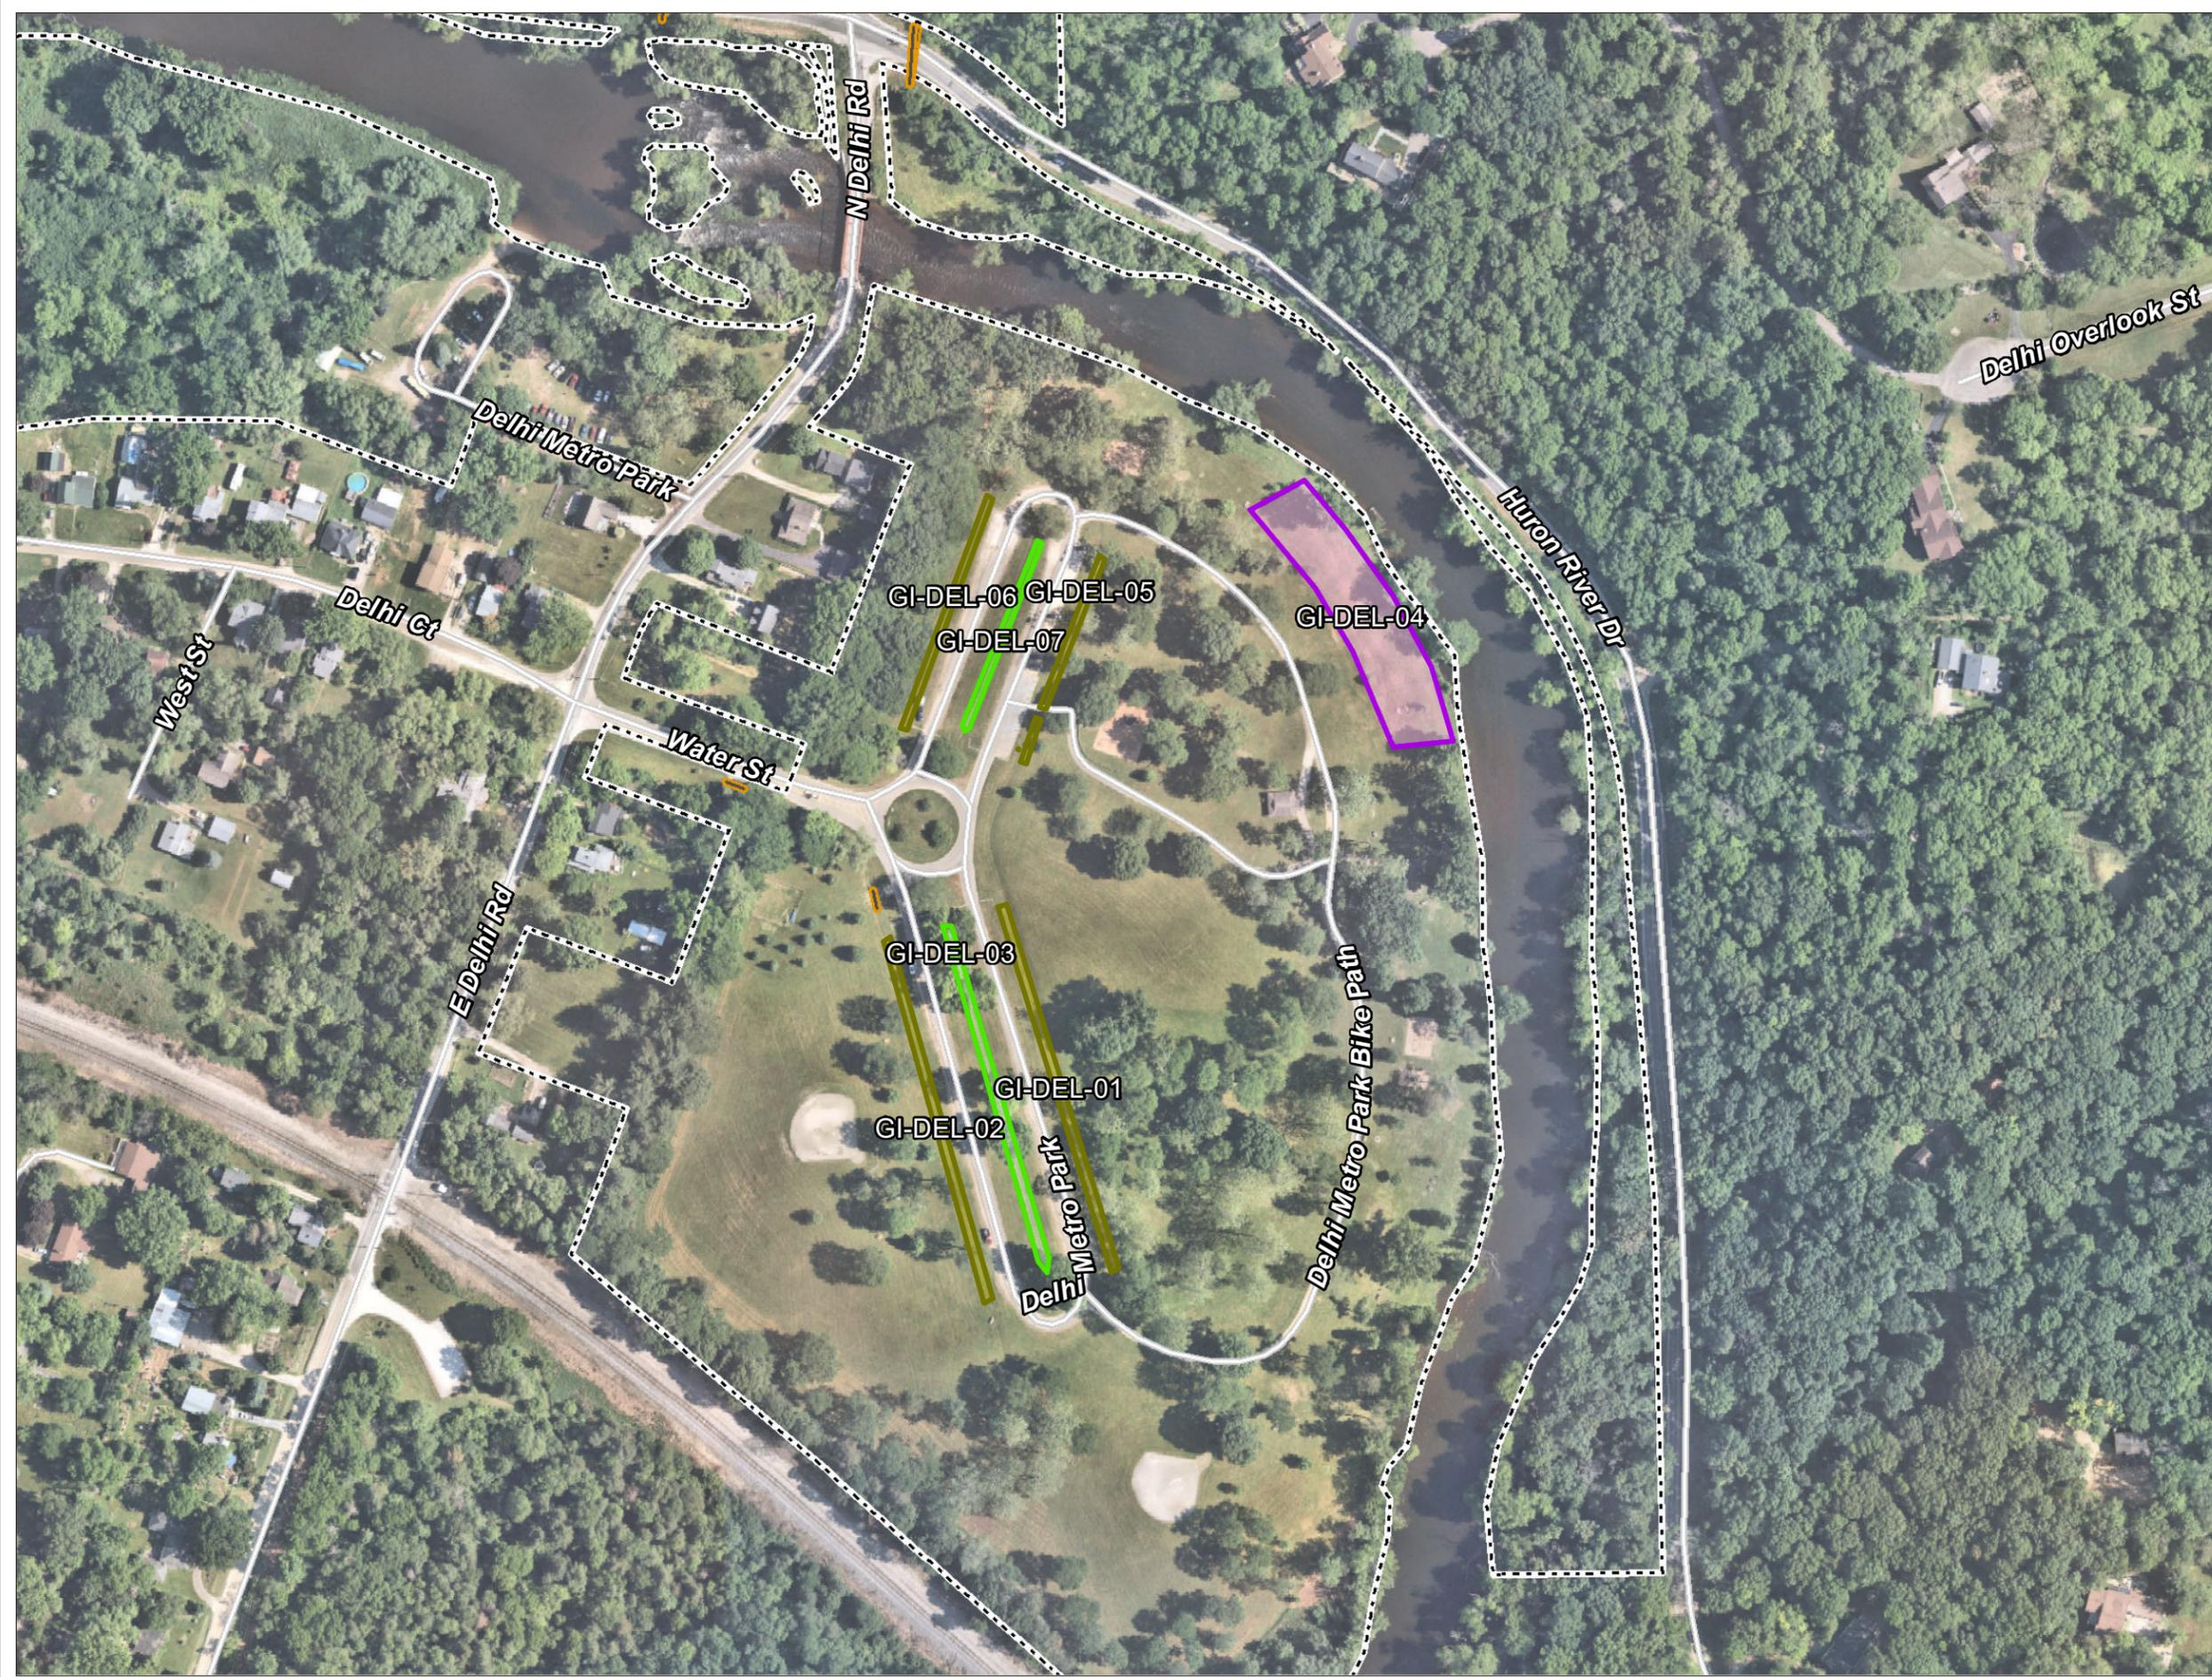
Area: 1 of 1

Green Infrastructure
Recommendation Areas

Site ID	Site	Practice Type	Treatment Surface Area (ft ²)	Cost Opinion	Cost per sq ft of Treatment Area (\$/ft ²)
GI-DEL-01	East Delhi	Naturalized Swale	5,444	\$9,255	\$1.70
GI-DEL-02	East Delhi	Naturalized Swale	5,343	\$9,083	\$1.70
GI-DEL-03	East Delhi	Bioswale	5,400	\$42,900	\$7.94
GI-DEL-04	East Delhi	Native Prairie	27,118	\$31,638	\$1.17
GI-DEL-05	East Delhi	Naturalized Swale	2,205	\$3,749	\$1.70
GI-DEL-06	East Delhi	Naturalized Swale	2,682	\$4,559	\$1.70
GI-DEL-07	East Delhi	Bioswale	2,080	\$16,524	\$7.94
Total:			50,272	\$117,708
