HURON-CLINTON
metroparks

Hudson Mills Metropark Stormwater Management Plan

September 2019

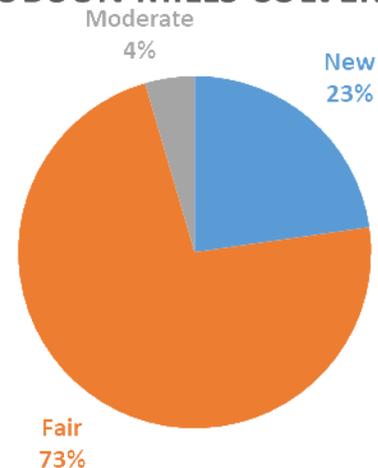
HUDSON MILLS CULVERTS

Left: Moderate culvert in Hudson Mills Metropark. Right: Proportion of culverts in each condition category.

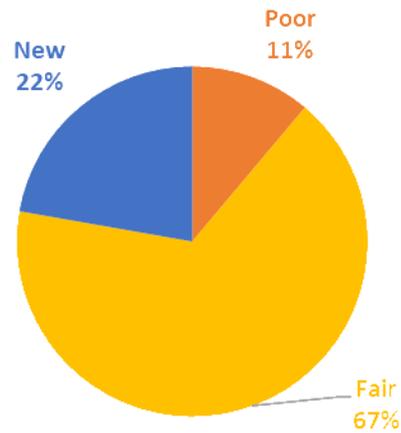
HUDSON MILLS OUTFALLS

Left: Fair outfall in Hudson Mills Metropark. Right: Proportion of outfalls in each condition category.

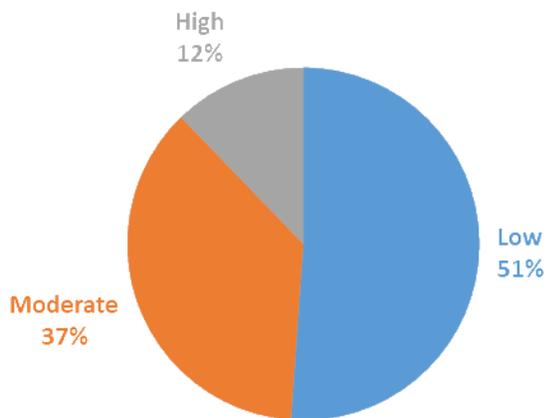
HUDSON MILLS EROSION SEVERITY

Left: Proportion of stream bank in each erosion severity category. Right: Severe erosion on a bank in Hudson Mills Metropark.

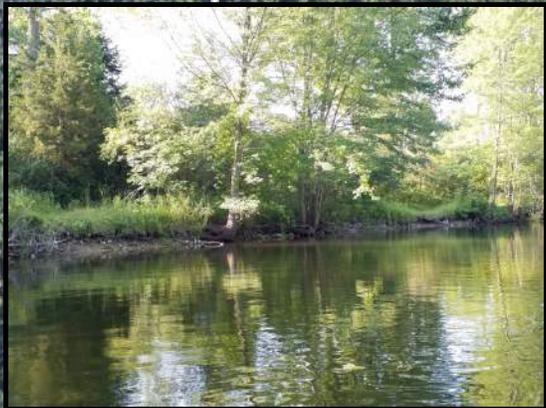
S3-HUD-002

Length: 131.53 ft

Recommended Treatment: Coir Block with Live Stakes
Construction Cost: \$23,000

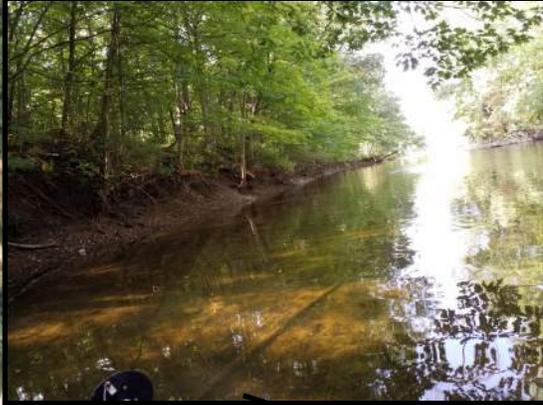
S3-HUD-004

Length: 2,025.57 ft
Recommended Treatment: Soil Lifts with Live Stakes
Construction Cost: \$1,374,000
