HURON-CLINTON  
**metroparks**

# Willow Metropark Stormwater Management Plan

September 2019

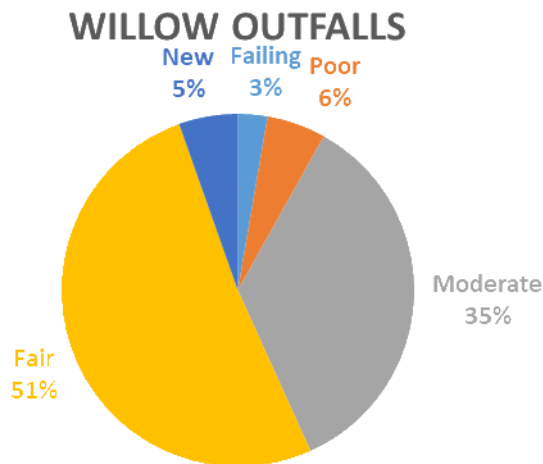
Left: Proportion of outfalls in each condition category. Right: Severely damaged outfall in failing condition in Willow.

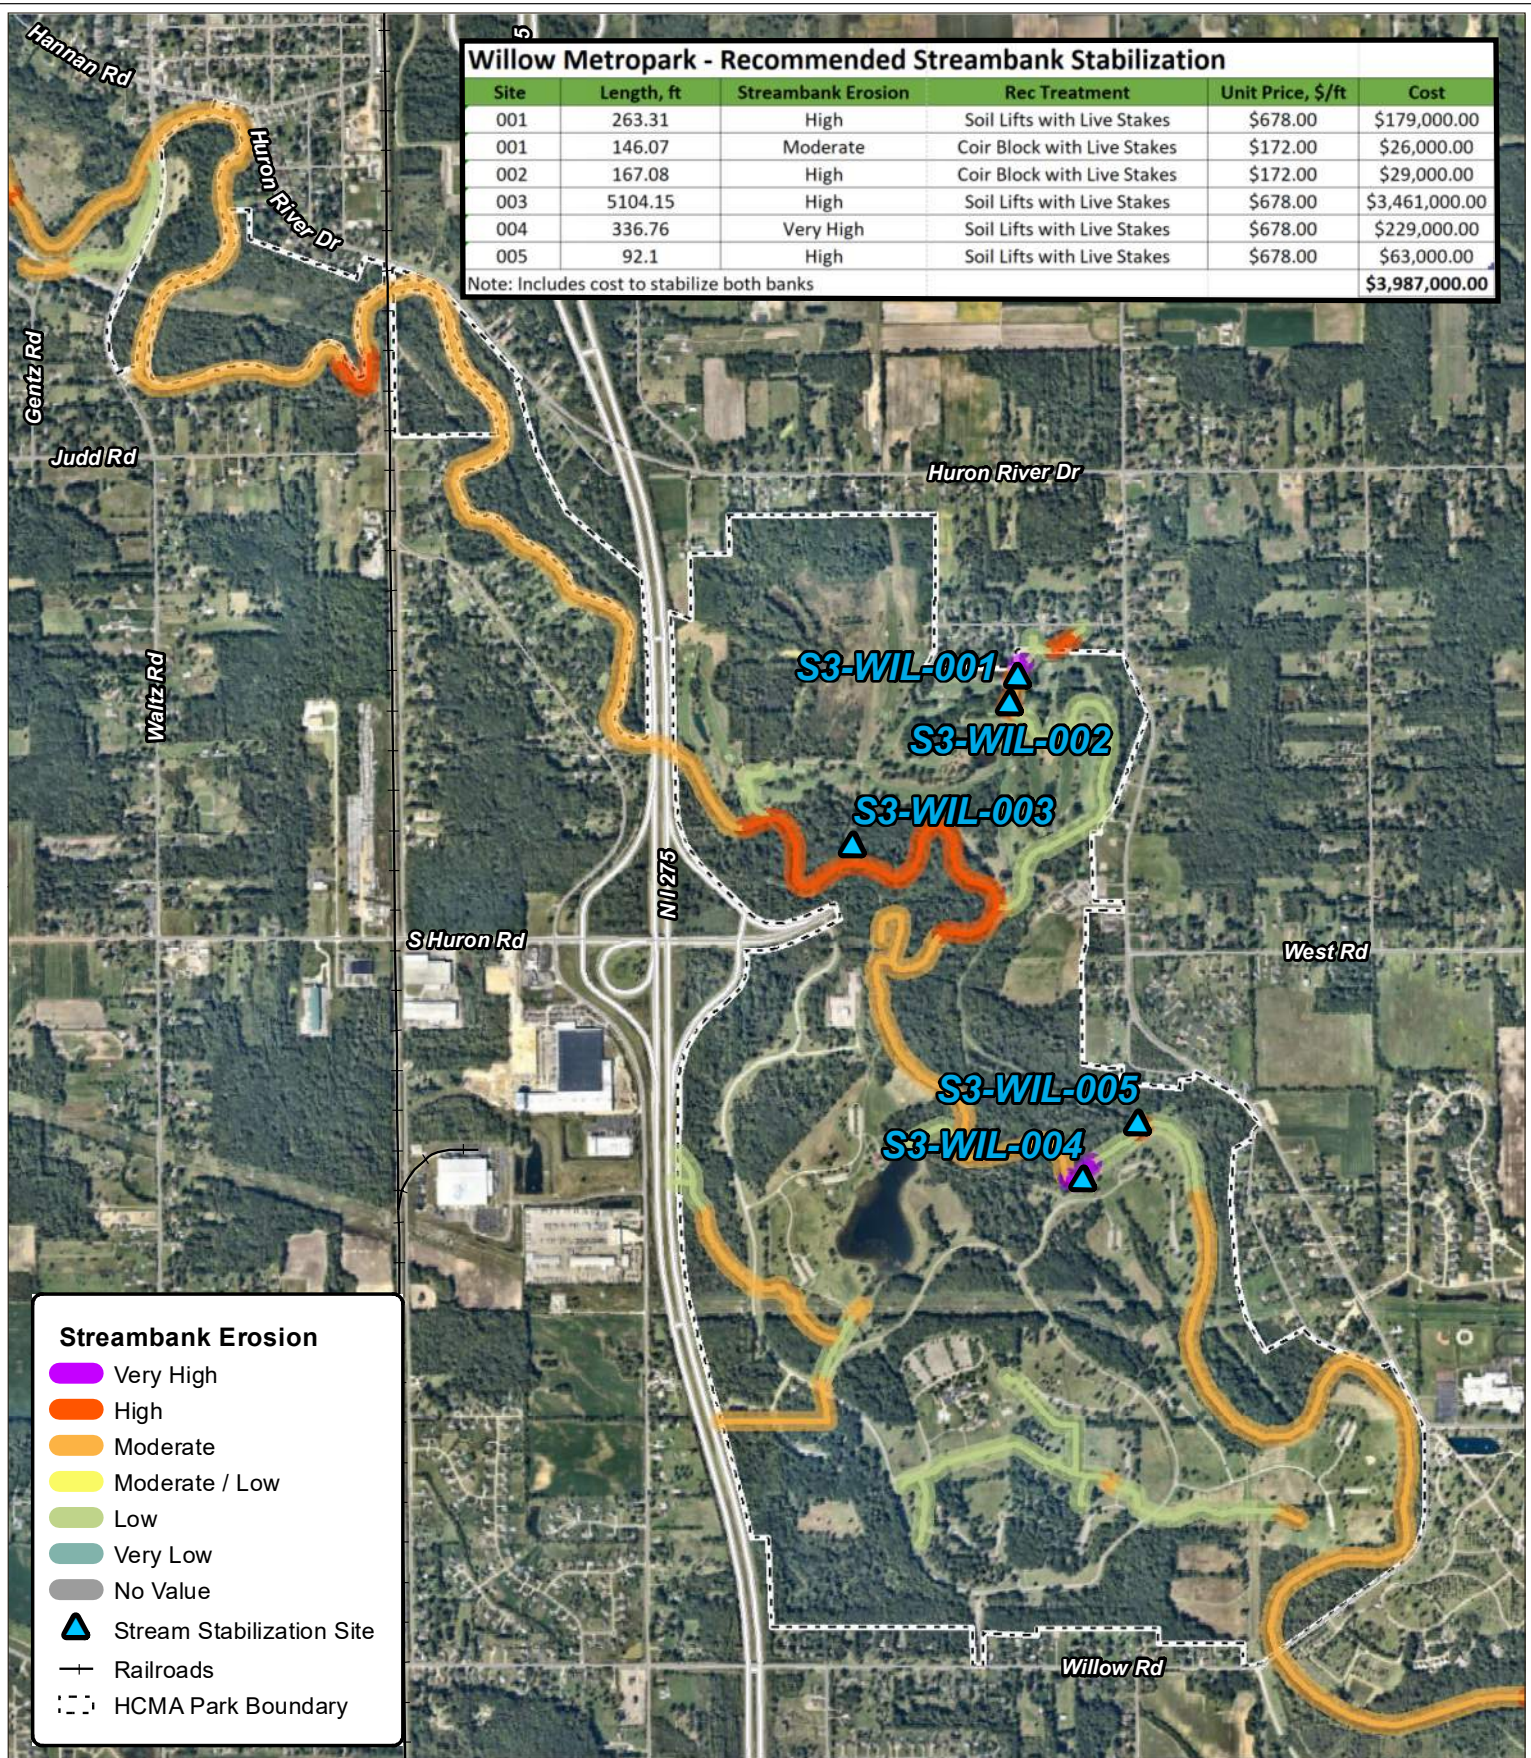
*Left: Proportion of stream in each erosion category. Right: High erosion on a bank next to a path in Willow Metropark.*

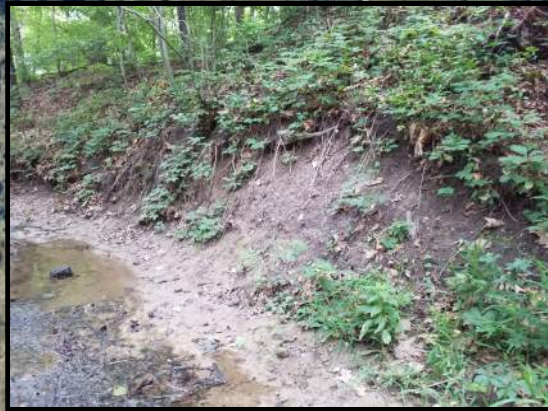
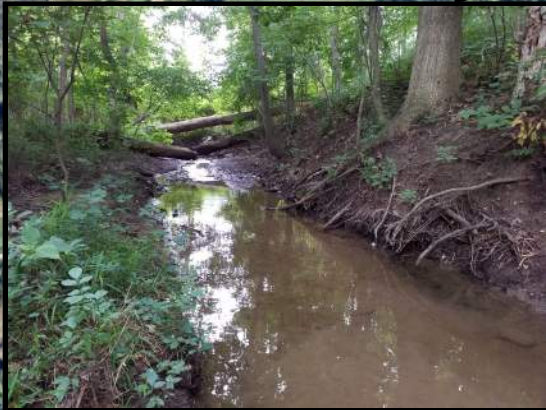
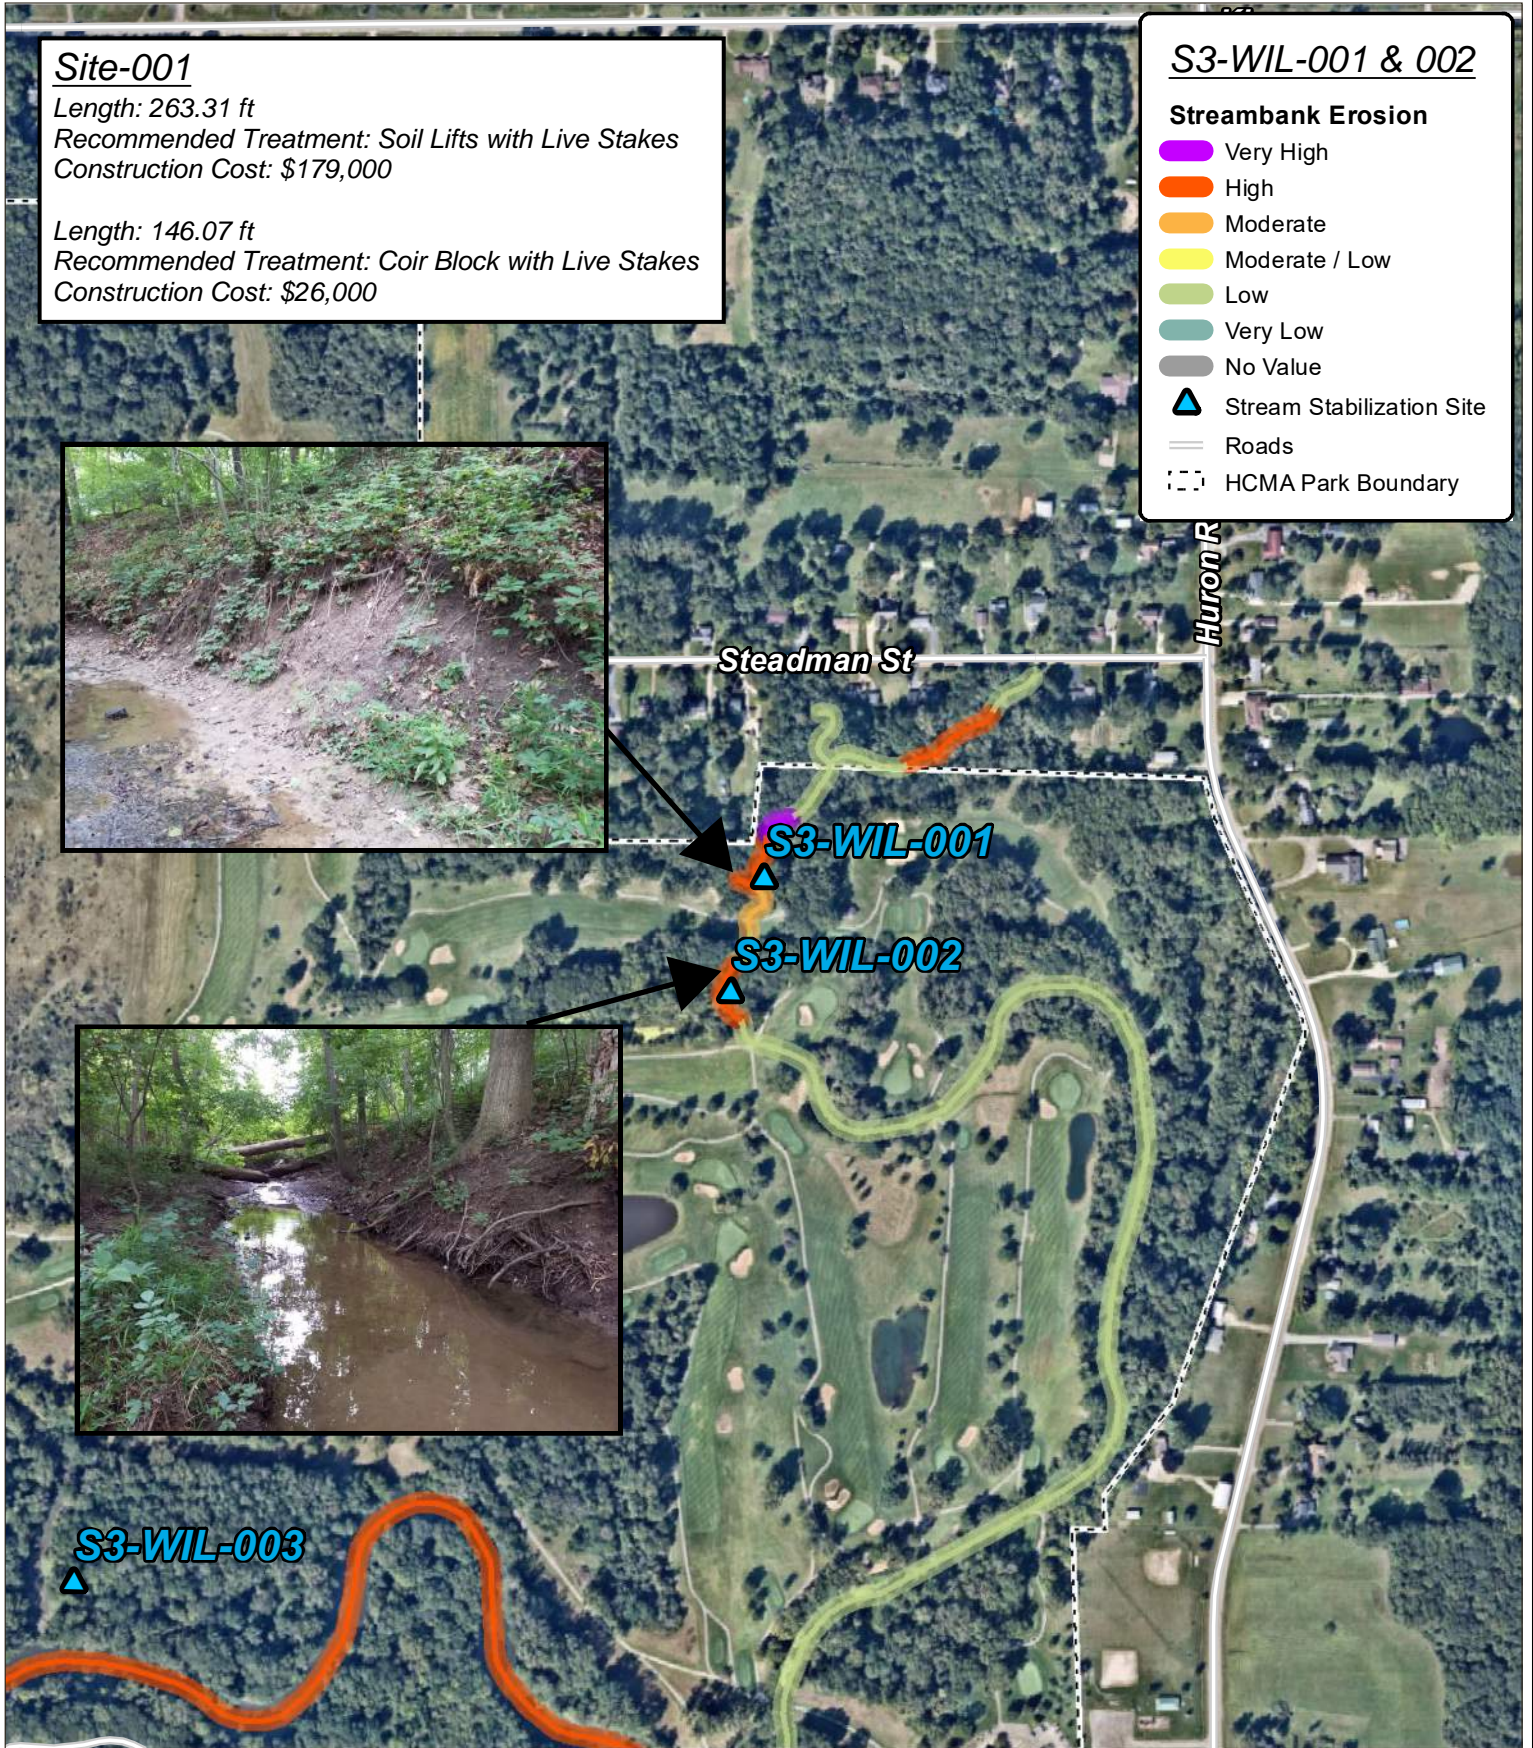
### S3-WIL-001 & 002

### Site-001

Length: 263.31 ft

Length: 146.07 ft

Recommended Treatment: Soil Lifts with Live Stakes  
Construction Cost: \$179,000

Recommended Treatment: Coir Block with Live Stakes  
Construction Cost: \$26,000

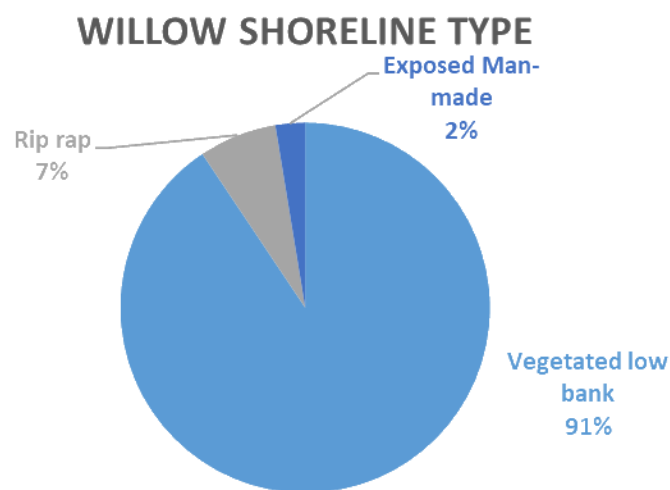
Erosion Condition	Length of Shoreline (ft)
Major	0.0
Minor	2,630.72
None	1,785.18
<b>Total:</b>	<b>4,415.90</b>
<b>Restoration Cost:</b>	<b>\$2,463</b>

*Proportion of each shoreline type present in Willow Metropark.*

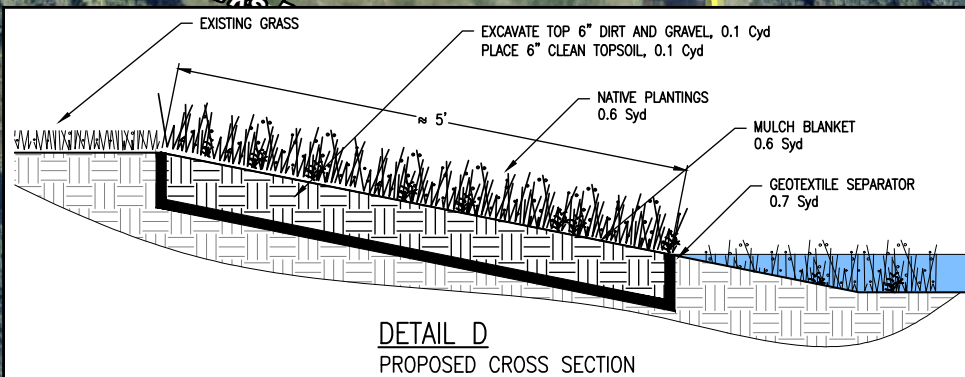
### SLR-WIL-001

### Site-001

Length: 307.86 Ft

Recommended Treatment: Detail D

Construction Cost: \$ 2,463
