# Wolcott Mill Metropark Stormwater Management Plan

September 2019

## Wolcott Mill Metropark Stormwater Structure Recommendations

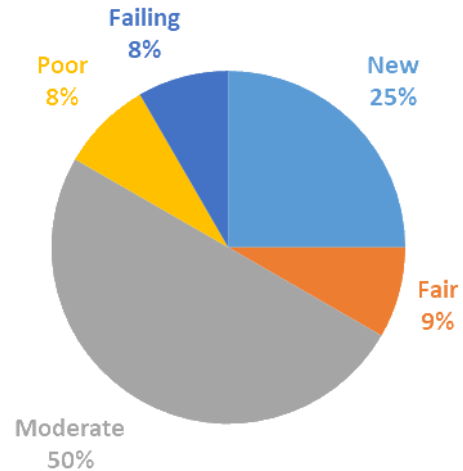
Left: Failing culvert in Wolcott Mill Metropark. Right: Proportion of culverts in each condition category.

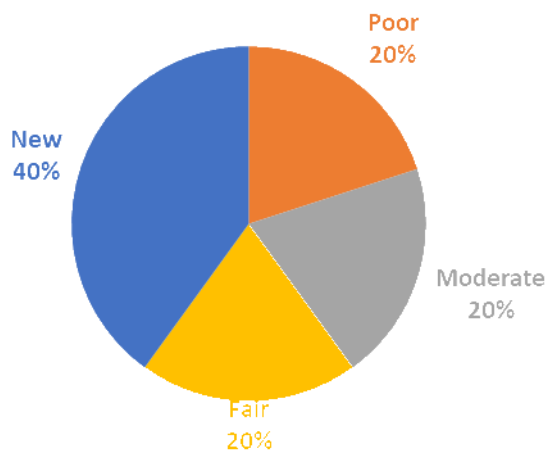
Left: Proportion of outfalls in each condition category. Right: Outfall in moderate condition in Wolcott Mill Metropark.

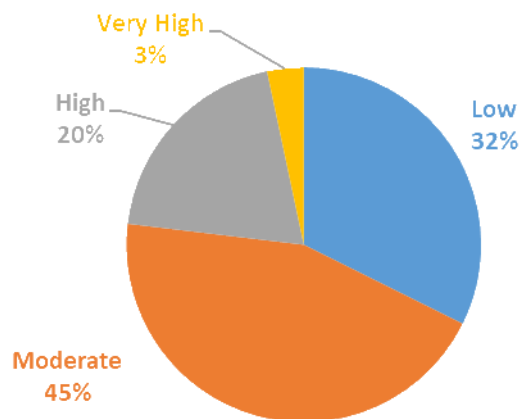
*Left: Proportion of stream in each erosion category. Right: High erosion endangering a power pole in Wolcott Mill Metropark.*

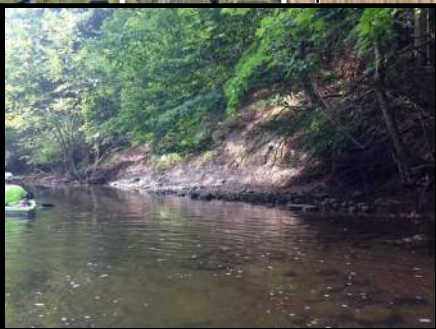
### S3-WOL-001

Length: 309.94 ft

Recommended Treatment: Soil Lifts with Live Stakes

Construction Cost: \$211,000
