# APPENDIX 3: PICNIC FACILITIES MAPS

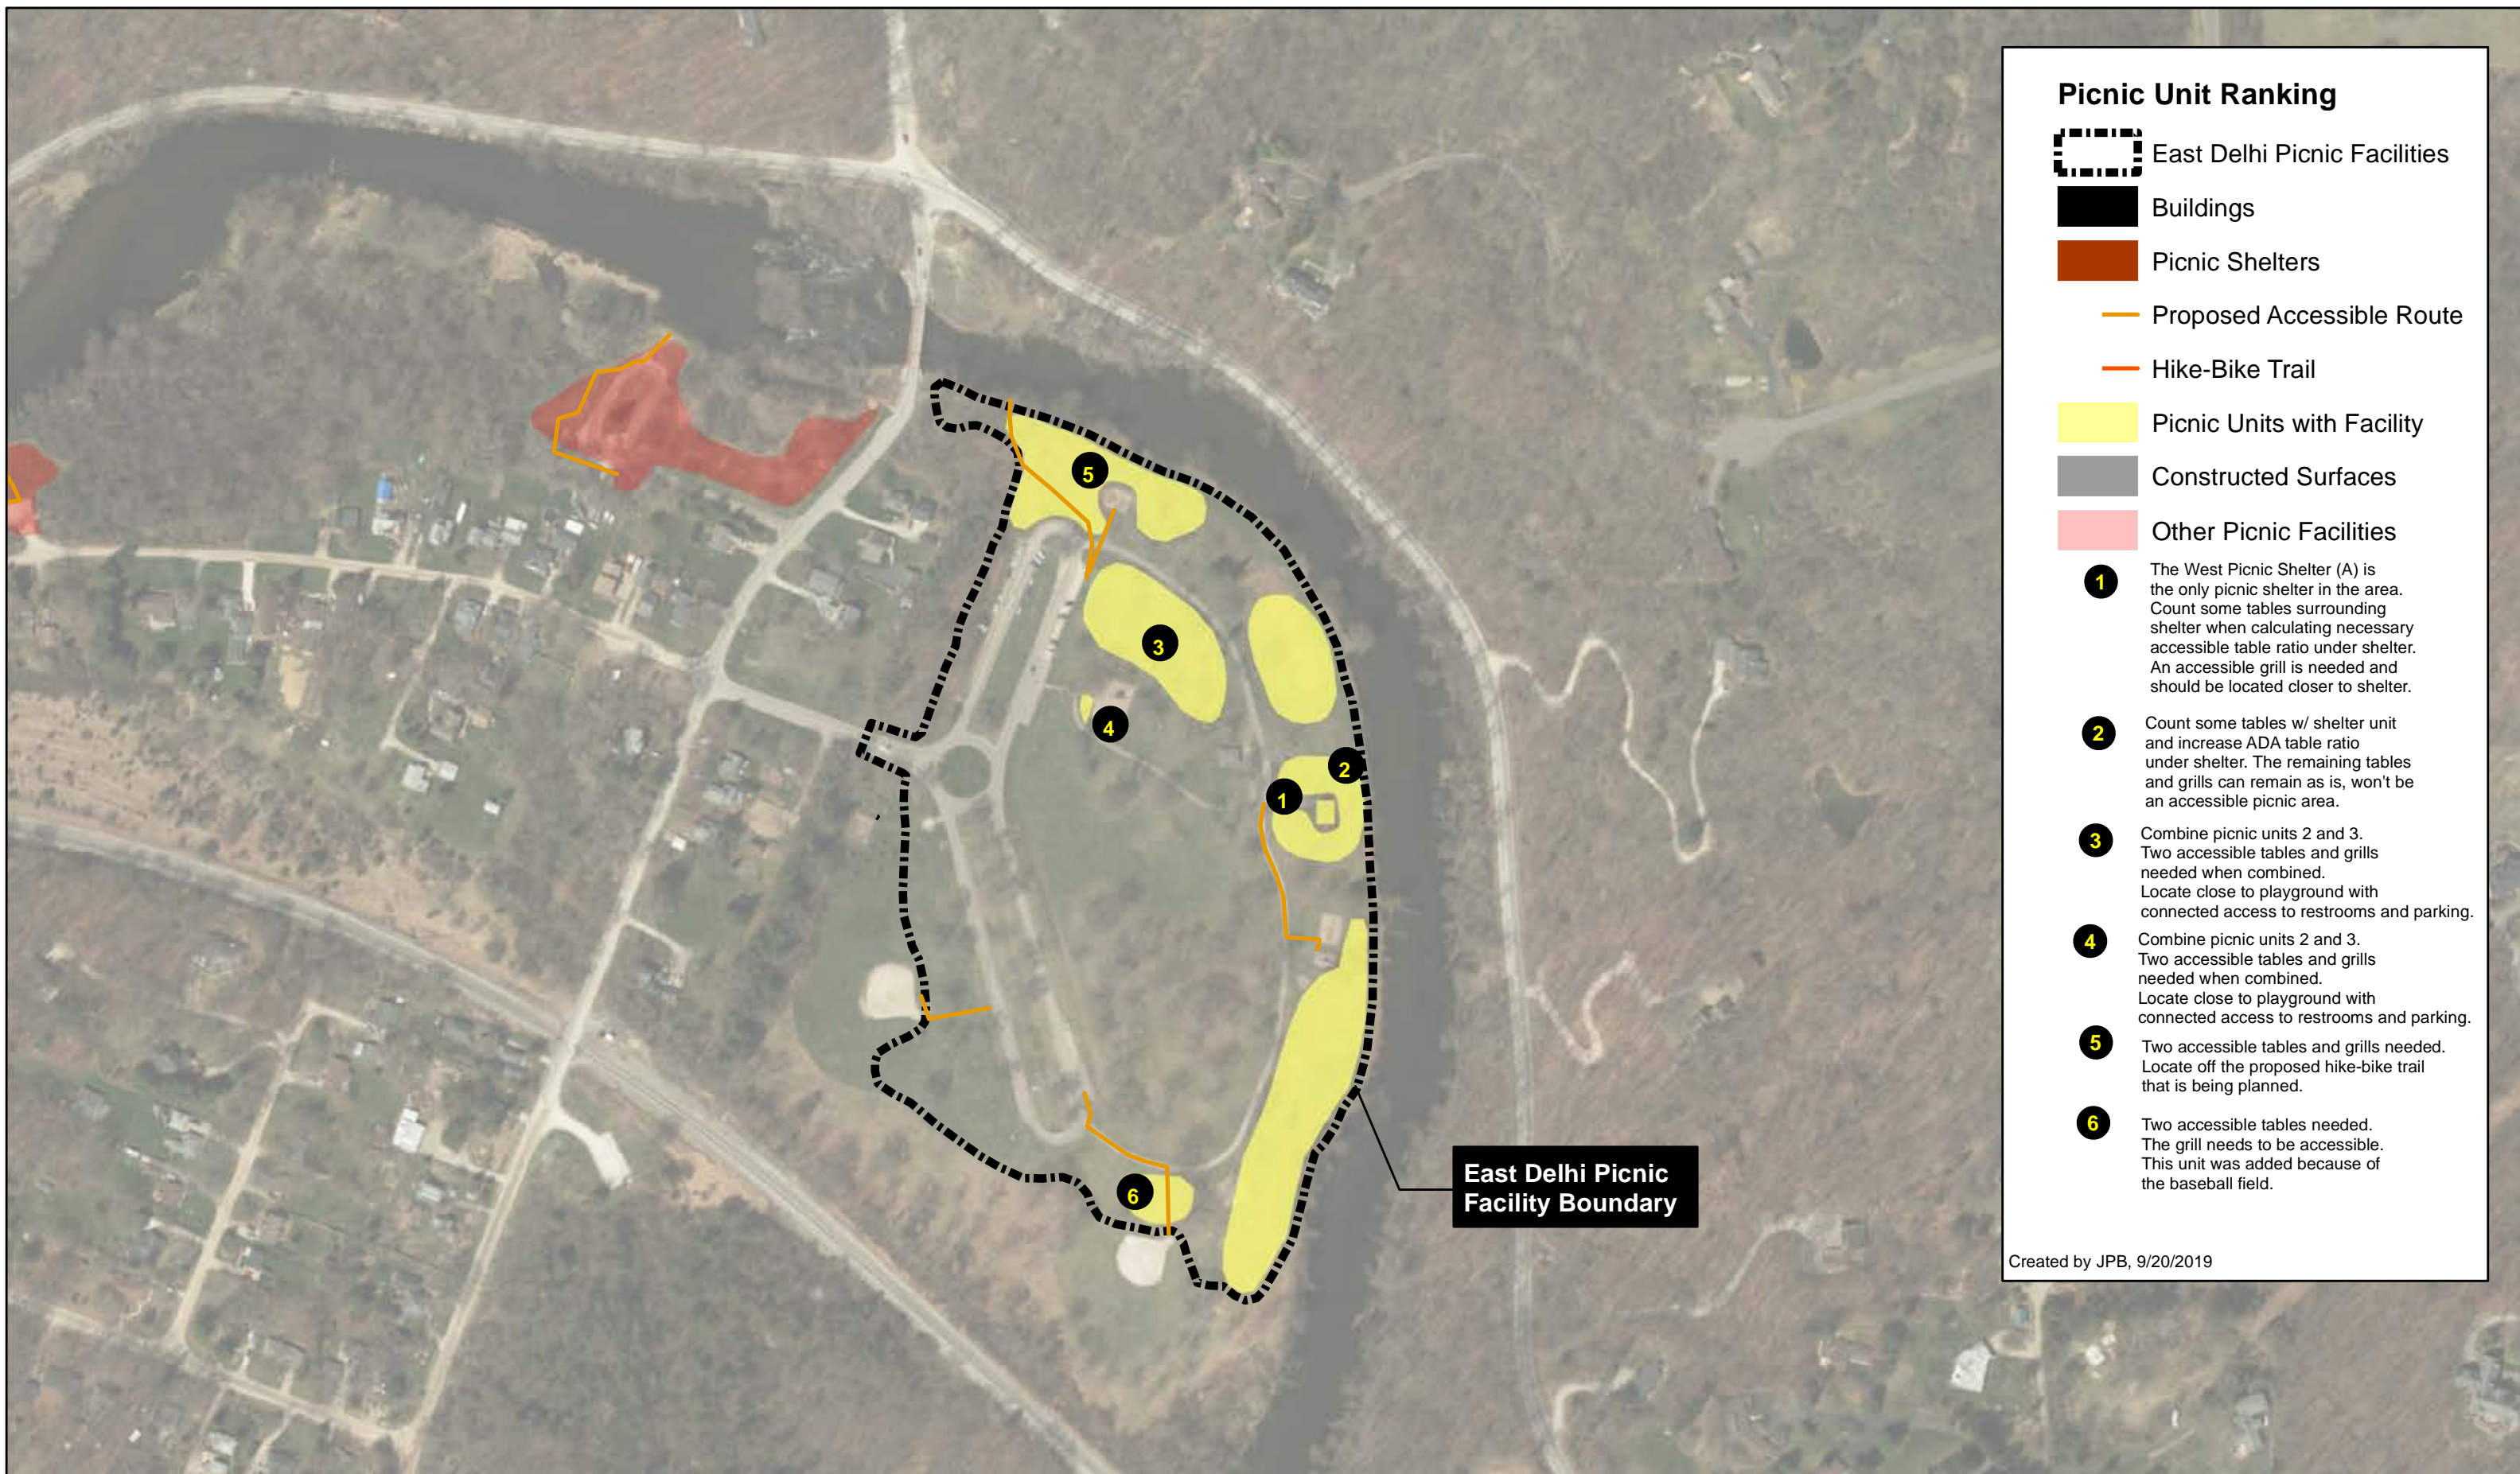
### Picnic Unit Ranking

- 1** The West Picnic Shelter (A) is the only picnic shelter in the area. Count some tables surrounding shelter when calculating necessary accessible table ratio under shelter. An accessible grill is needed and should be located closer to shelter.

- 2** Count some tables w/ shelter unit and increase ADA table ratio under shelter. The remaining tables and grills can remain as is, won't be an accessible picnic area.

- 3** Combine picnic units 2 and 3. Two accessible tables and grills needed when combined. Locate close to playground with connected access to restrooms and parking.

- 4** Combine picnic units 2 and 3. Two accessible tables and grills needed when combined. Locate close to playground with connected access to restrooms and parking.

- 5** Two accessible tables and grills needed. Locate off the proposed hike-bike trail that is being planned.
- 6** Two accessible tables needed. The grill needs to be accessible. This unit was added because of the baseball field.

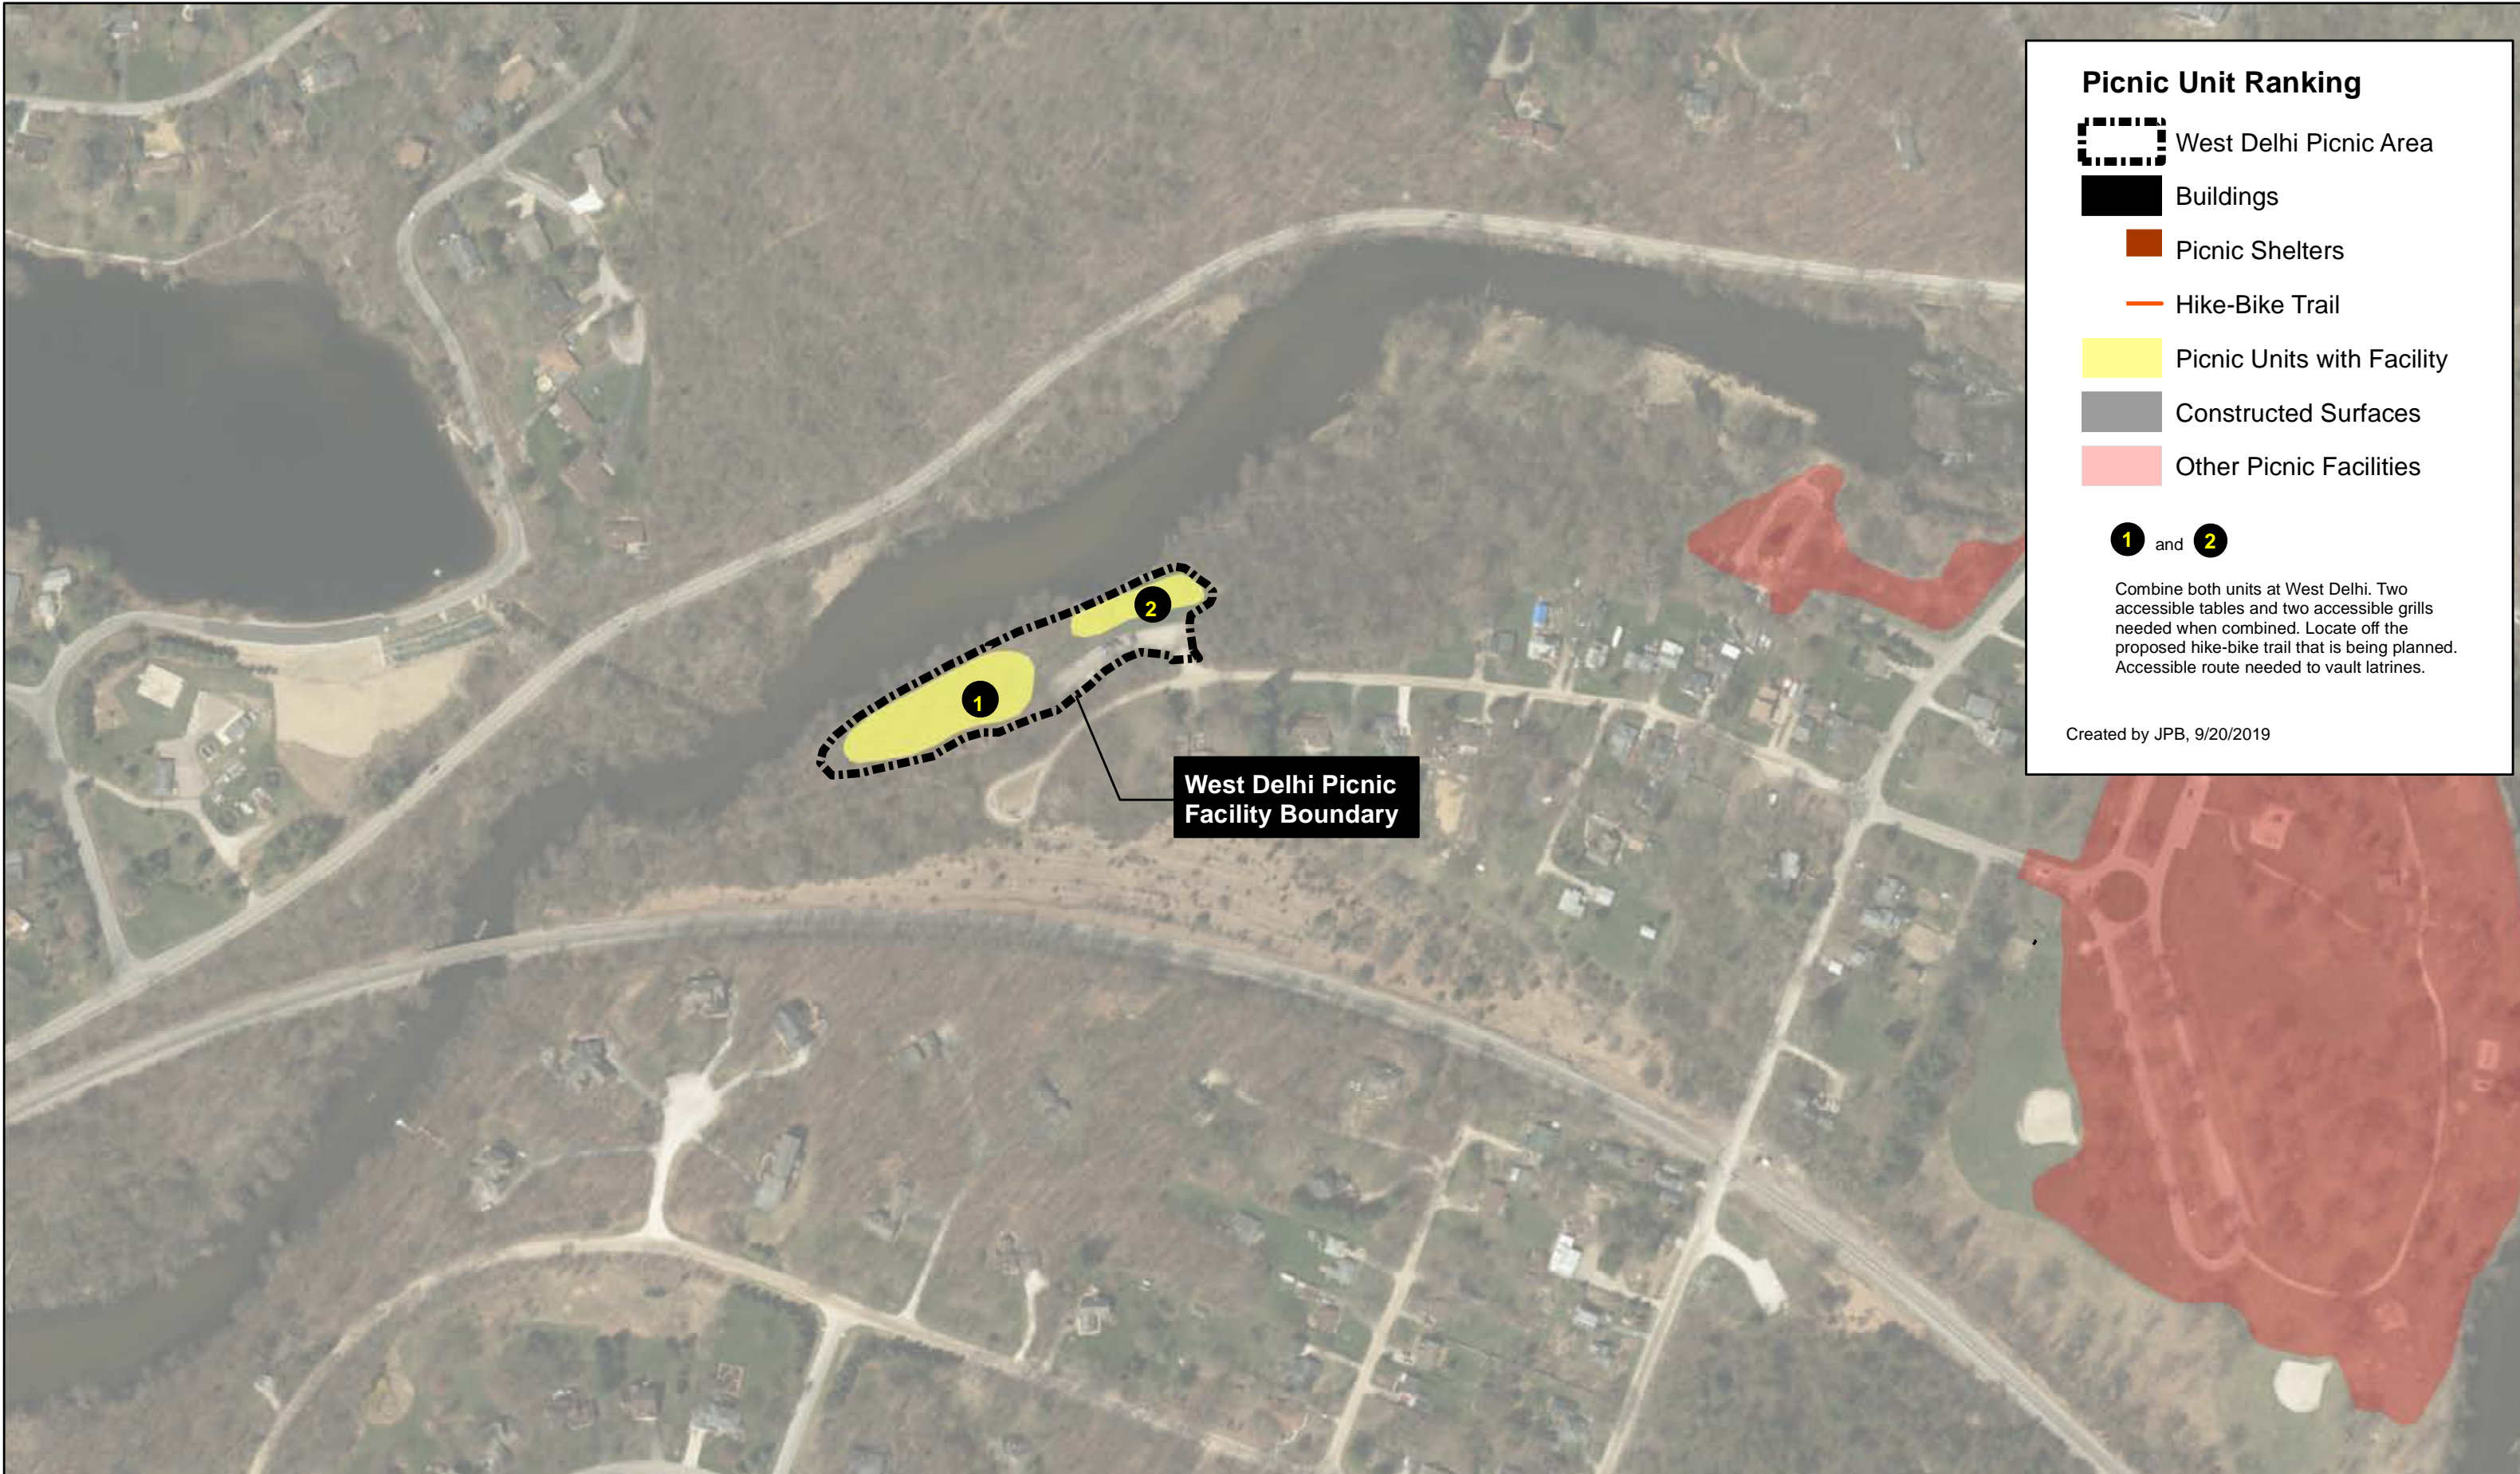
**Picnic Unit Ranking**

**1** and **2**

Combine both units at West Delhi. Two accessible tables and two accessible grills needed when combined. Locate off the proposed hike-bike trail that is being planned. Accessible route needed to vault latrines.

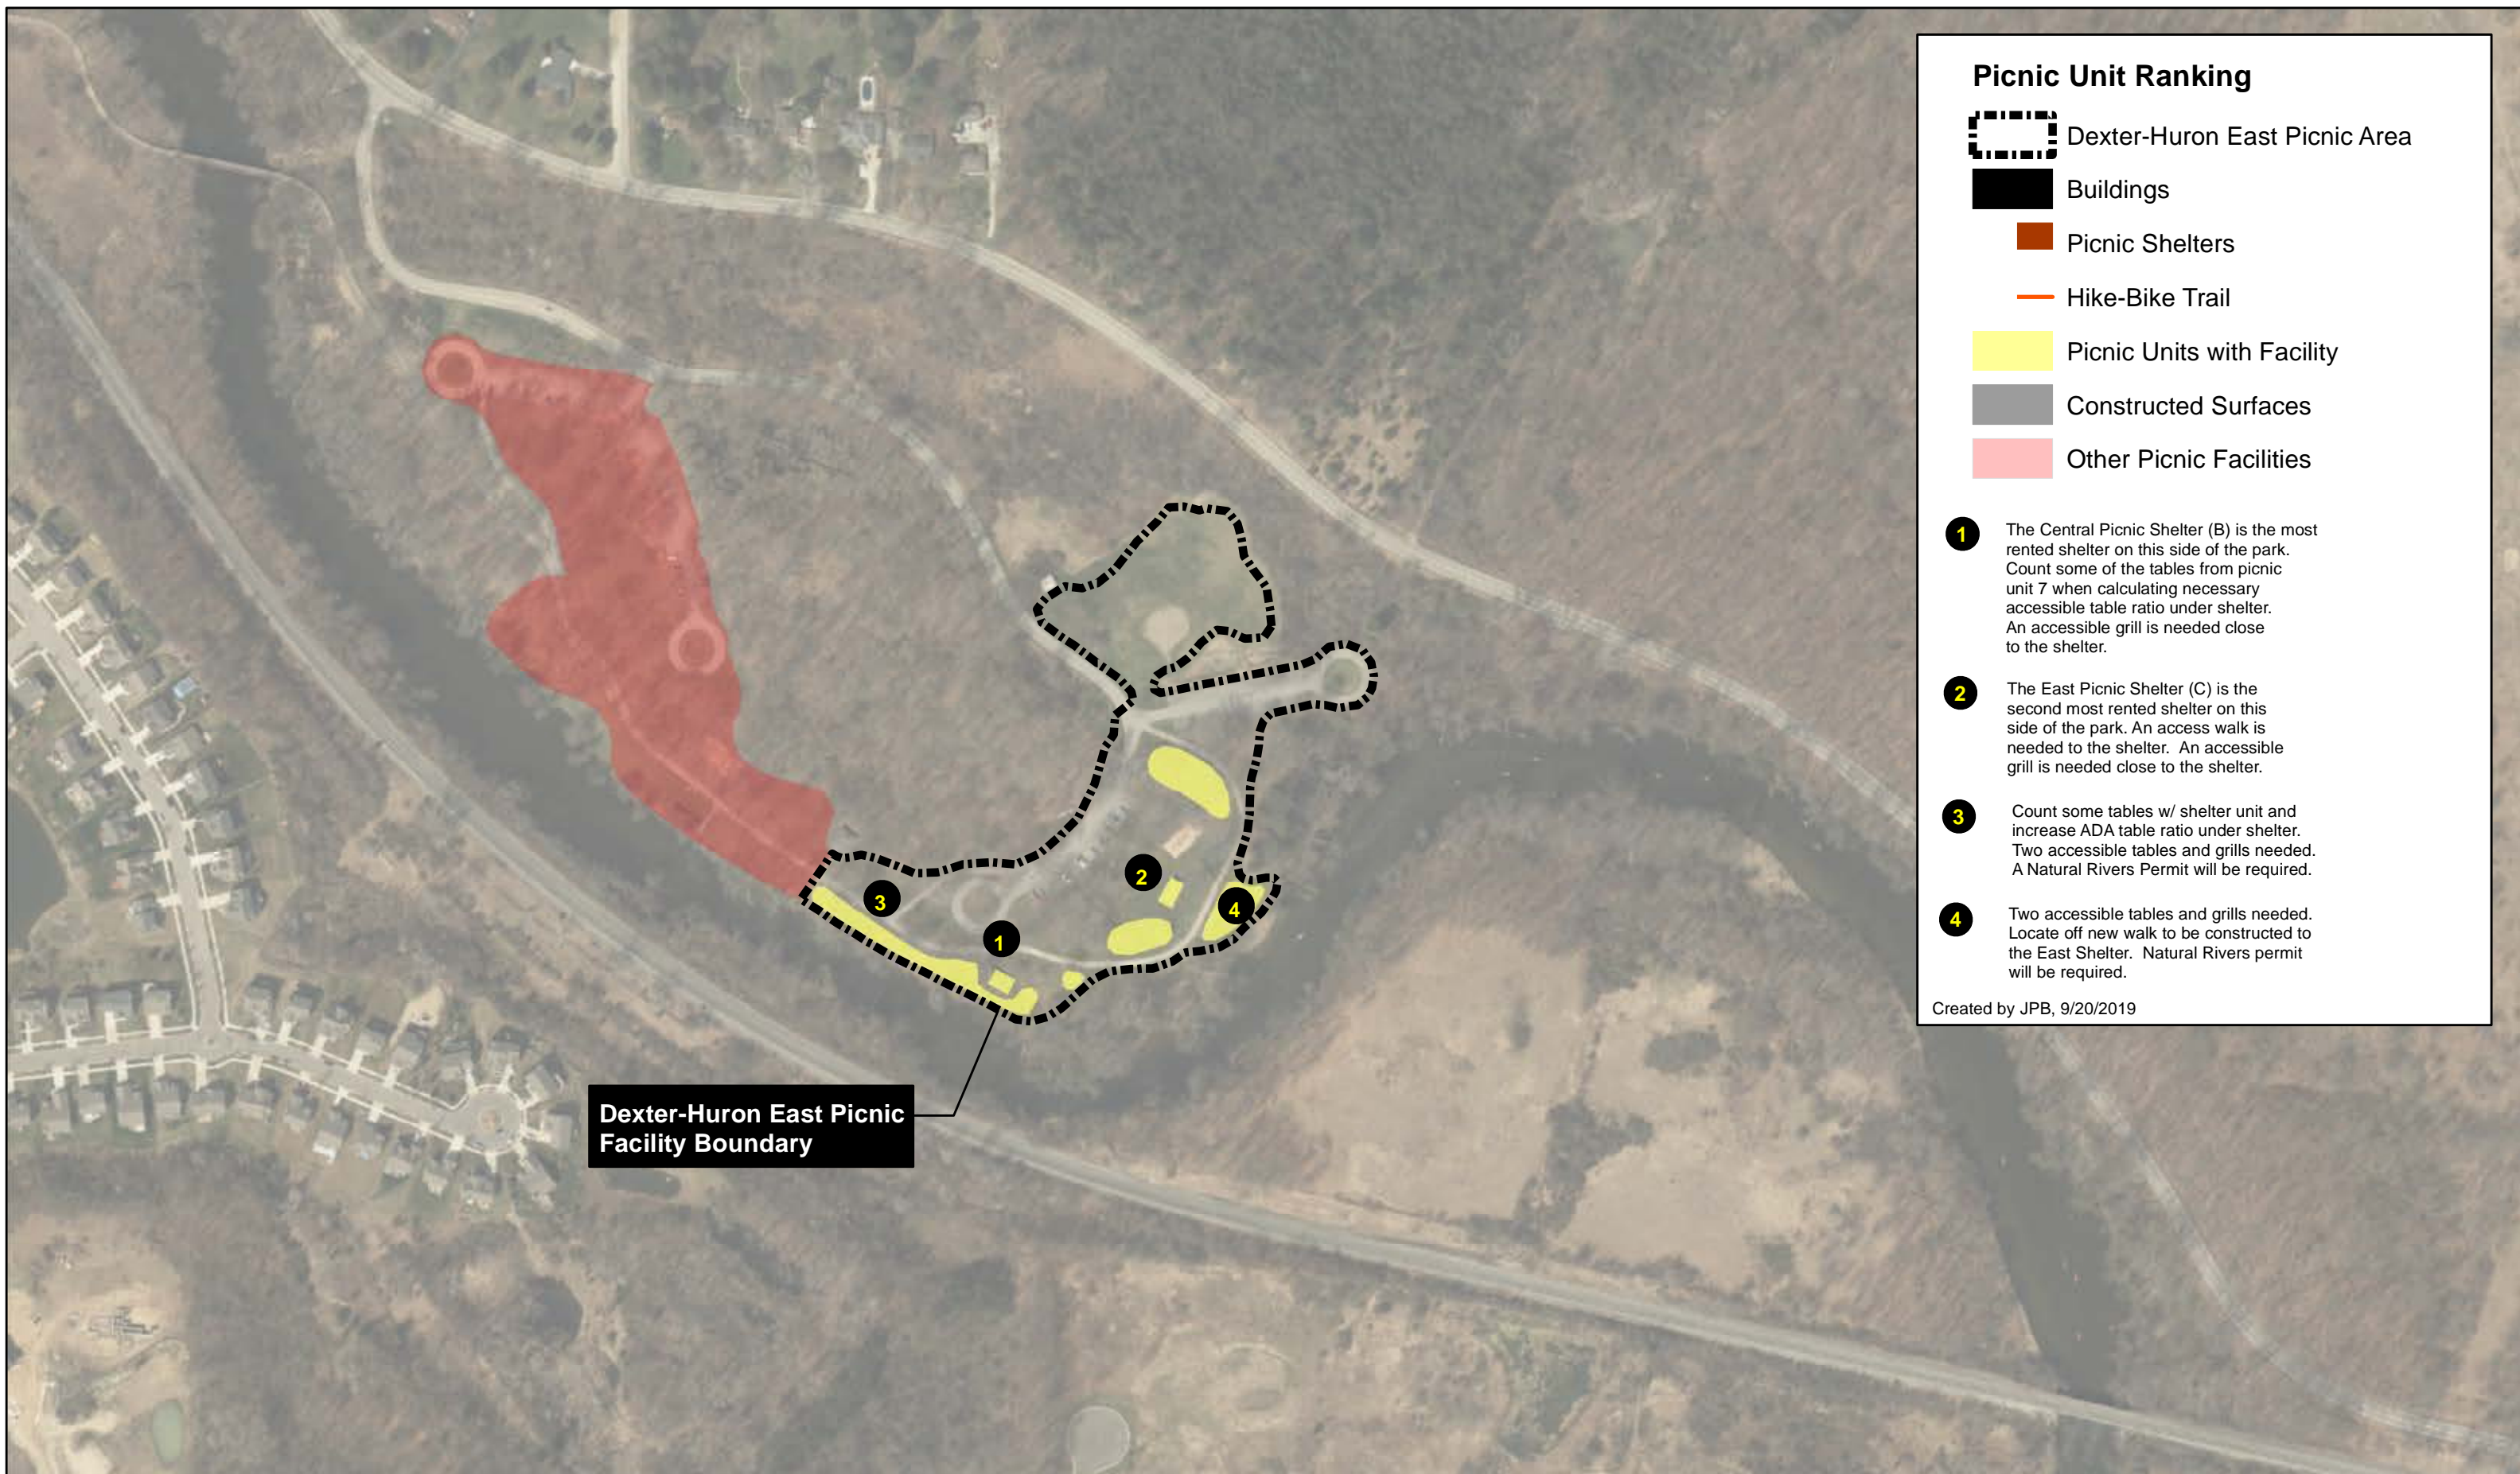
## Picnic Unit Ranking

- 1** The Central Picnic Shelter (B) is the most rented shelter on this side of the park. Count some of the tables from picnic unit 7 when calculating necessary accessible table ratio under shelter. An accessible grill is needed close to the shelter.
- 2** The East Picnic Shelter (C) is the second most rented shelter on this side of the park. An access walk is needed to the shelter. An accessible grill is needed close to the shelter.
- 3** Count some tables w/ shelter unit and increase ADA table ratio under shelter. Two accessible tables and grills needed. A Natural Rivers Permit will be required.
- 4** Two accessible tables and grills needed. Locate off new walk to be constructed to the East Shelter. Natural Rivers permit will be required.

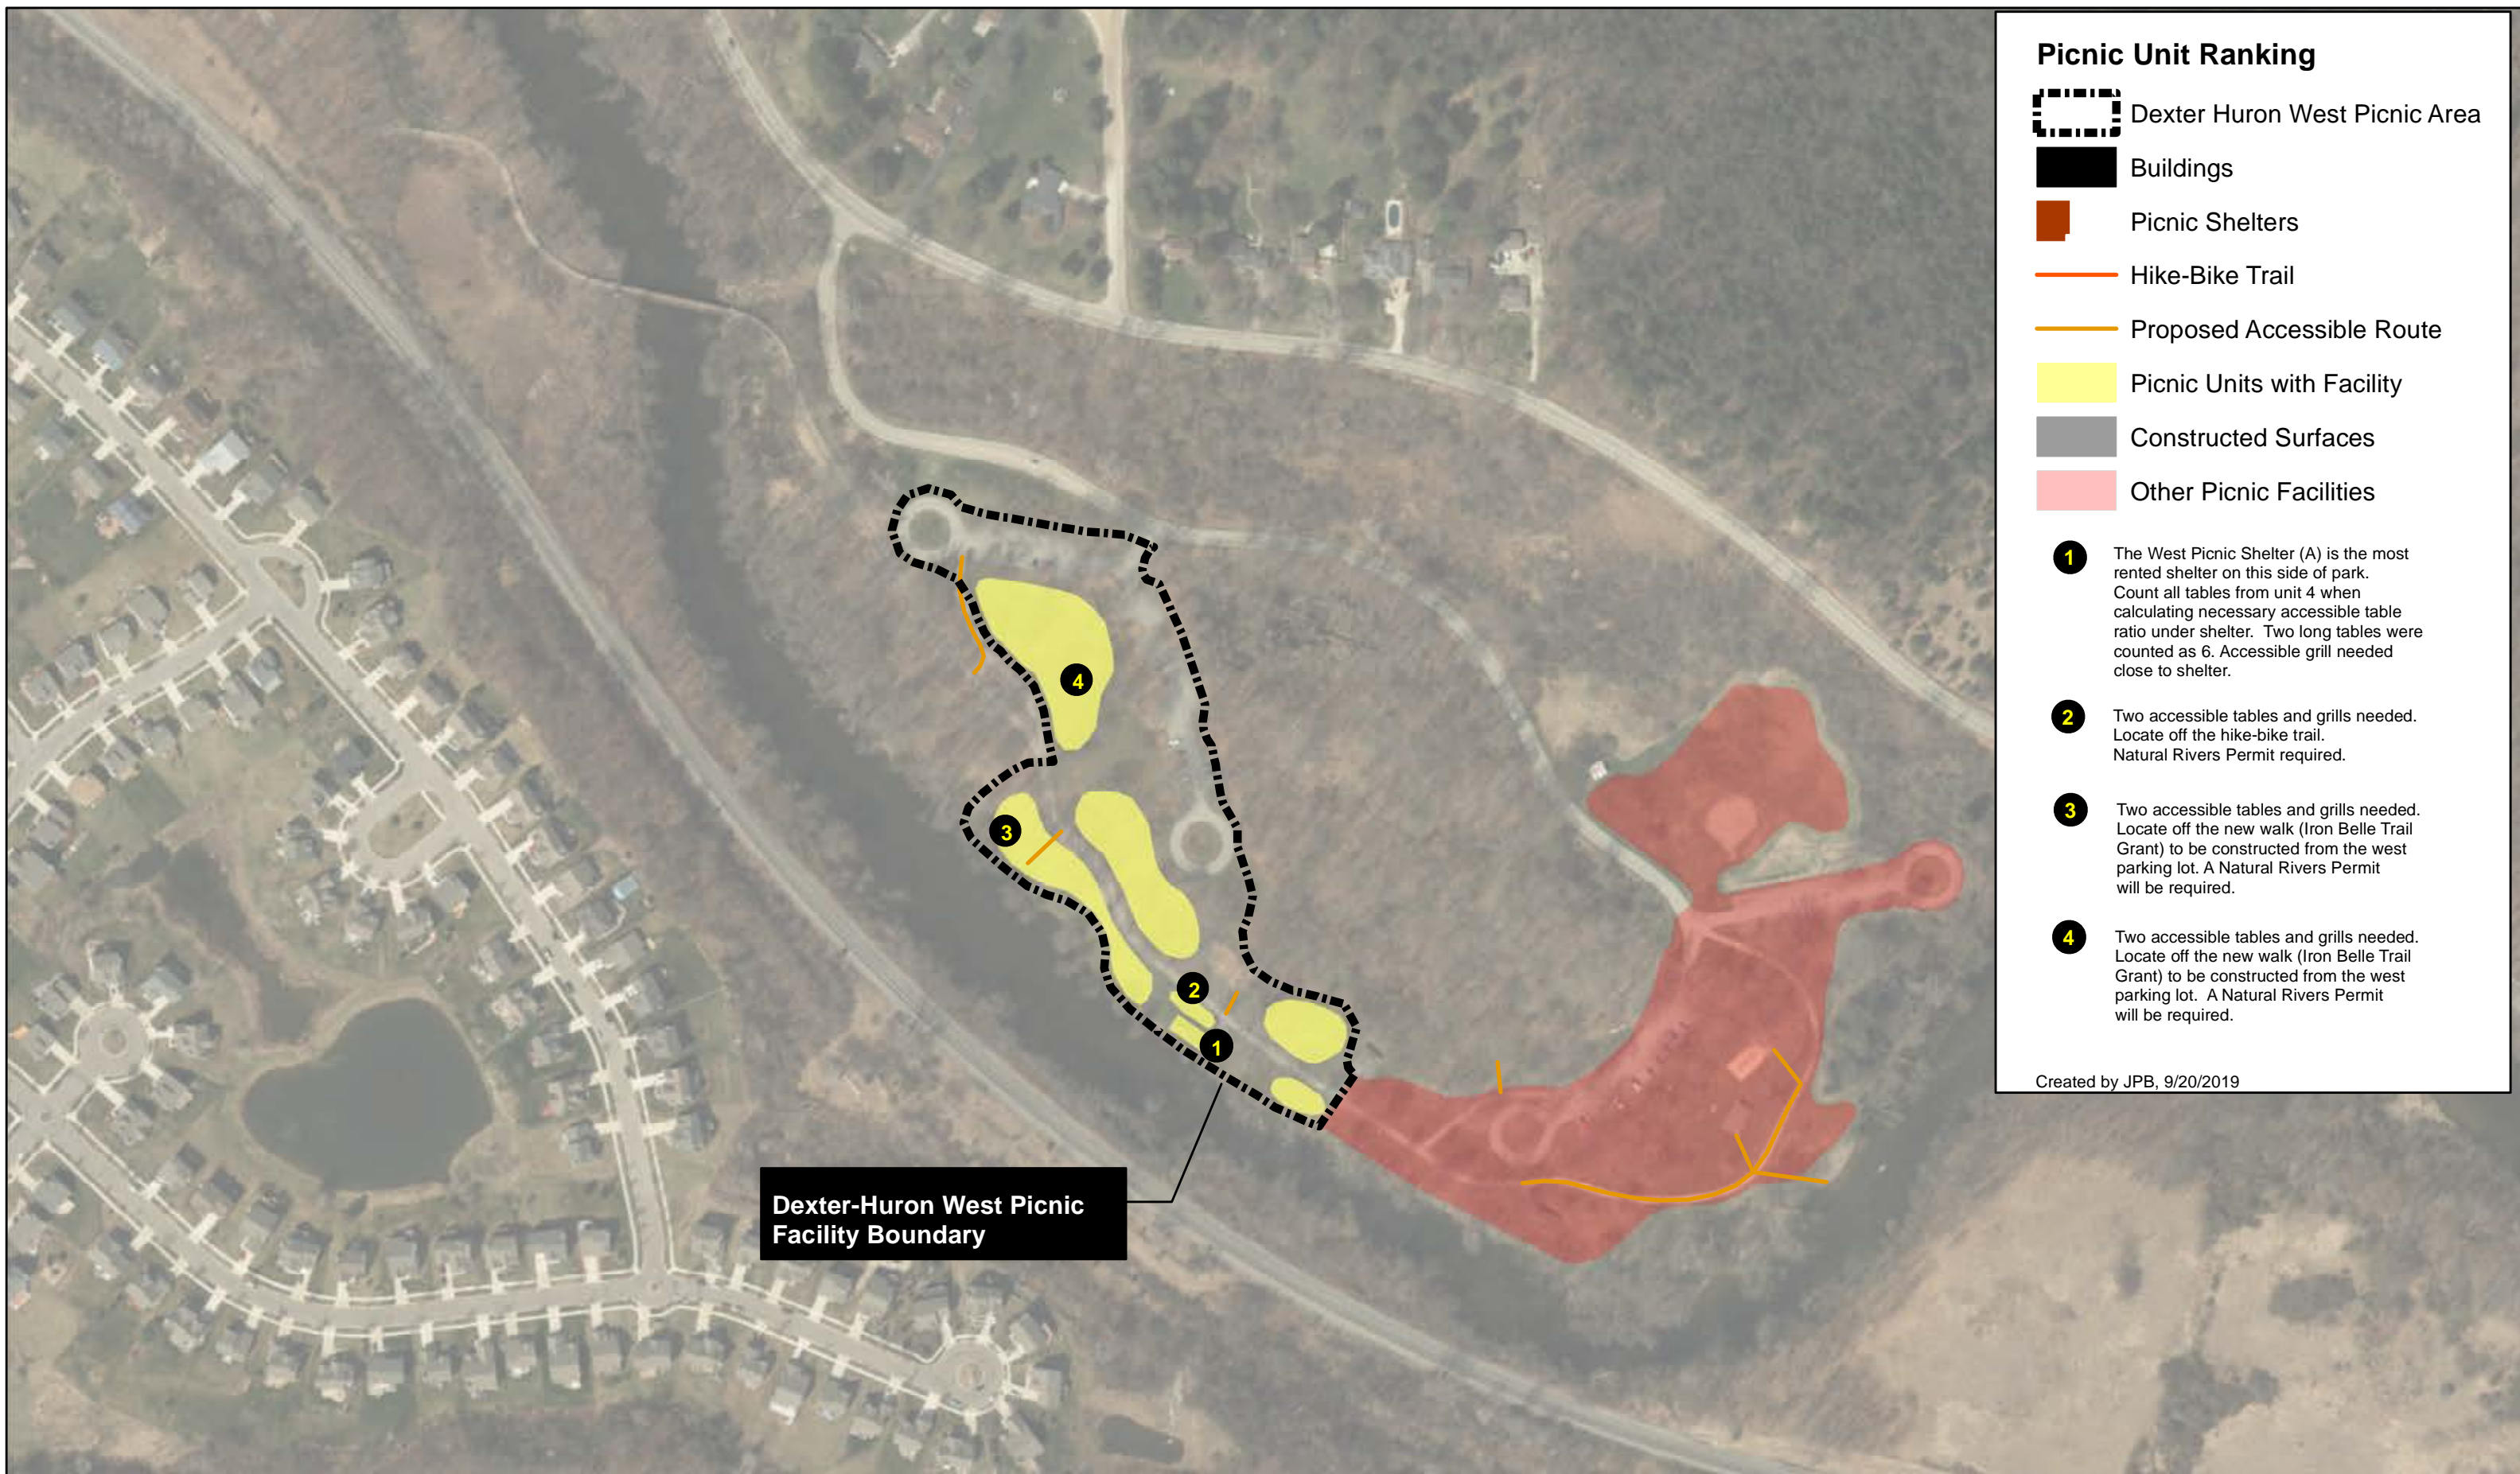
## Picnic Unit Ranking

- 1** The West Picnic Shelter (A) is the most rented shelter on this side of park. Count all tables from unit 4 when calculating necessary accessible table ratio under shelter. Two long tables were counted as 6. Accessible grill needed close to shelter.
- 2** Two accessible tables and grills needed. Locate off the hike-bike trail. Natural Rivers Permit required.
- 3** Two accessible tables and grills needed. Locate off the new walk (Iron Belle Trail Grant) to be constructed from the west parking lot. A Natural Rivers Permit will be required.
- 4** Two accessible tables and grills needed. Locate off the new walk (Iron Belle Trail Grant) to be constructed from the west parking lot. A Natural Rivers Permit will be required.

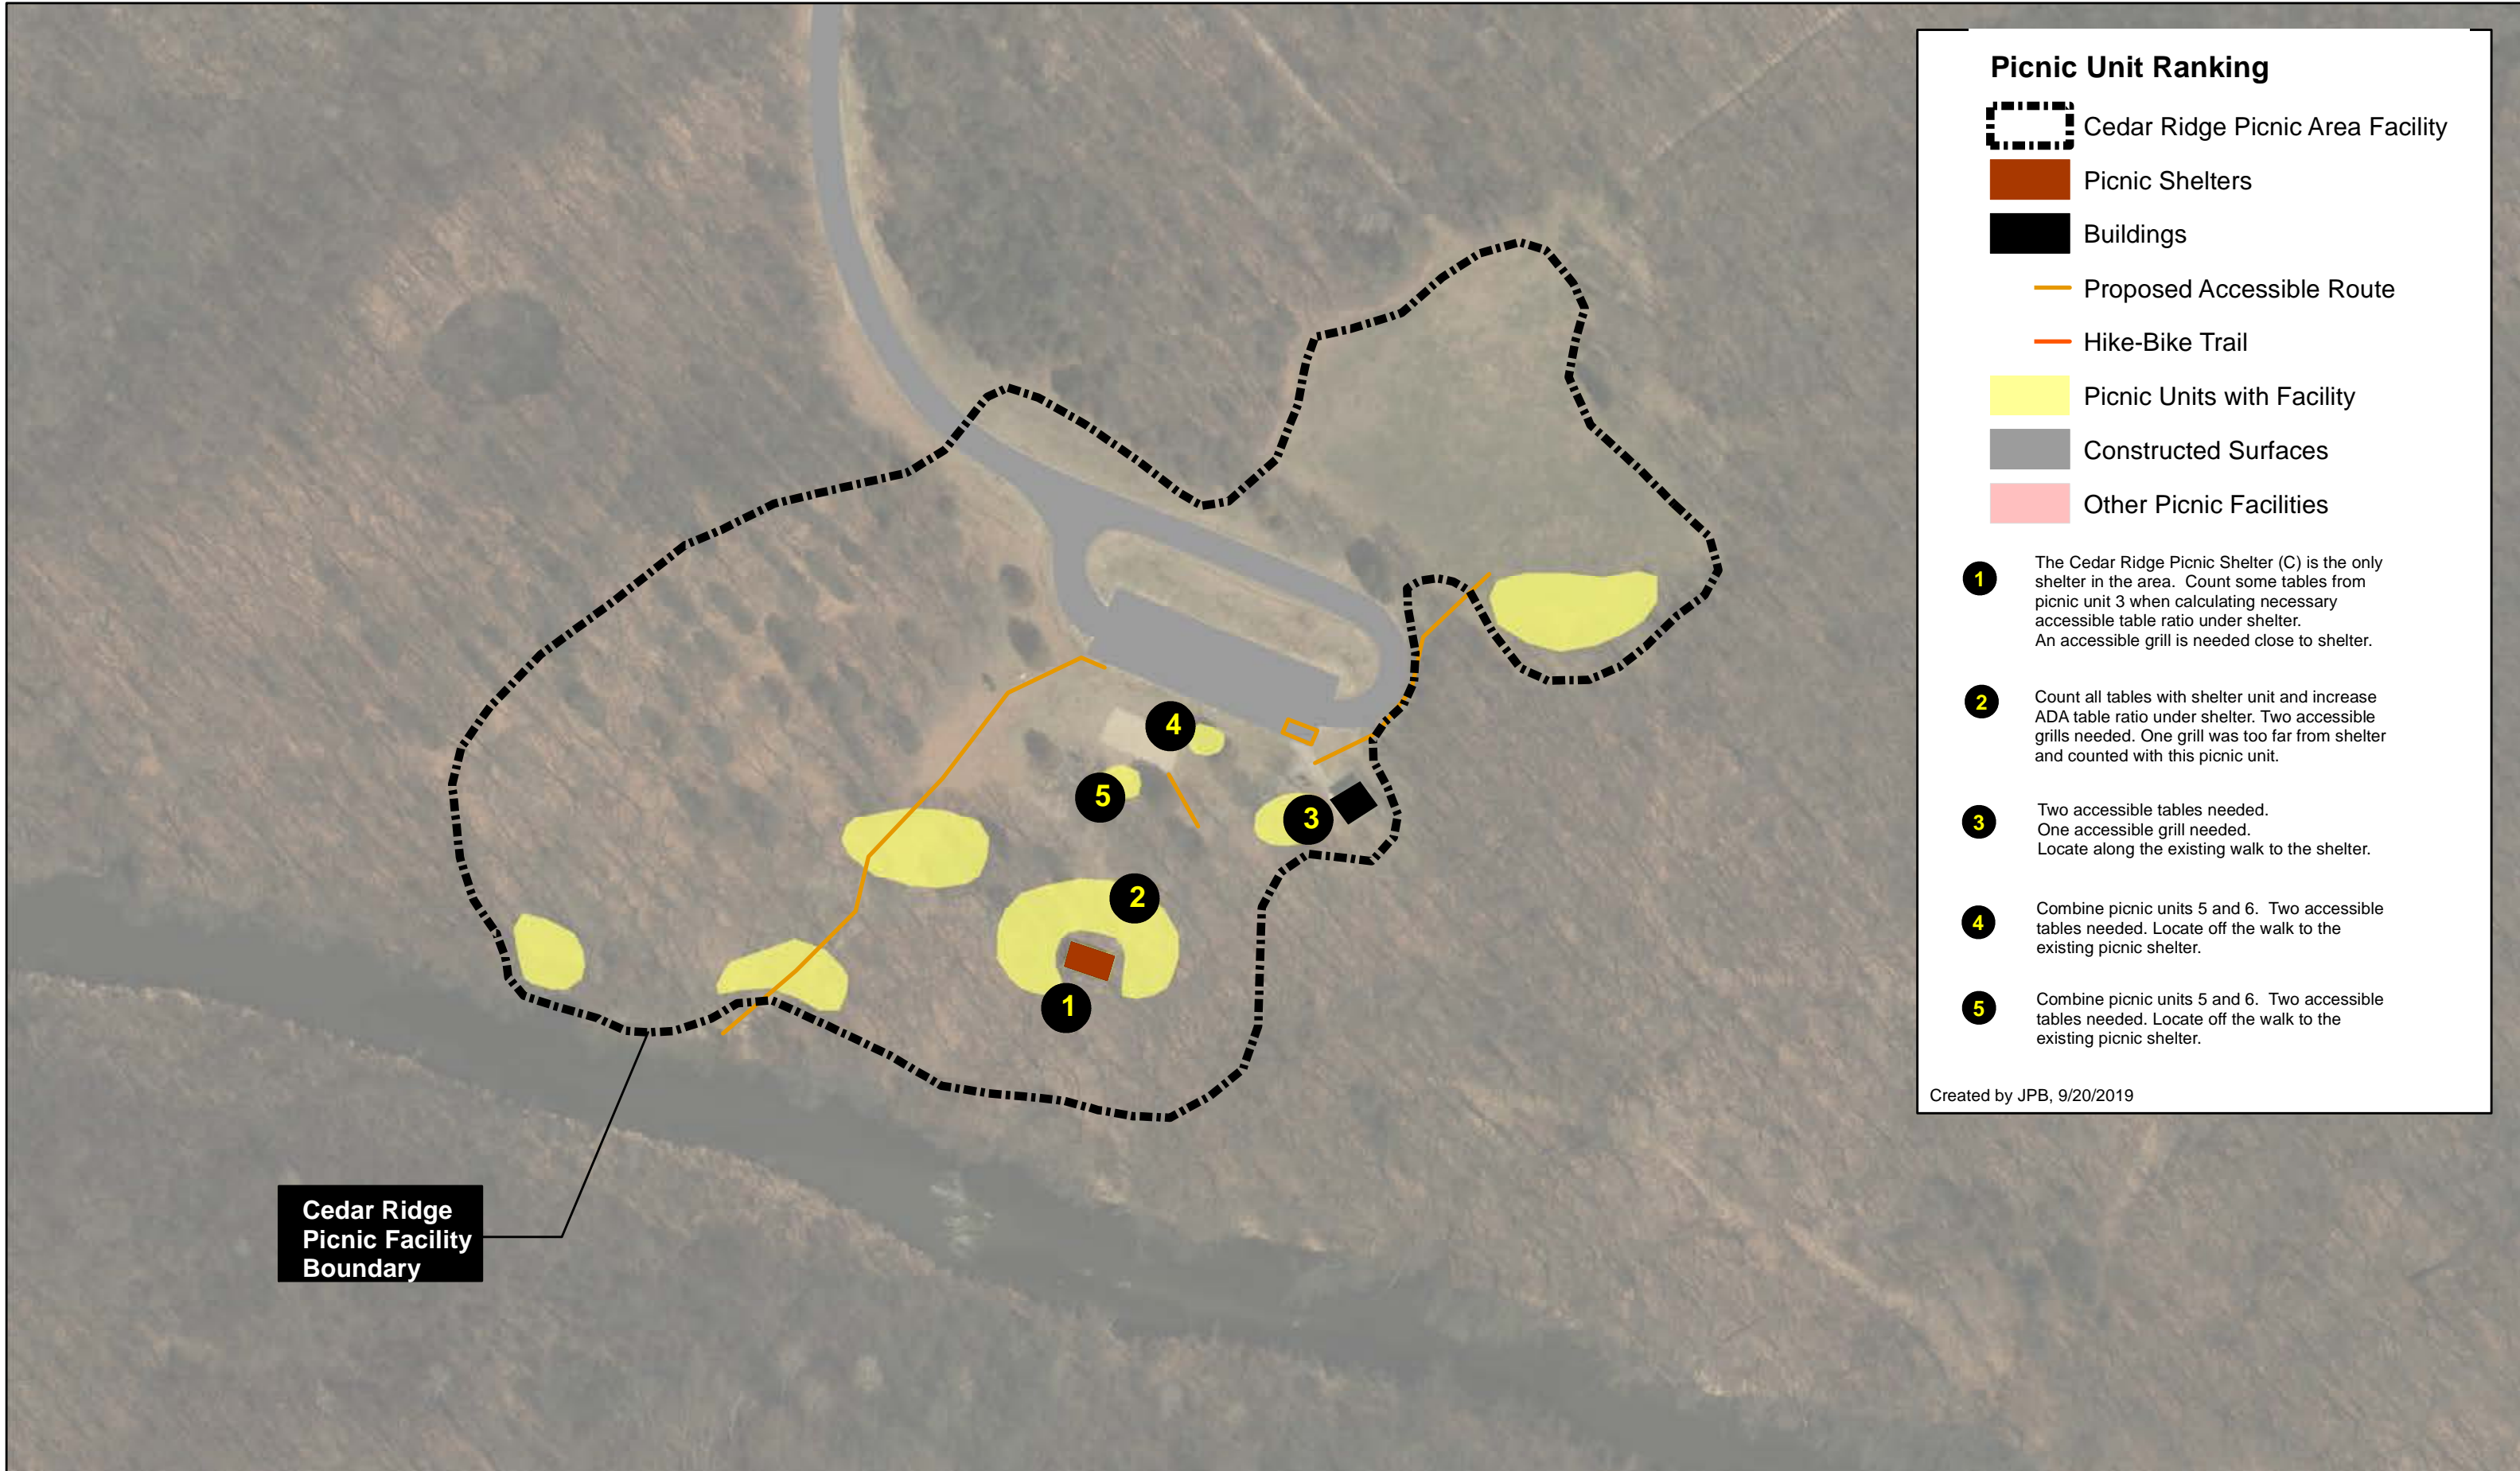
**Picnic Unit Ranking**

- 1** The Cedar Ridge Picnic Shelter (C) is the only shelter in the area. Count some tables from picnic unit 3 when calculating necessary accessible table ratio under shelter. An accessible grill is needed close to shelter.
- 2** Count all tables with shelter unit and increase ADA table ratio under shelter. Two accessible grills needed. One grill was too far from shelter and counted with this picnic unit.
- 3** Two accessible tables needed. One accessible grill needed. Locate along the existing walk to the shelter.
- 4** Combine picnic units 5 and 6. Two accessible tables needed. Locate off the walk to the existing picnic shelter.
- 5** Combine picnic units 5 and 6. Two accessible tables needed. Locate off the walk to the existing picnic shelter.
