# APPENDIX 3: PICNIC FACILITIES MAPS

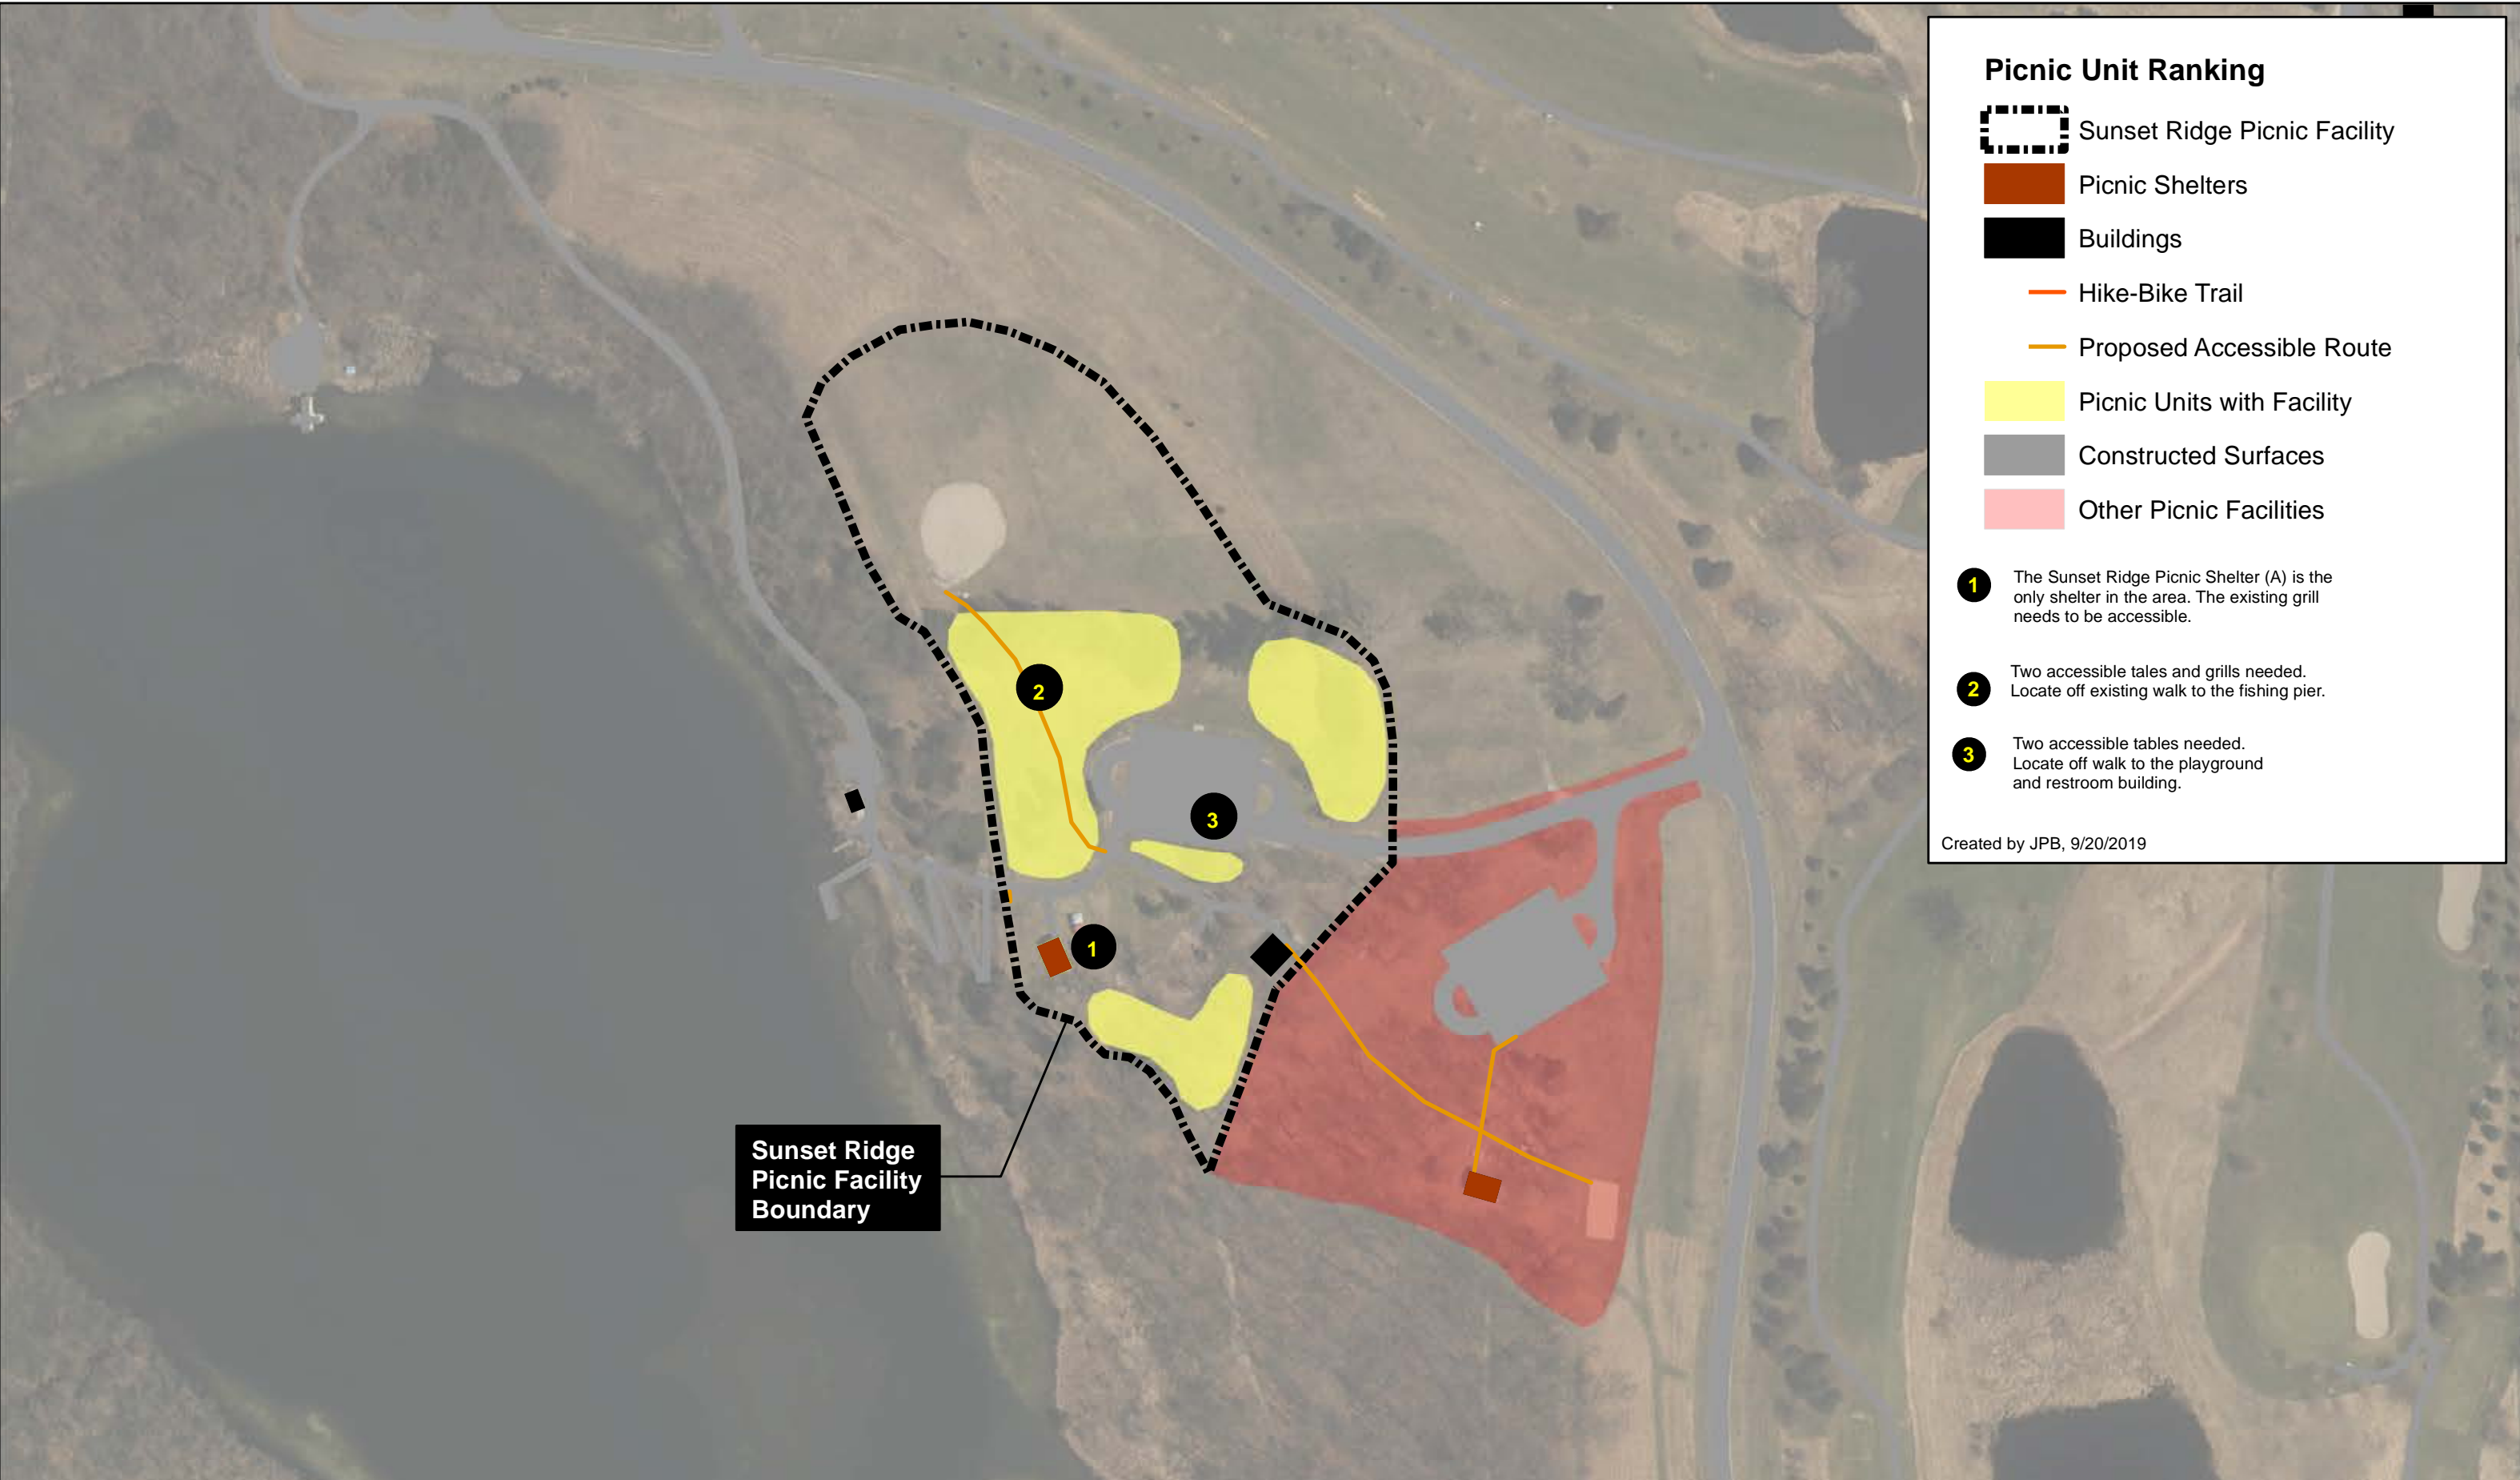
**Picnic Unit Ranking**

- 1** The Sunset Ridge Picnic Shelter (A) is the only shelter in the area. The existing grill needs to be accessible.
- 2** Two accessible tales and grills needed. Locate off existing walk to the fishing pier.
- 3** Two accessible tables needed. Locate off walk to the playground and restroom building.

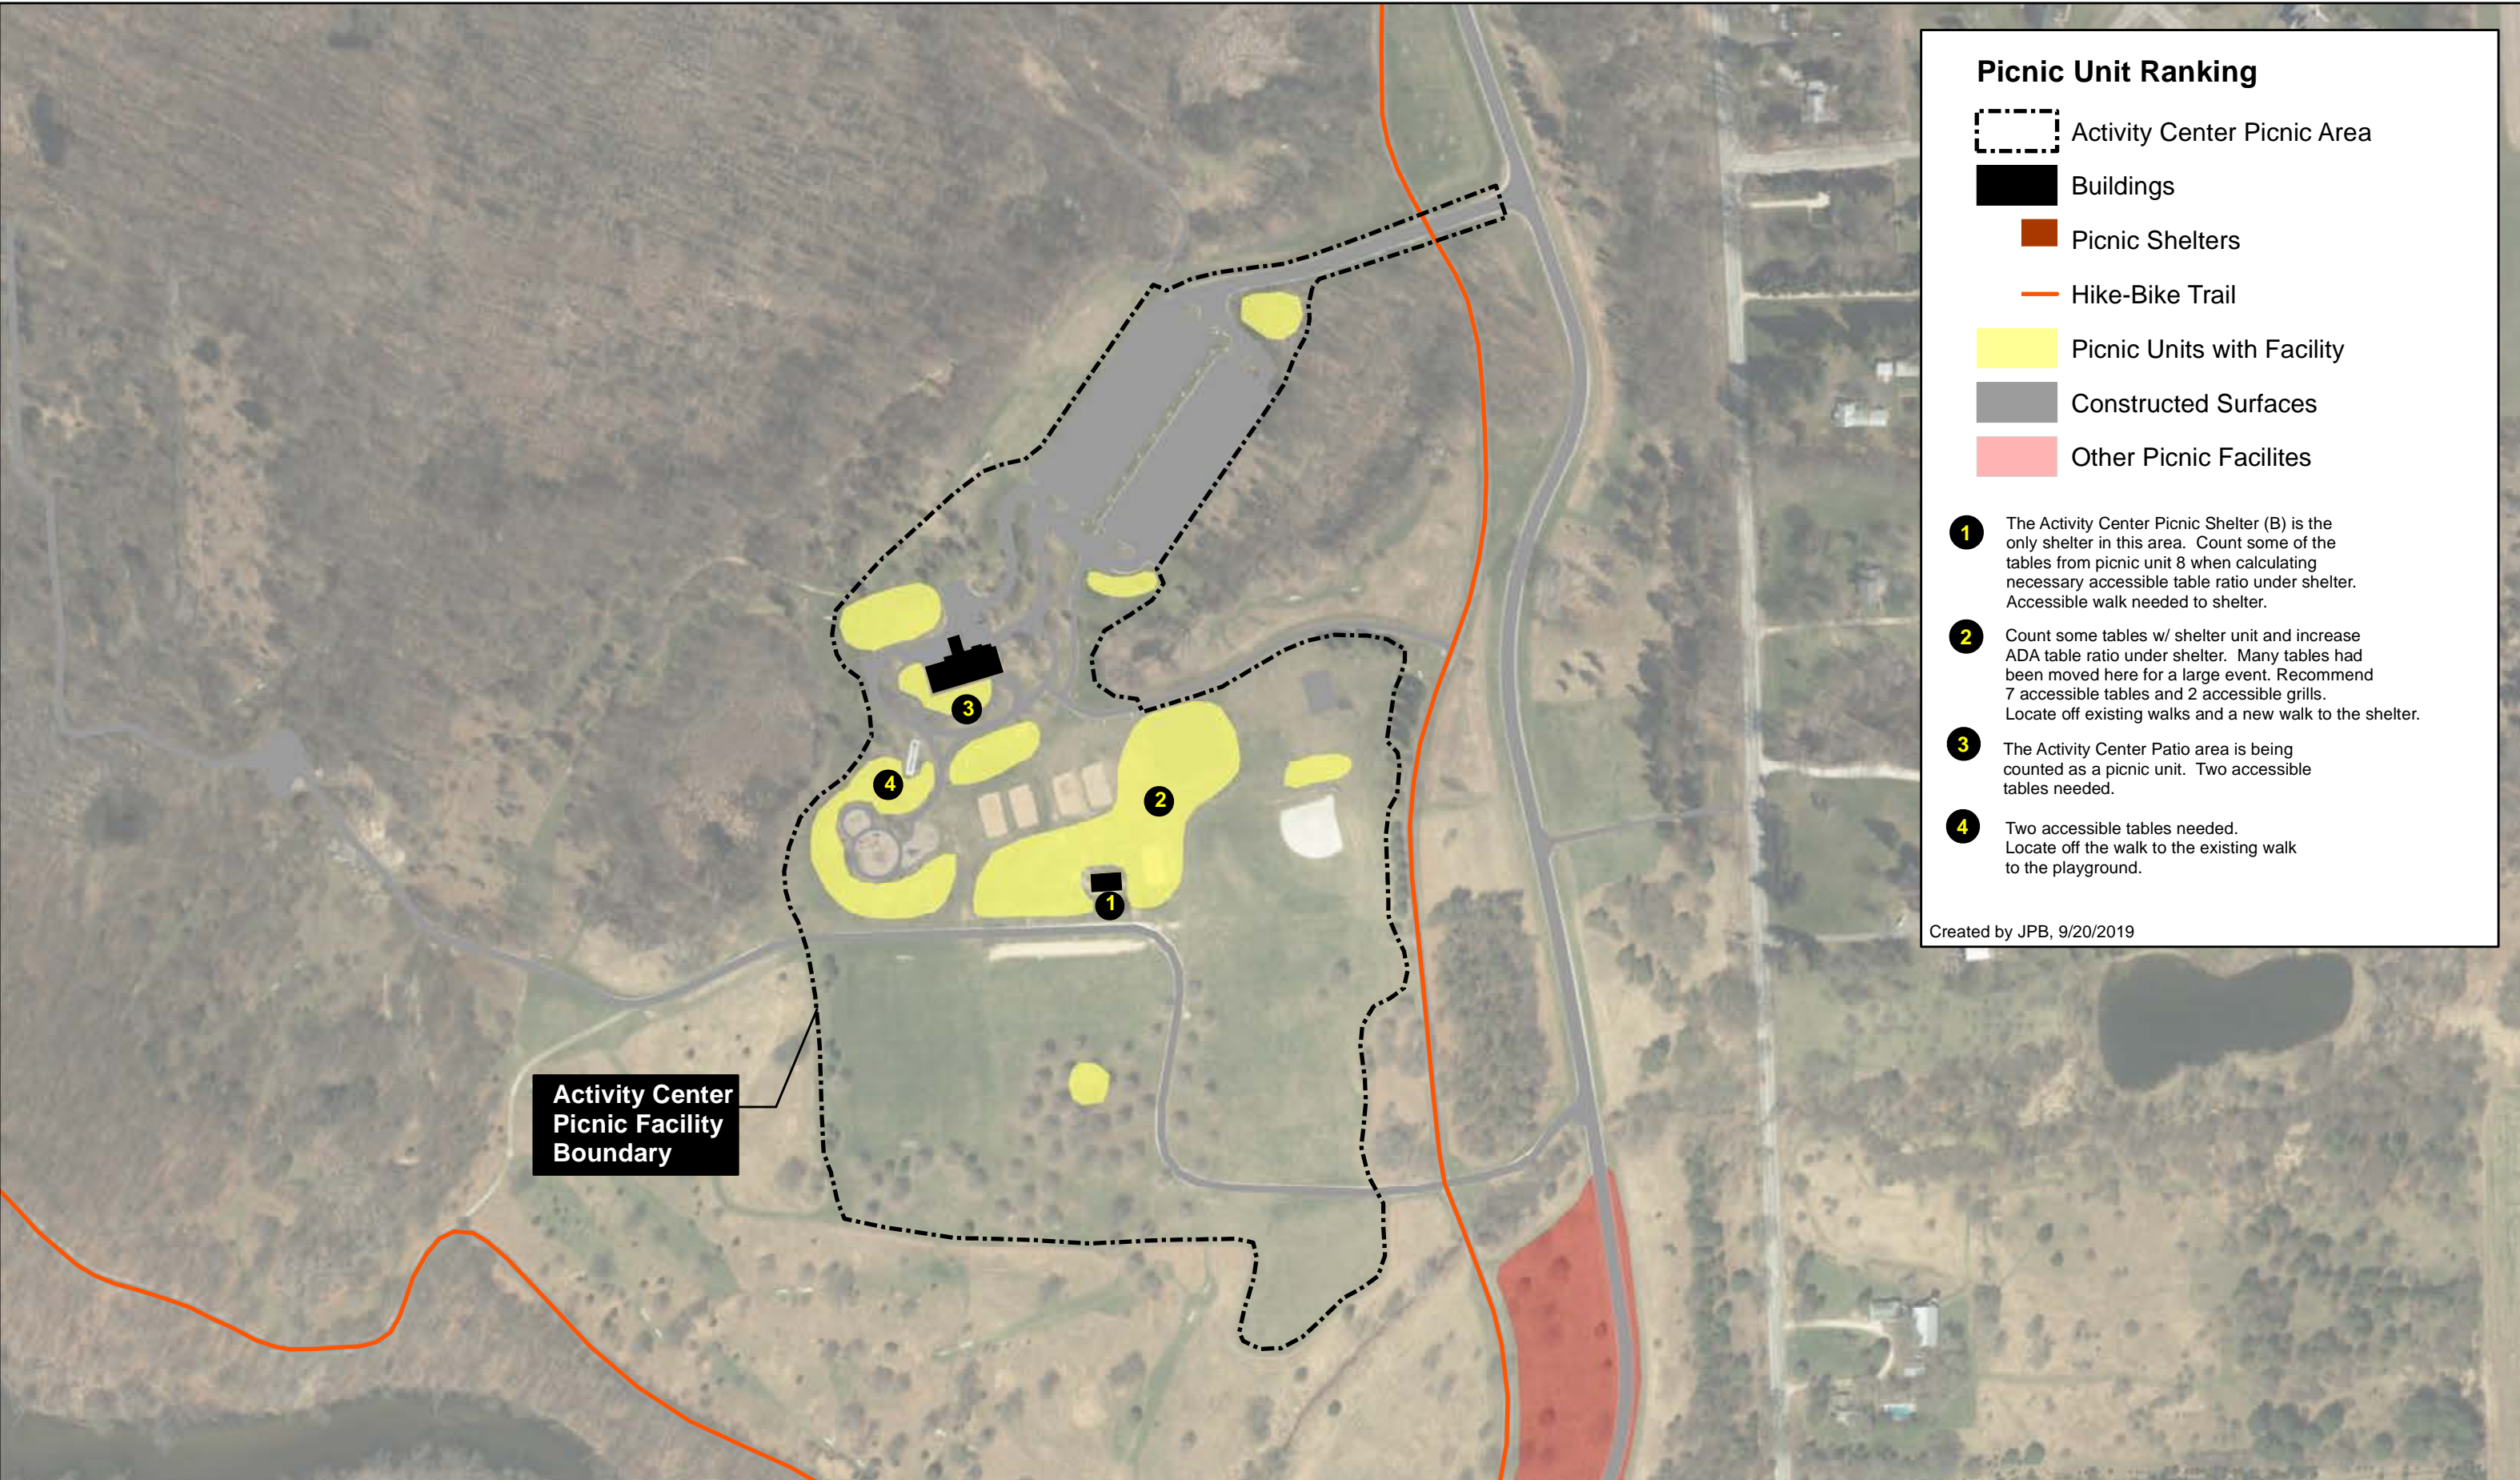
**Picnic Unit Ranking**

- 1** The Activity Center Picnic Shelter (B) is the only shelter in this area. Count some of the tables from picnic unit 8 when calculating necessary accessible table ratio under shelter. Accessible walk needed to shelter.
- 2** Count some tables w/ shelter unit and increase ADA table ratio under shelter. Many tables had been moved here for a large event. Recommend 7 accessible tables and 2 accessible grills. Locate off existing walks and a new walk to the shelter.
- 3** The Activity Center Patio area is being counted as a picnic unit. Two accessible tables needed.
- 4** Two accessible tables needed. Locate off the walk to the existing walk to the playground.

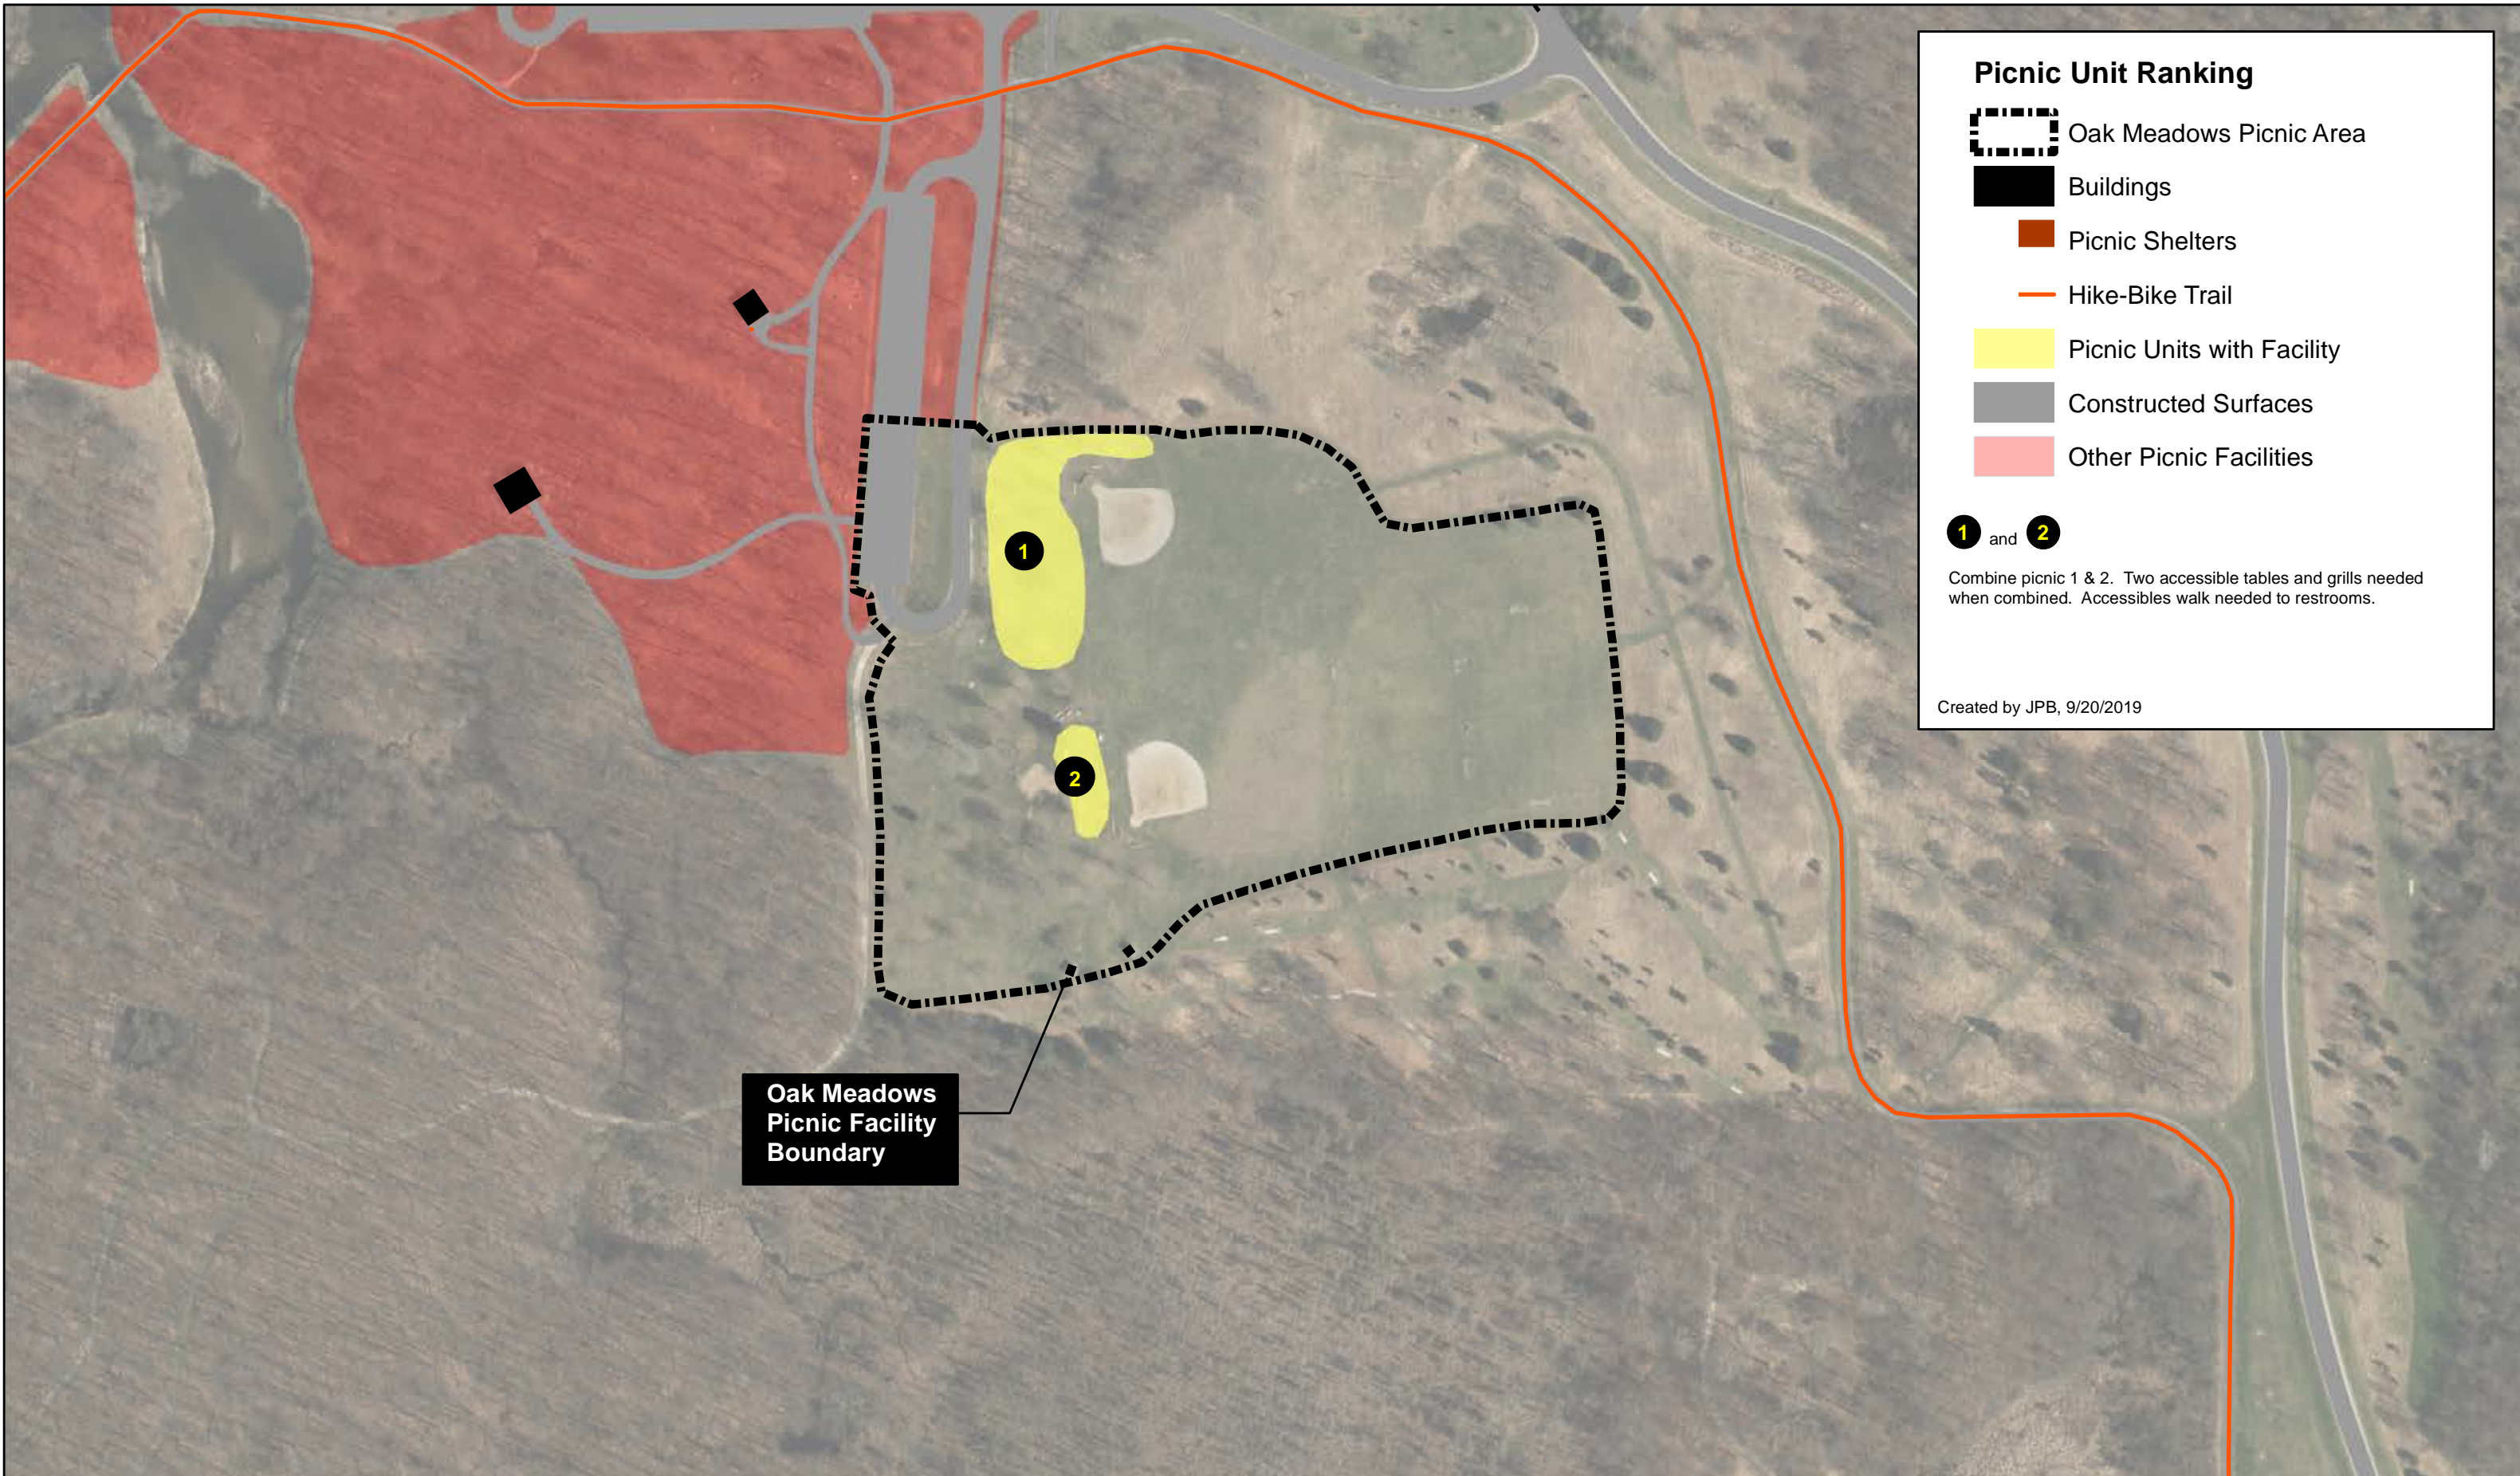
**Picnic Unit Ranking**

**1** and **2**

Combine picnic 1 & 2. Two accessible tables and grills needed when combined. Accessibles walk needed to restrooms.

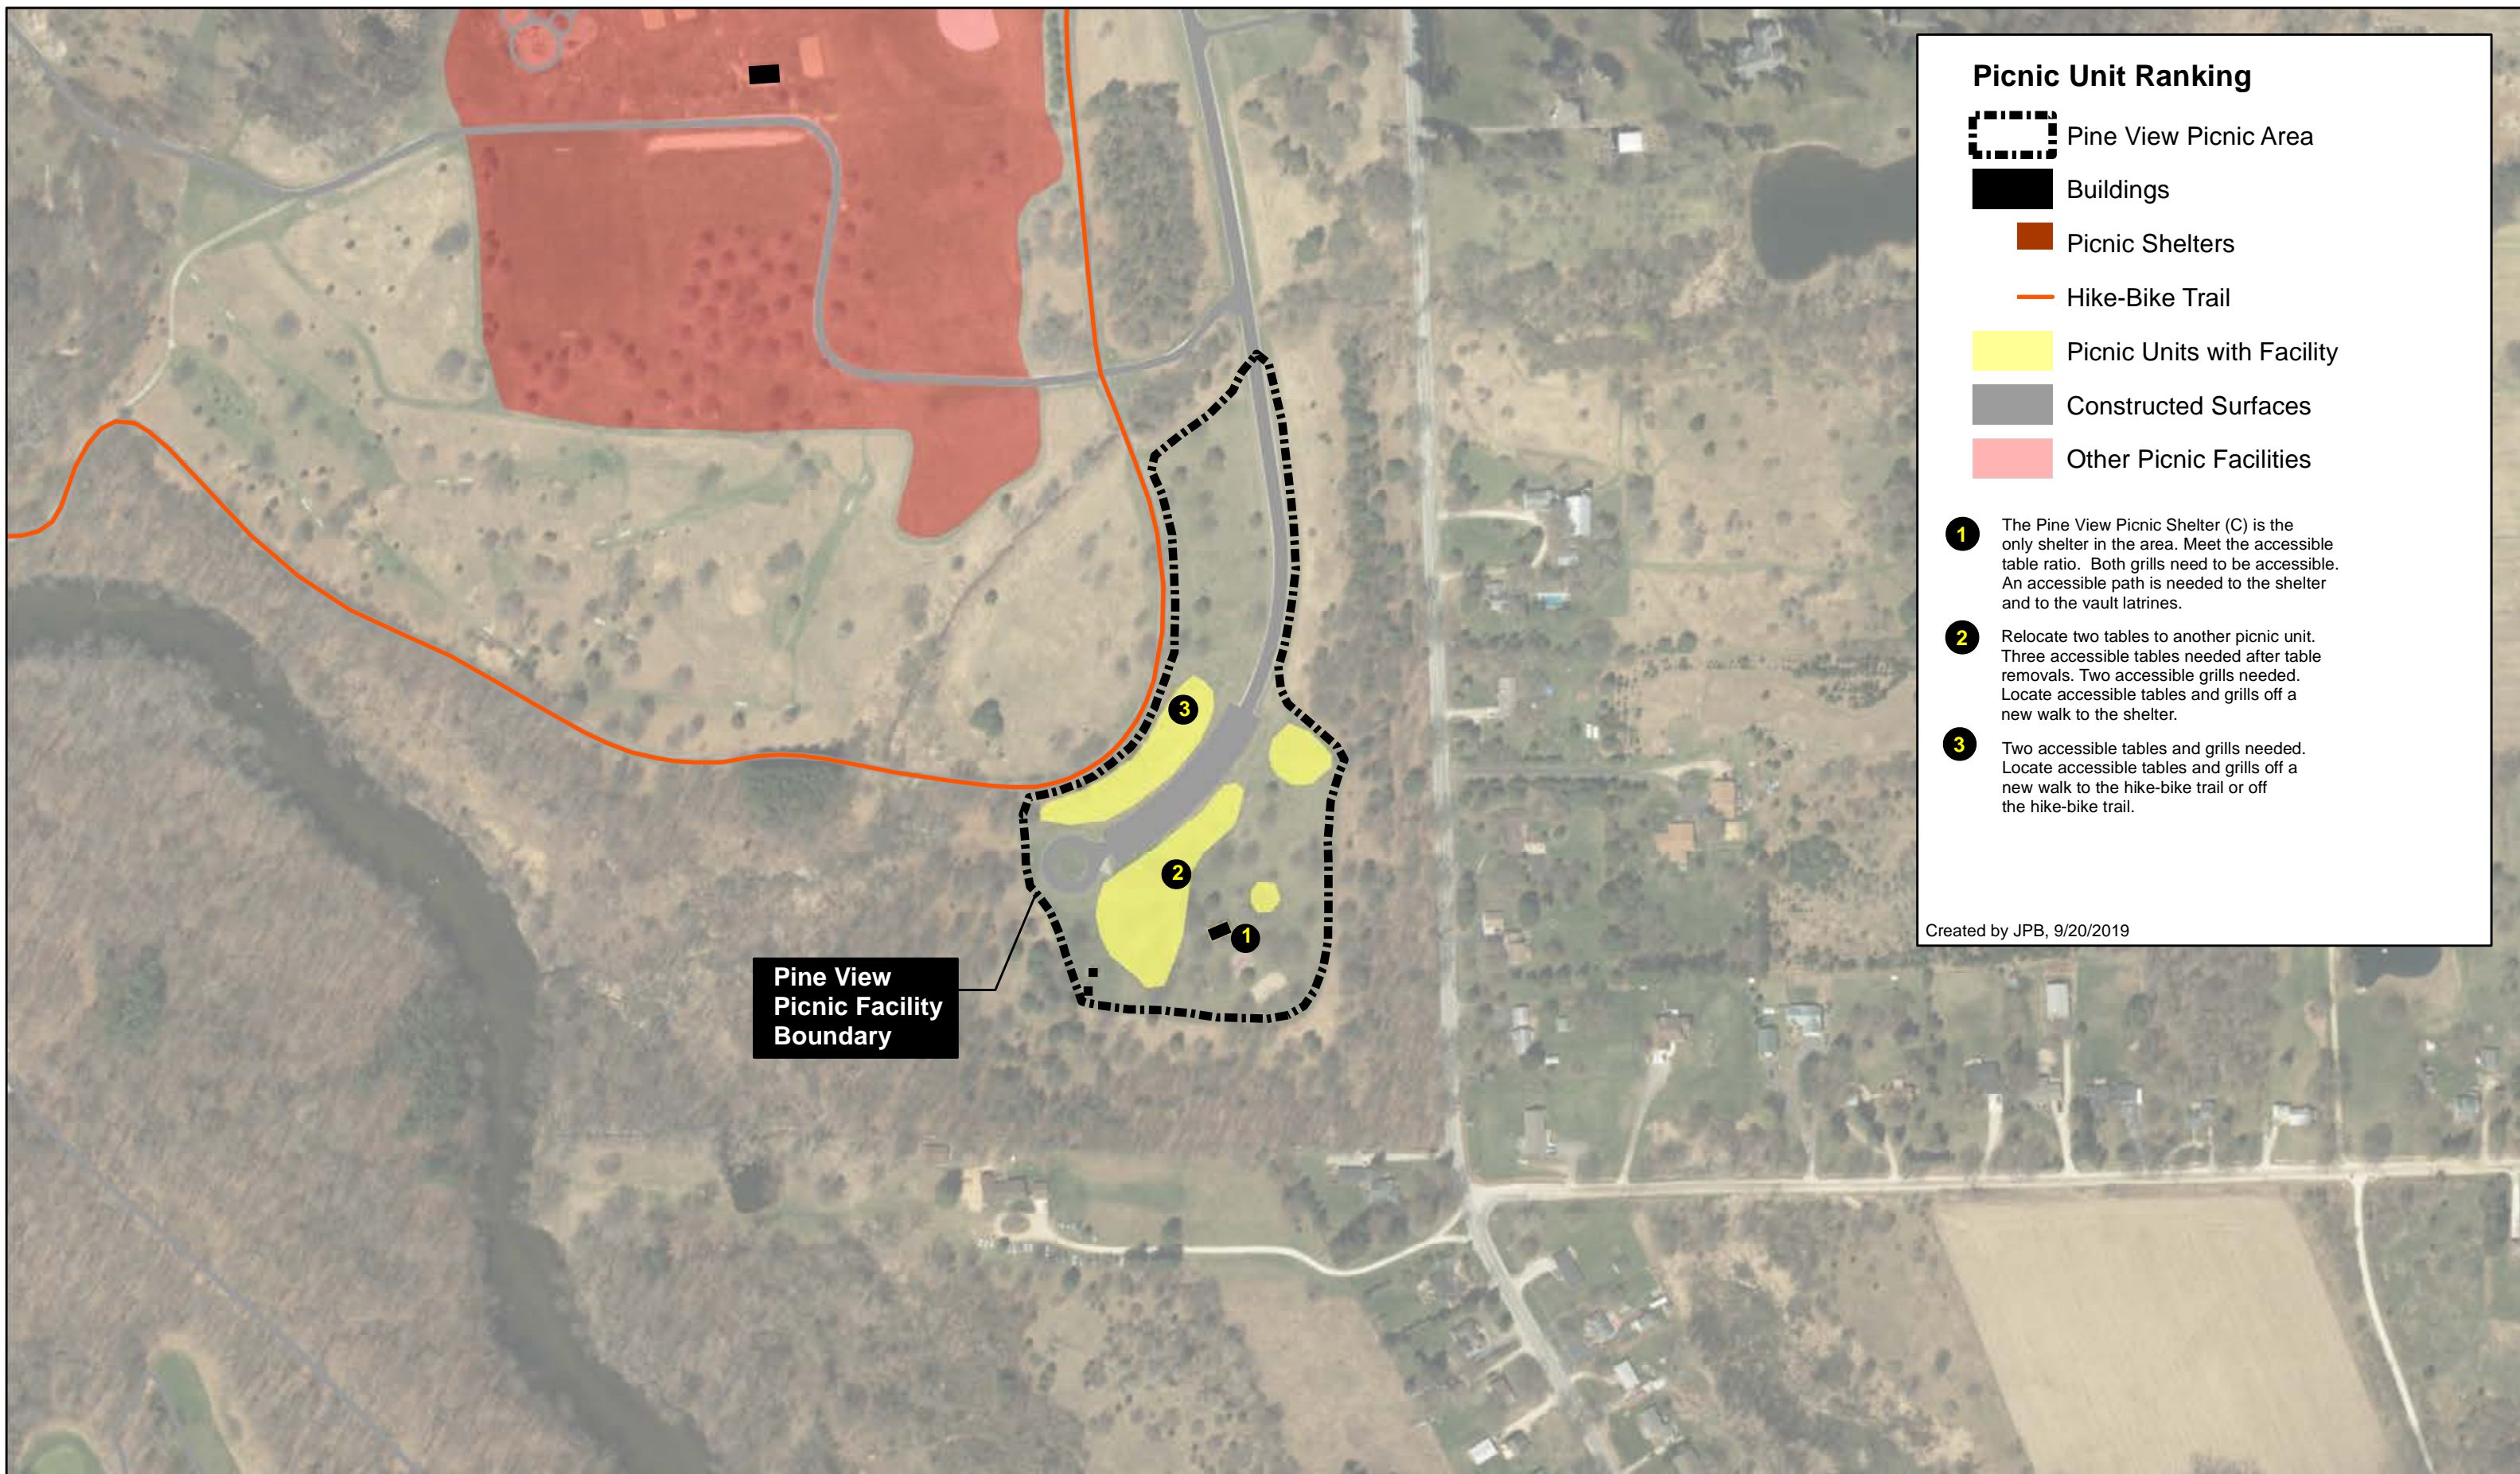
### Picnic Unit Ranking

- 1** The Pine View Picnic Shelter (C) is the only shelter in the area. Meet the accessible table ratio. Both grills need to be accessible. An accessible path is needed to the shelter and to the vault latrines.
- 2** Relocate two tables to another picnic unit. Three accessible tables needed after table removals. Two accessible grills needed. Locate accessible tables and grills off a new walk to the shelter.
- 3** Two accessible tables and grills needed. Locate accessible tables and grills off a new walk to the hike-bike trail or off the hike-bike trail.

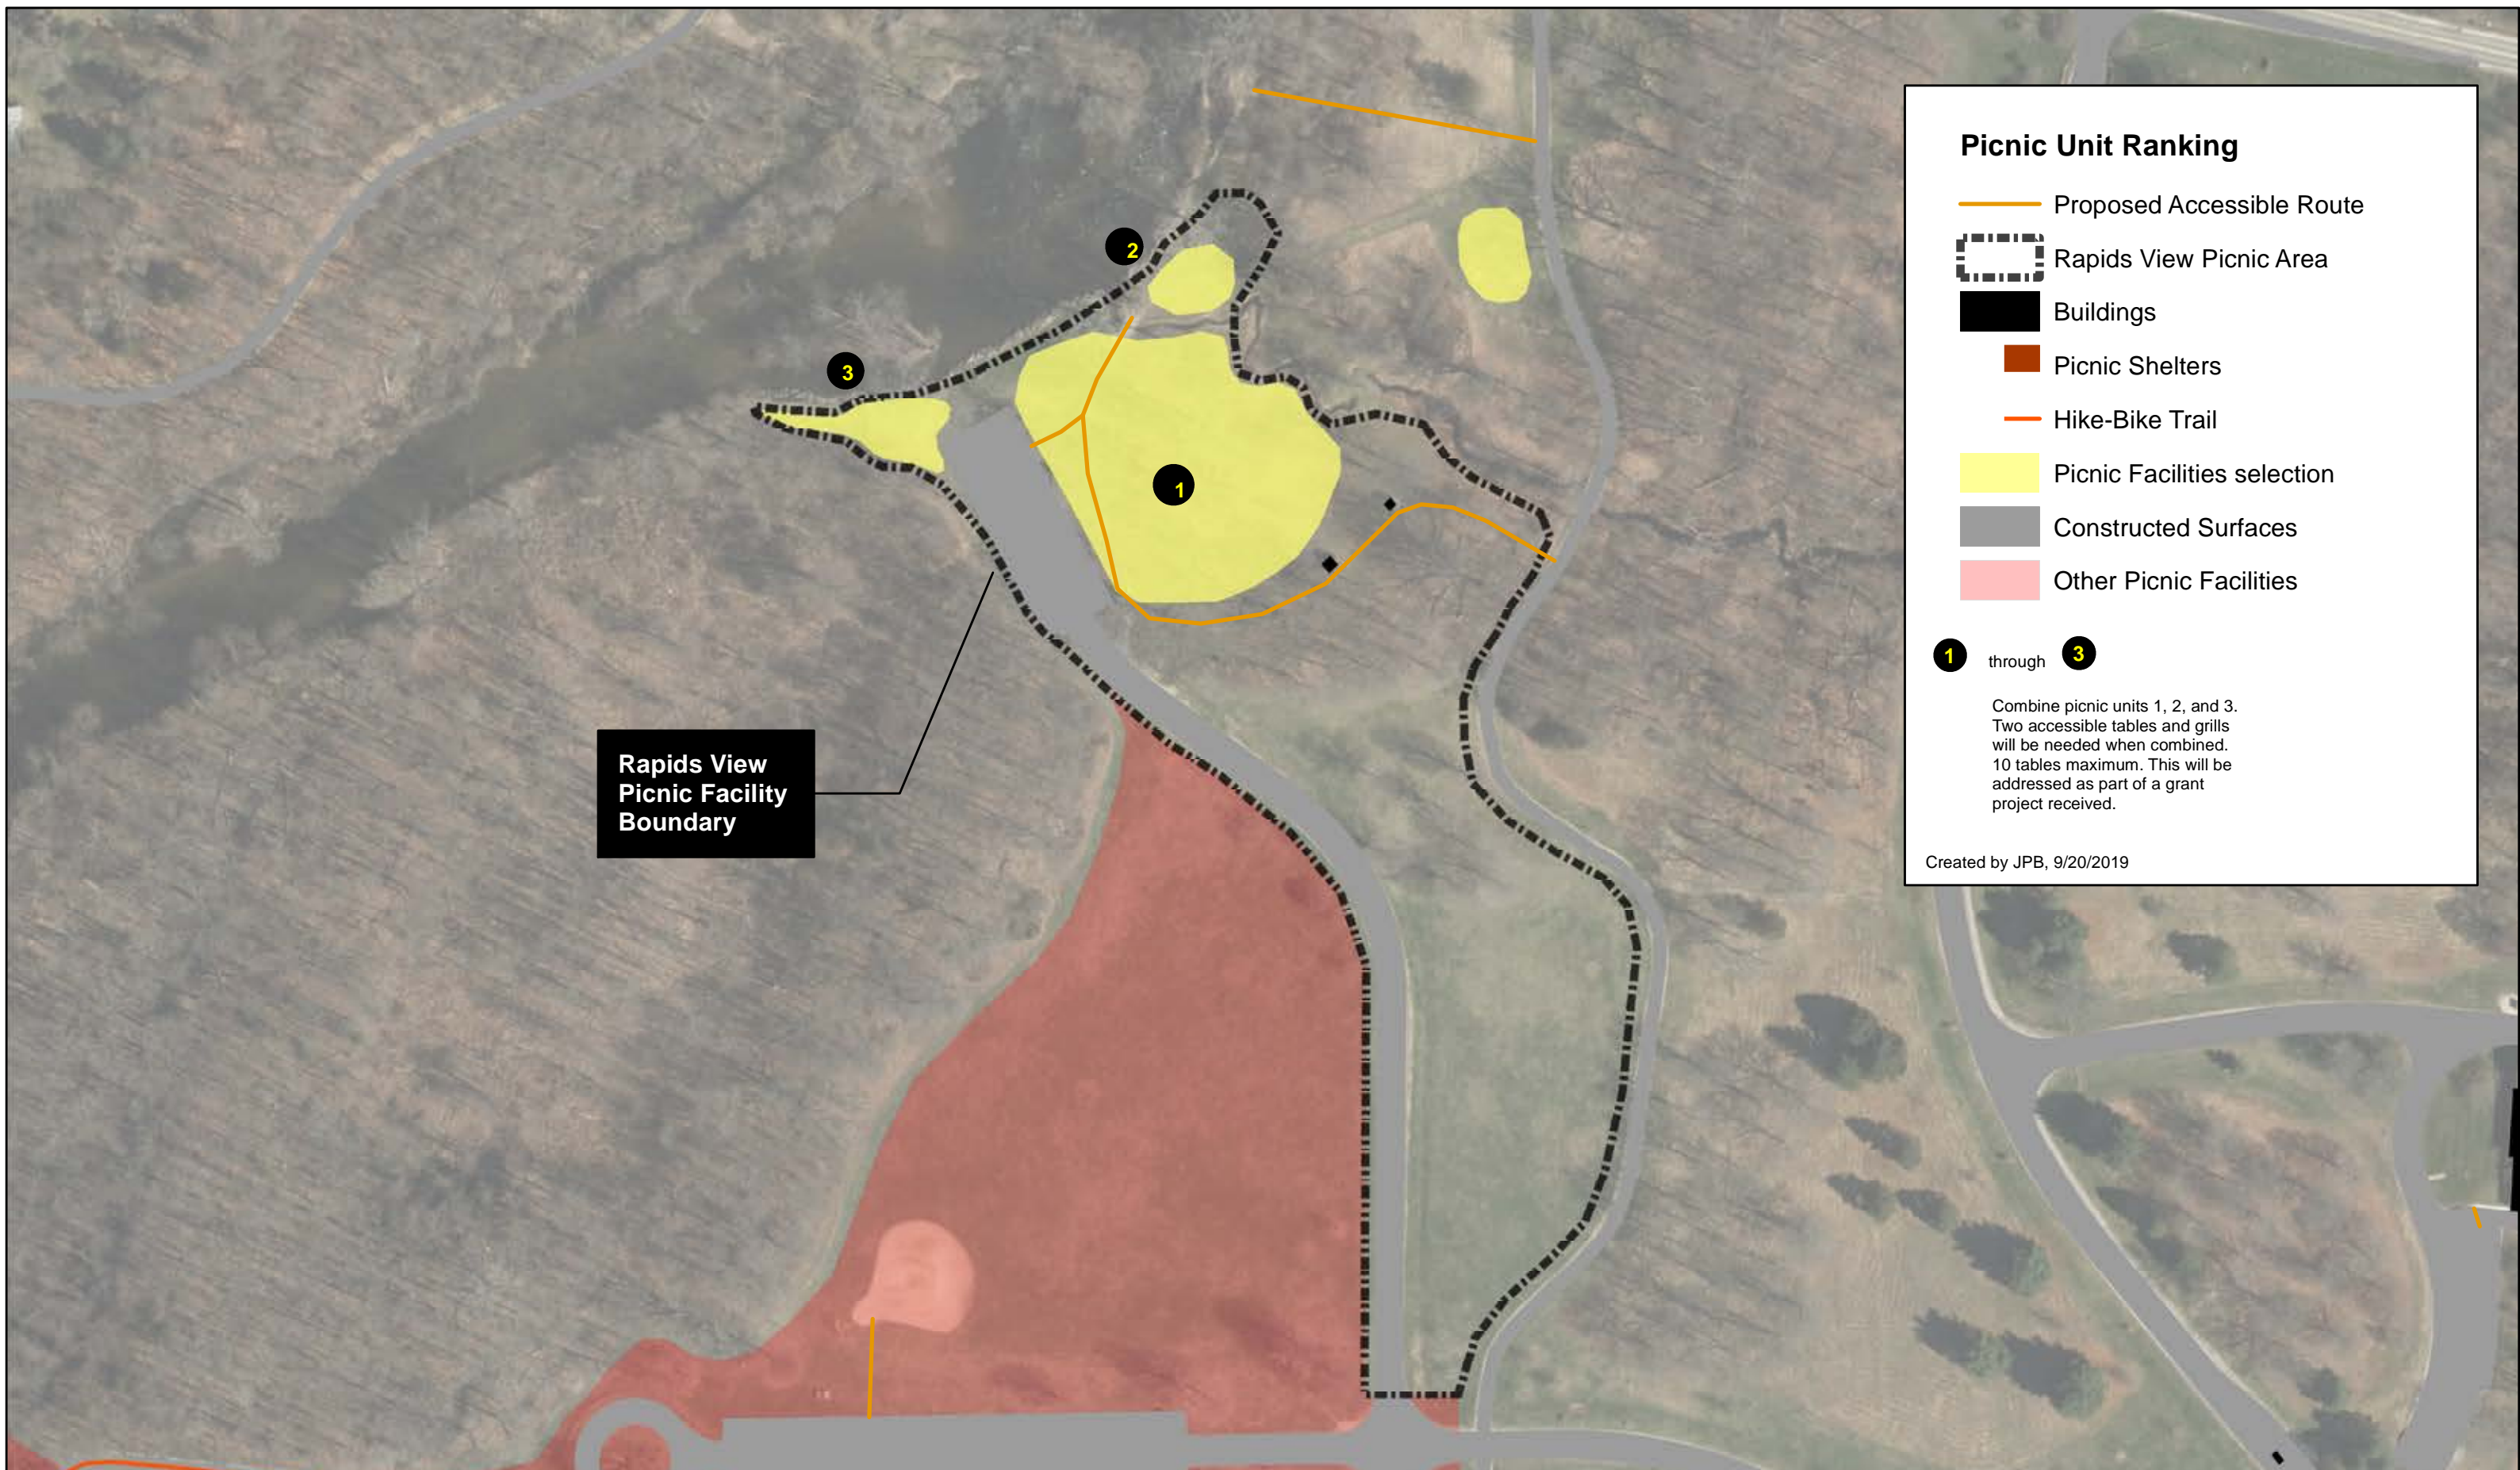
### Picnic Unit Ranking

**1** through **3**

Combine picnic units 1, 2, and 3. Two accessible tables and grills will be needed when combined. 10 tables maximum. This will be addressed as part of a grant project received.

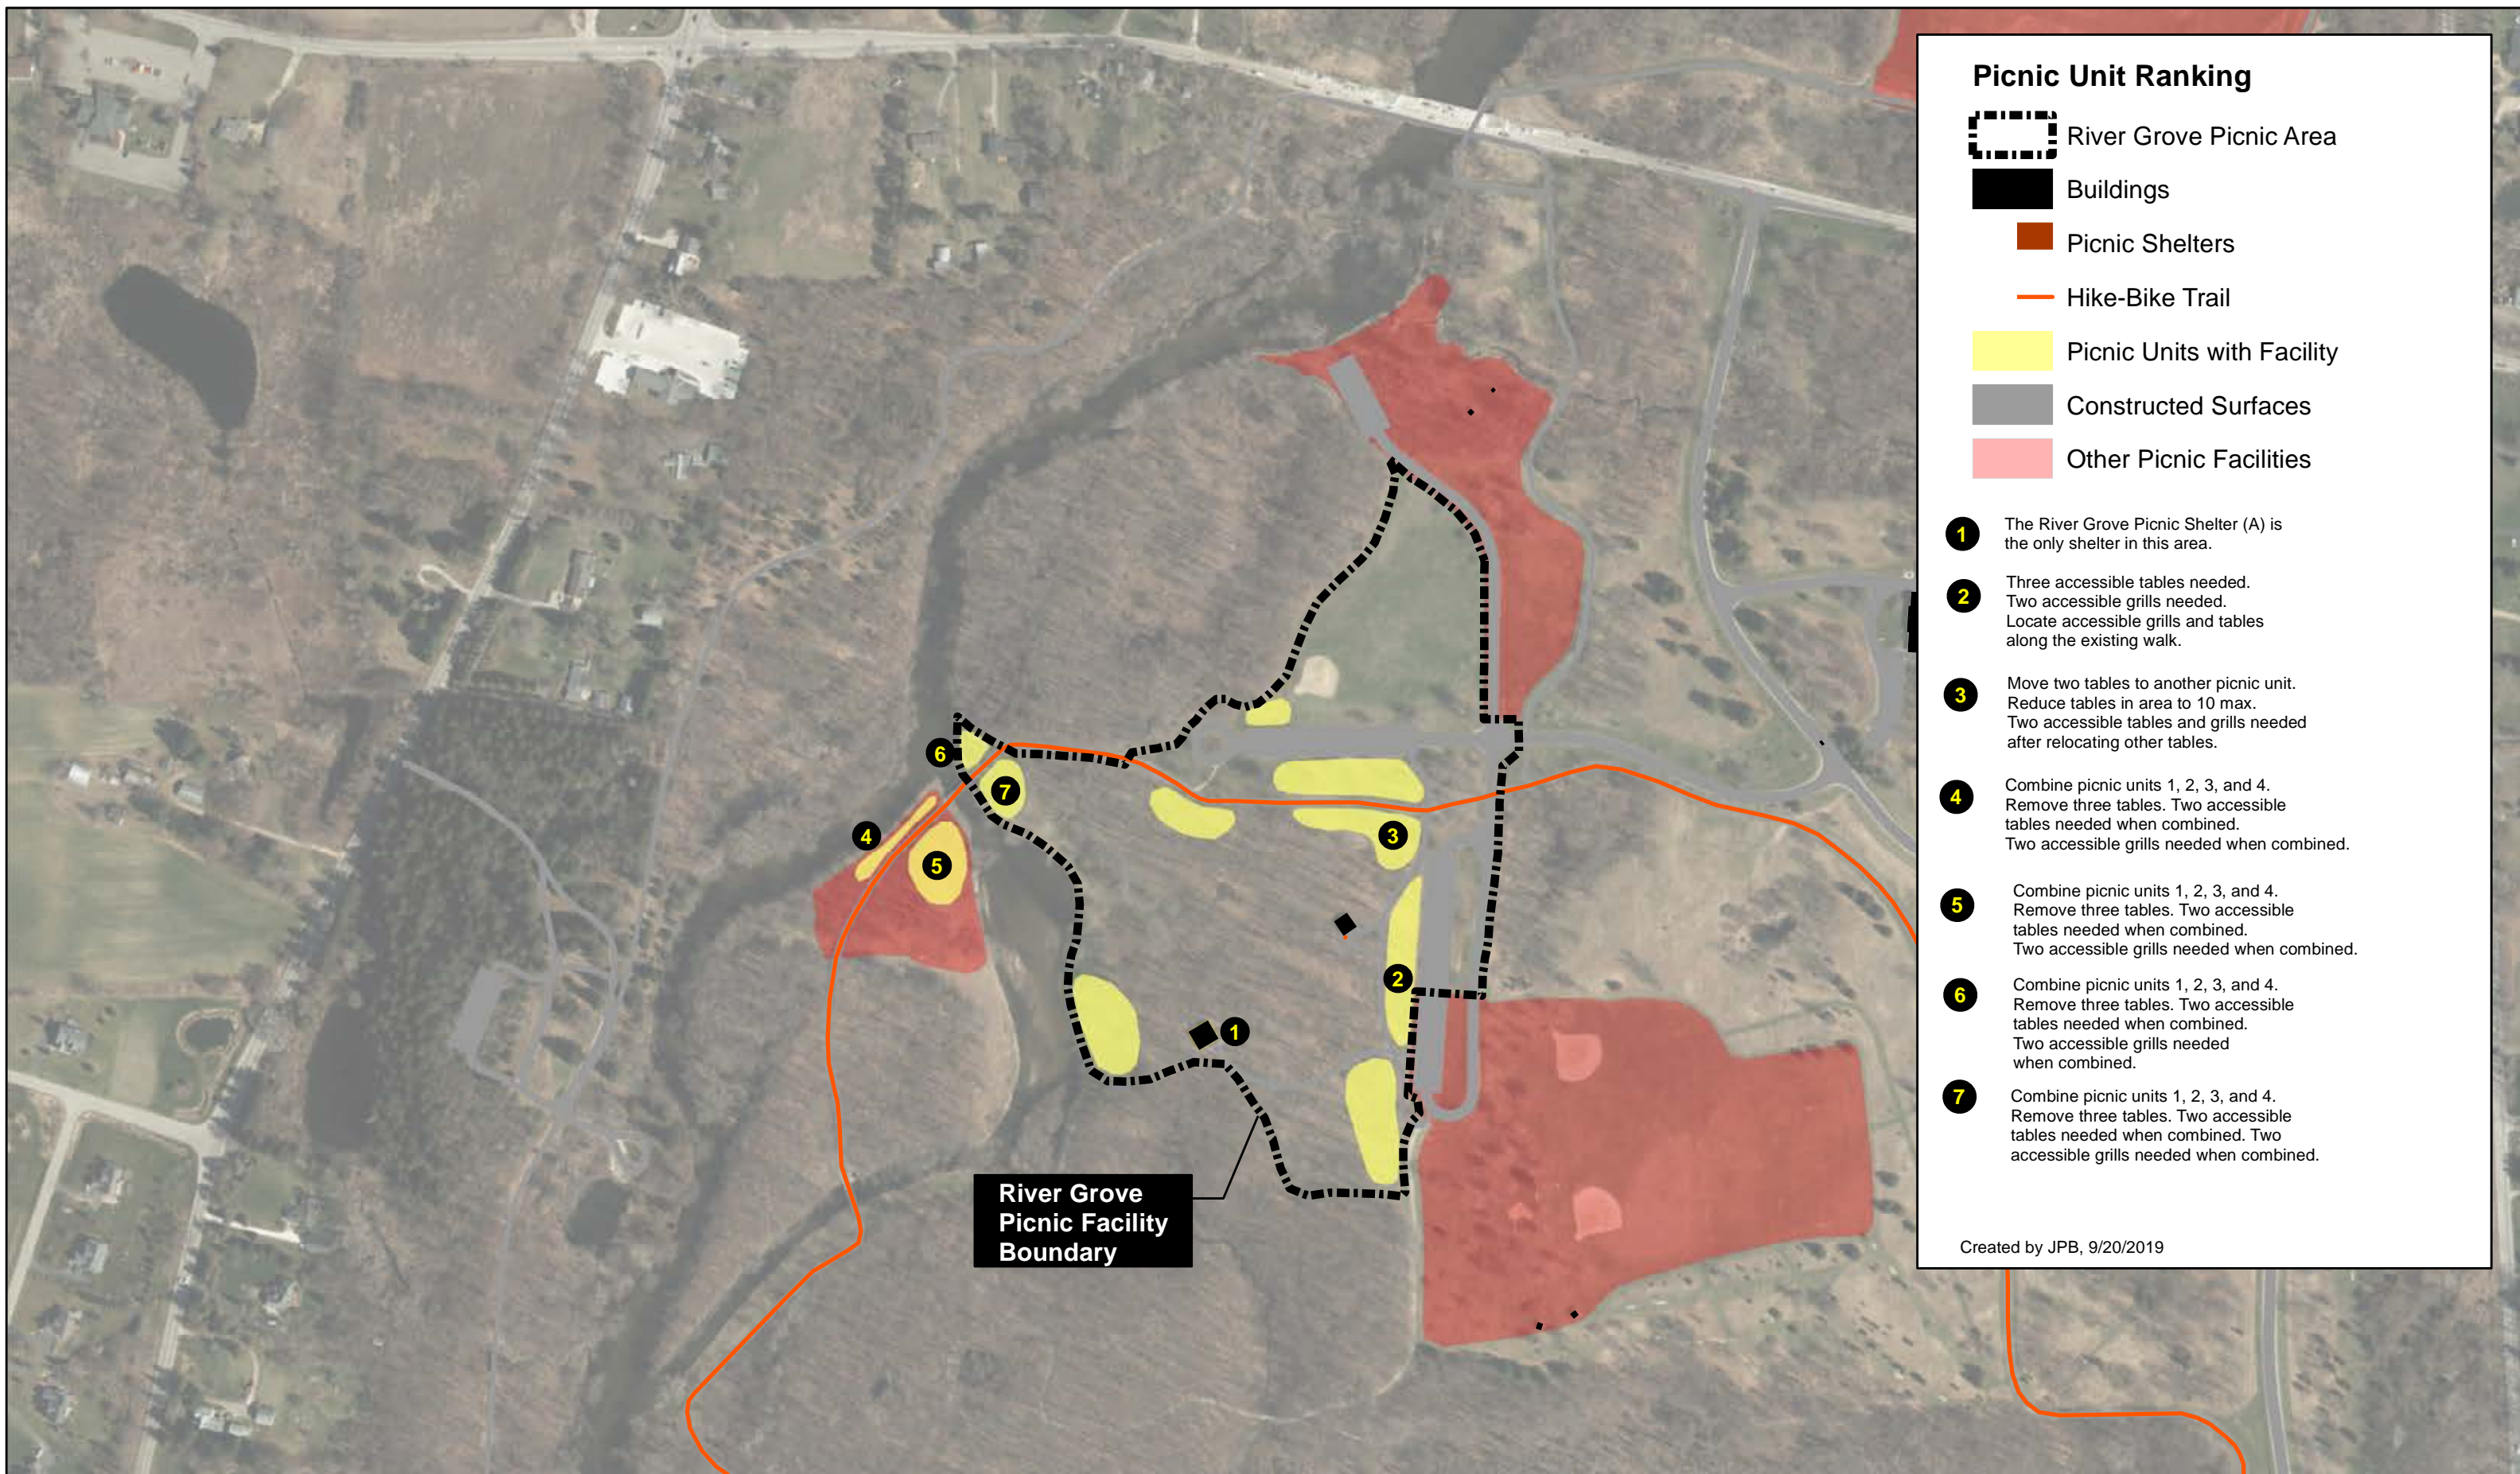
### Picnic Unit Ranking

- 1** The River Grove Picnic Shelter (A) is the only shelter in this area.
- 2** Three accessible tables needed. Two accessible grills needed. Locate accessible grills and tables along the existing walk.

- 3** Move two tables to another picnic unit. Reduce tables in area to 10 max. Two accessible tables and grills needed after relocating other tables.
- 4** Combine picnic units 1, 2, 3, and 4. Remove three tables. Two accessible tables needed when combined. Two accessible grills needed when combined.

- 5** Combine picnic units 1, 2, 3, and 4. Remove three tables. Two accessible tables needed when combined. Two accessible grills needed when combined.

- 6** Combine picnic units 1, 2, 3, and 4. Remove three tables. Two accessible tables needed when combined. Two accessible grills needed when combined.

- 7** Combine picnic units 1, 2, 3, and 4. Remove three tables. Two accessible tables needed when combined. Two accessible grills needed when combined.
