# APPENDIX 3: PICNIC FACILITIES MAPS

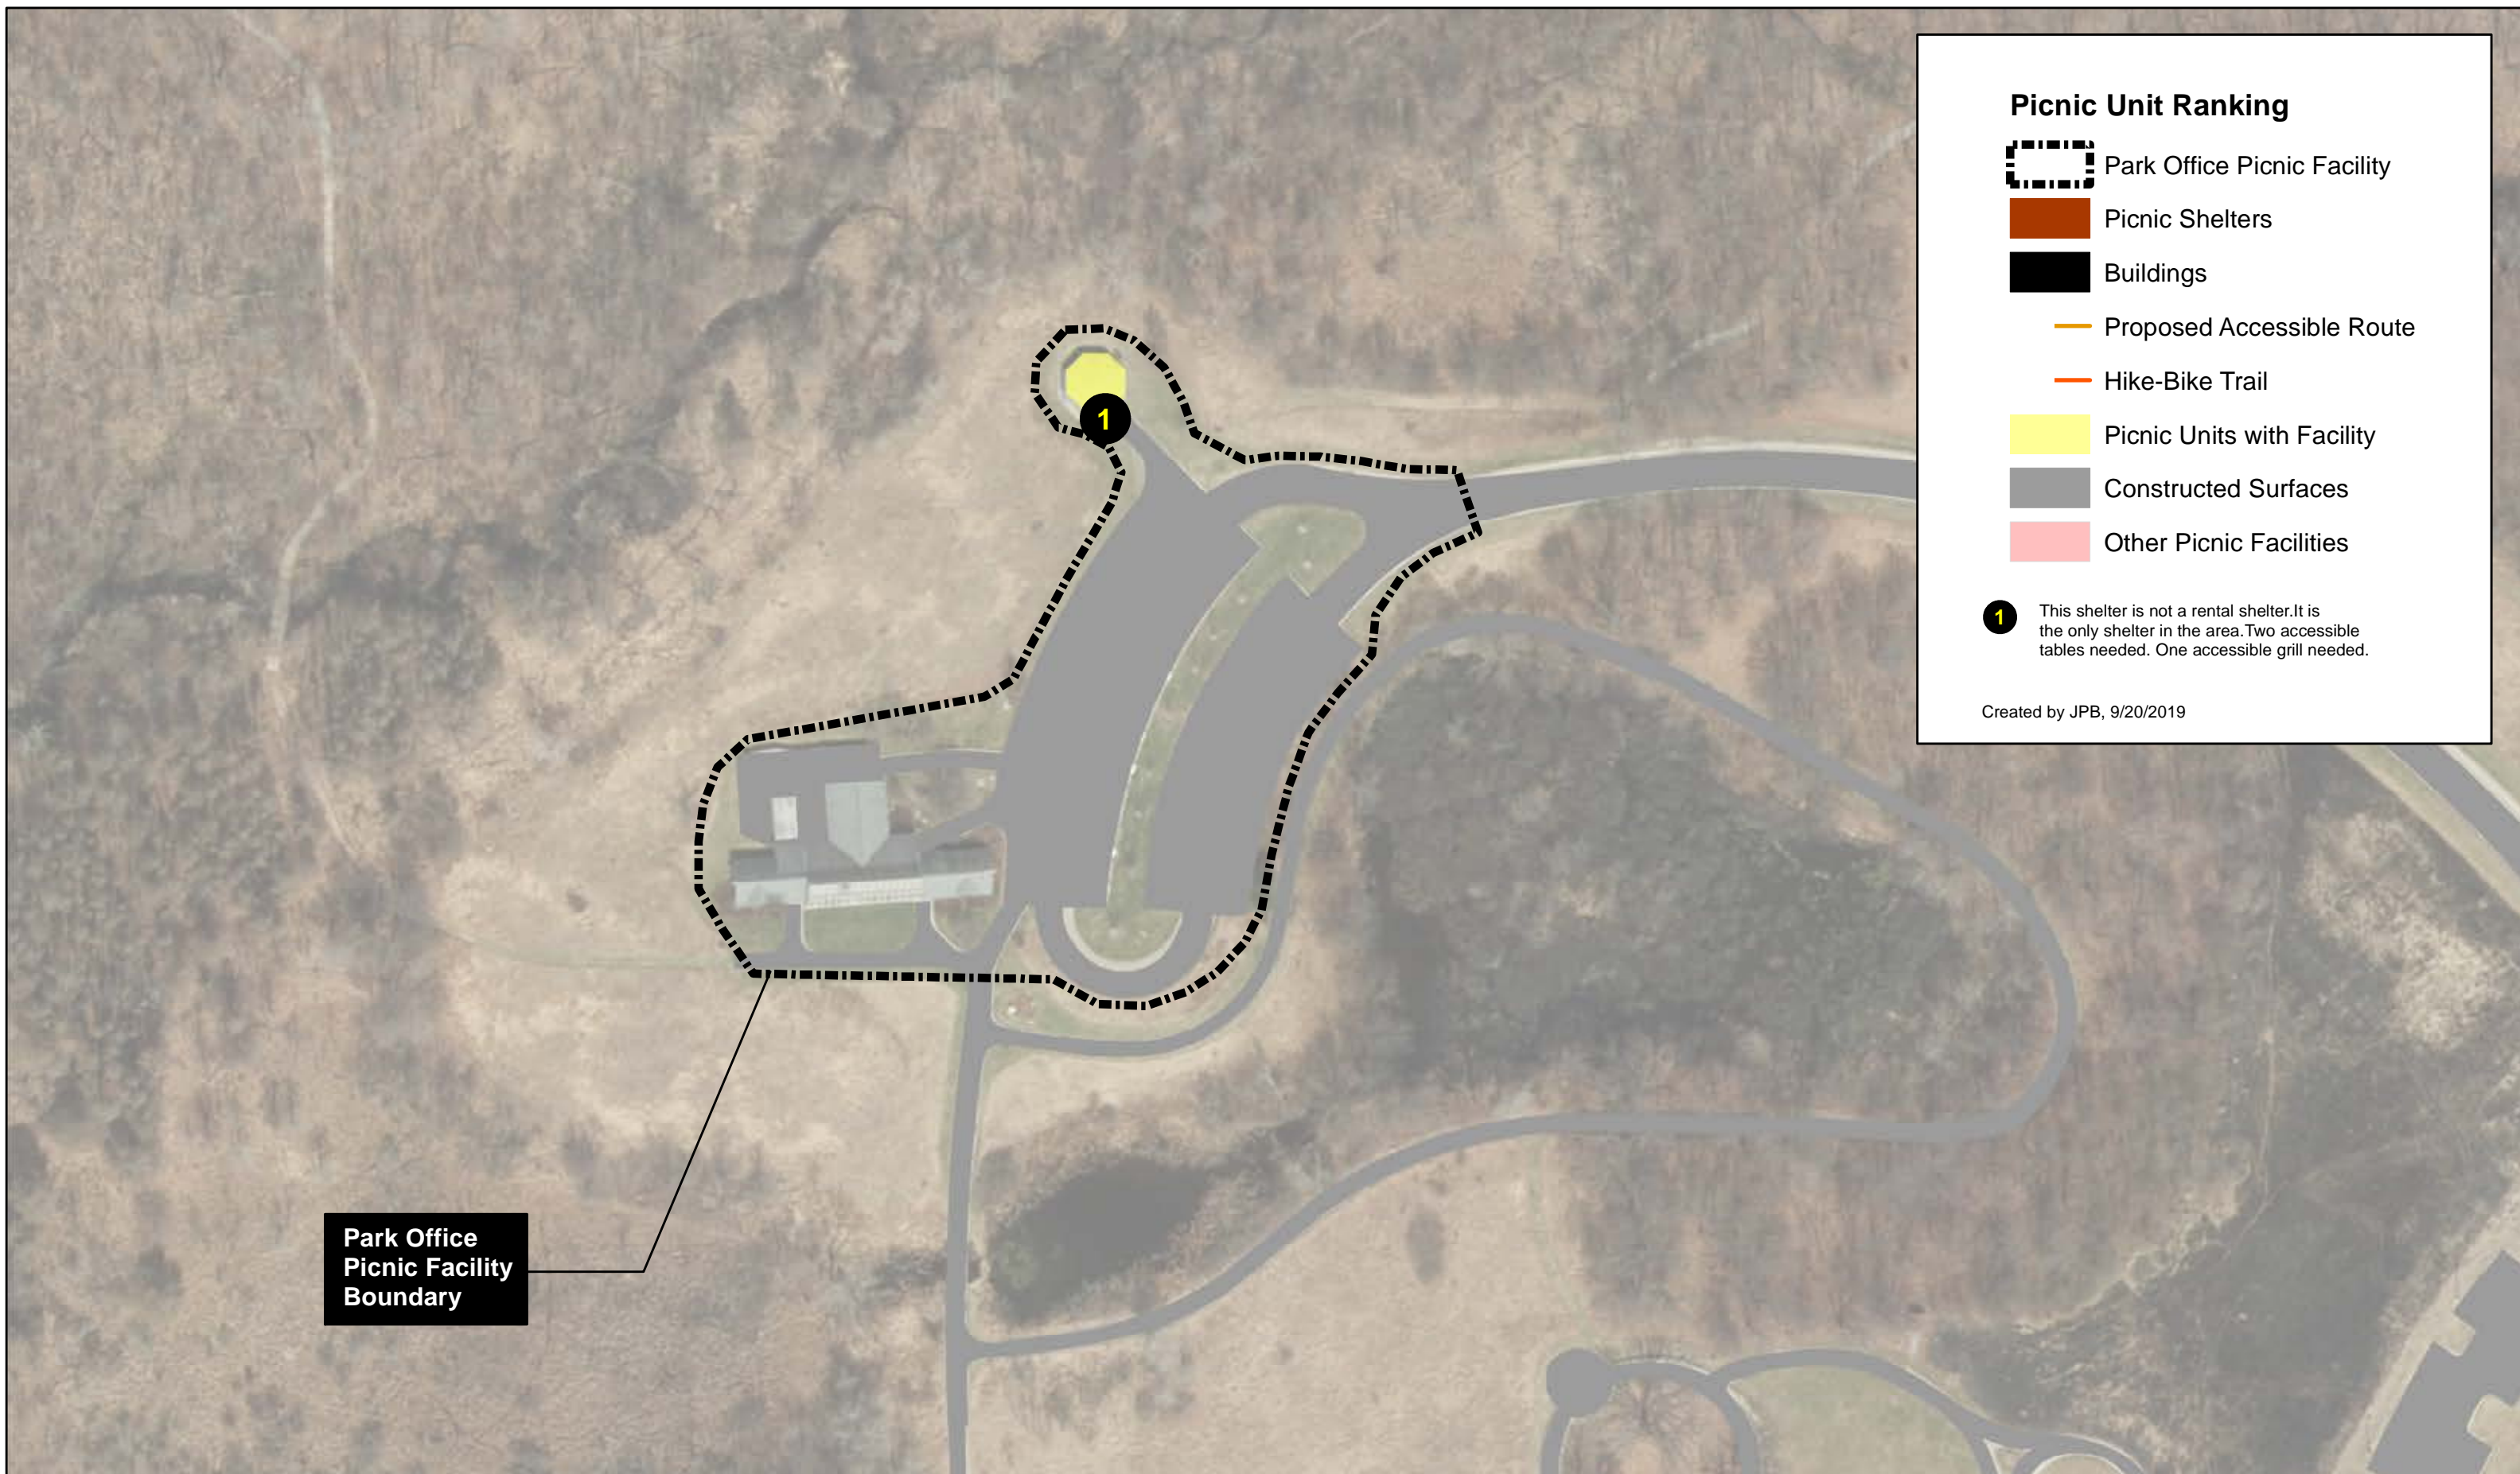
### Picnic Unit Ranking

**1** This shelter is not a rental shelter. It is the only shelter in the area. Two accessible tables needed. One accessible grill needed.

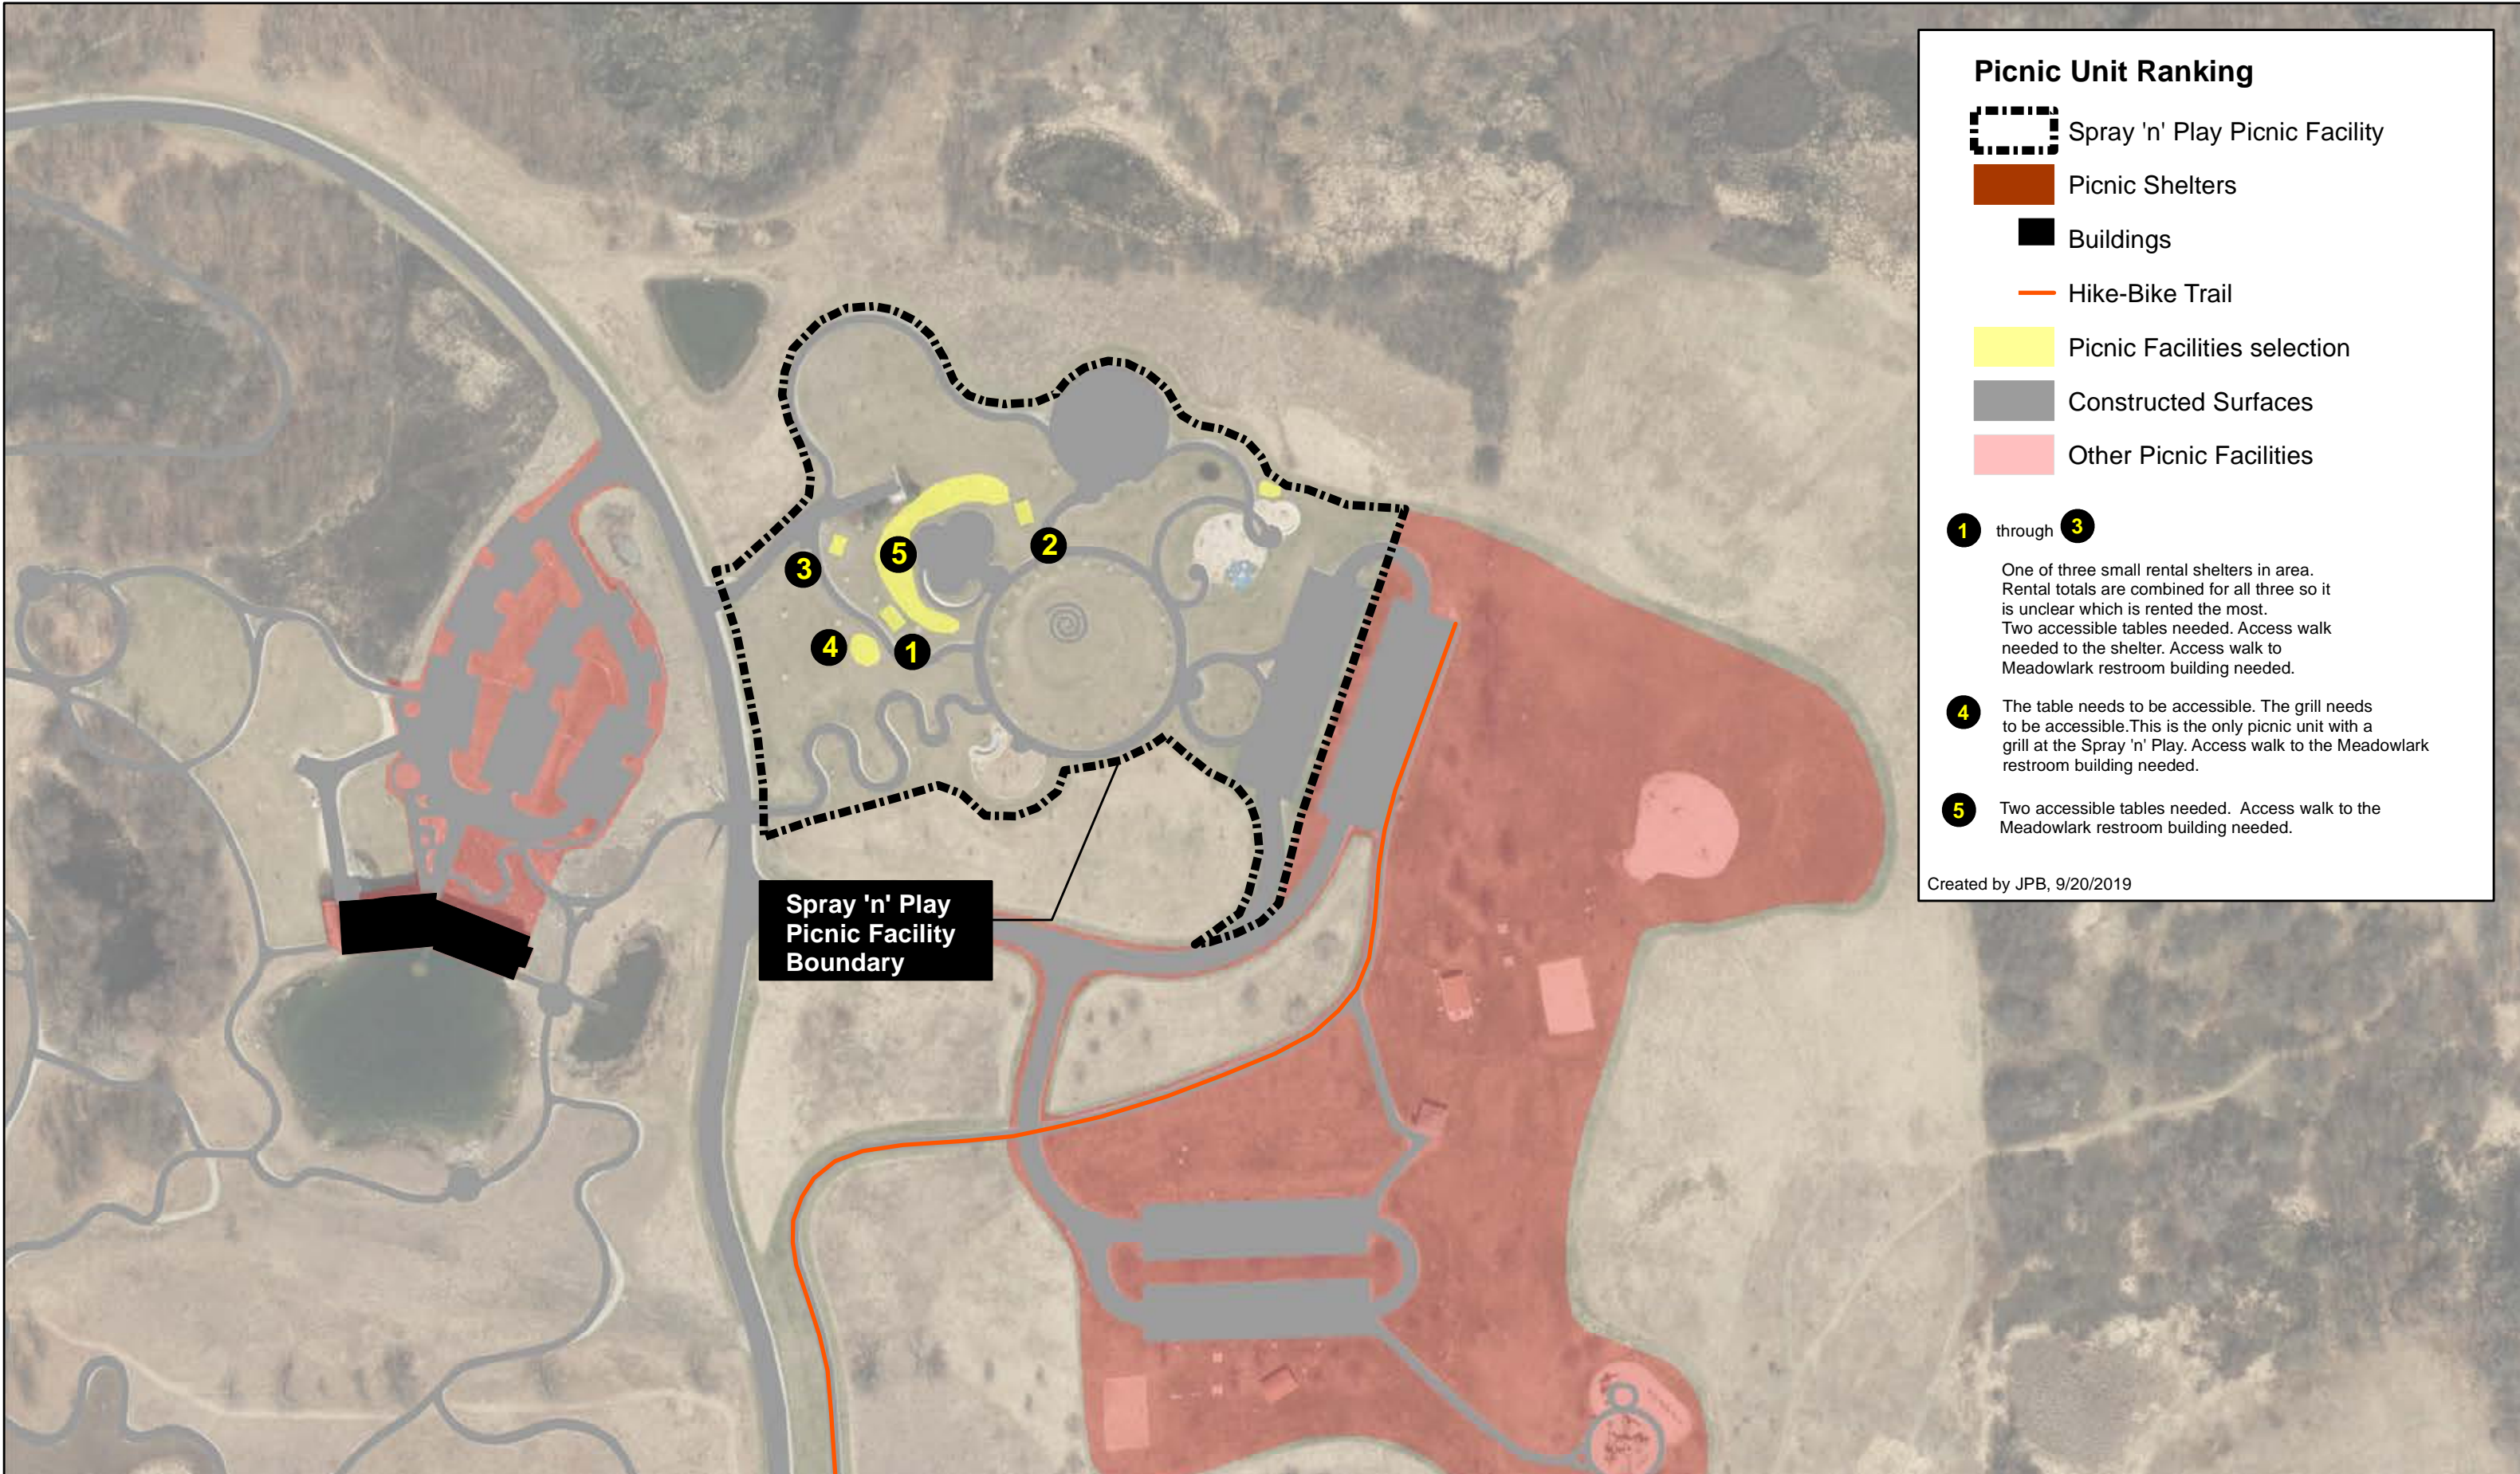
**Picnic Unit Ranking**

- 1** through **3**
- One of three small rental shelters in area. Rental totals are combined for all three so it is unclear which is rented the most. Two accessible tables needed. Access walk needed to the shelter. Access walk to Meadowlark restroom building needed.
- 4**
- The table needs to be accessible. The grill needs to be accessible. This is the only picnic unit with a grill at the Spray 'n' Play. Access walk to the Meadowlark restroom building needed.
- 5**
- Two accessible tables needed. Access walk to the Meadowlark restroom building needed.

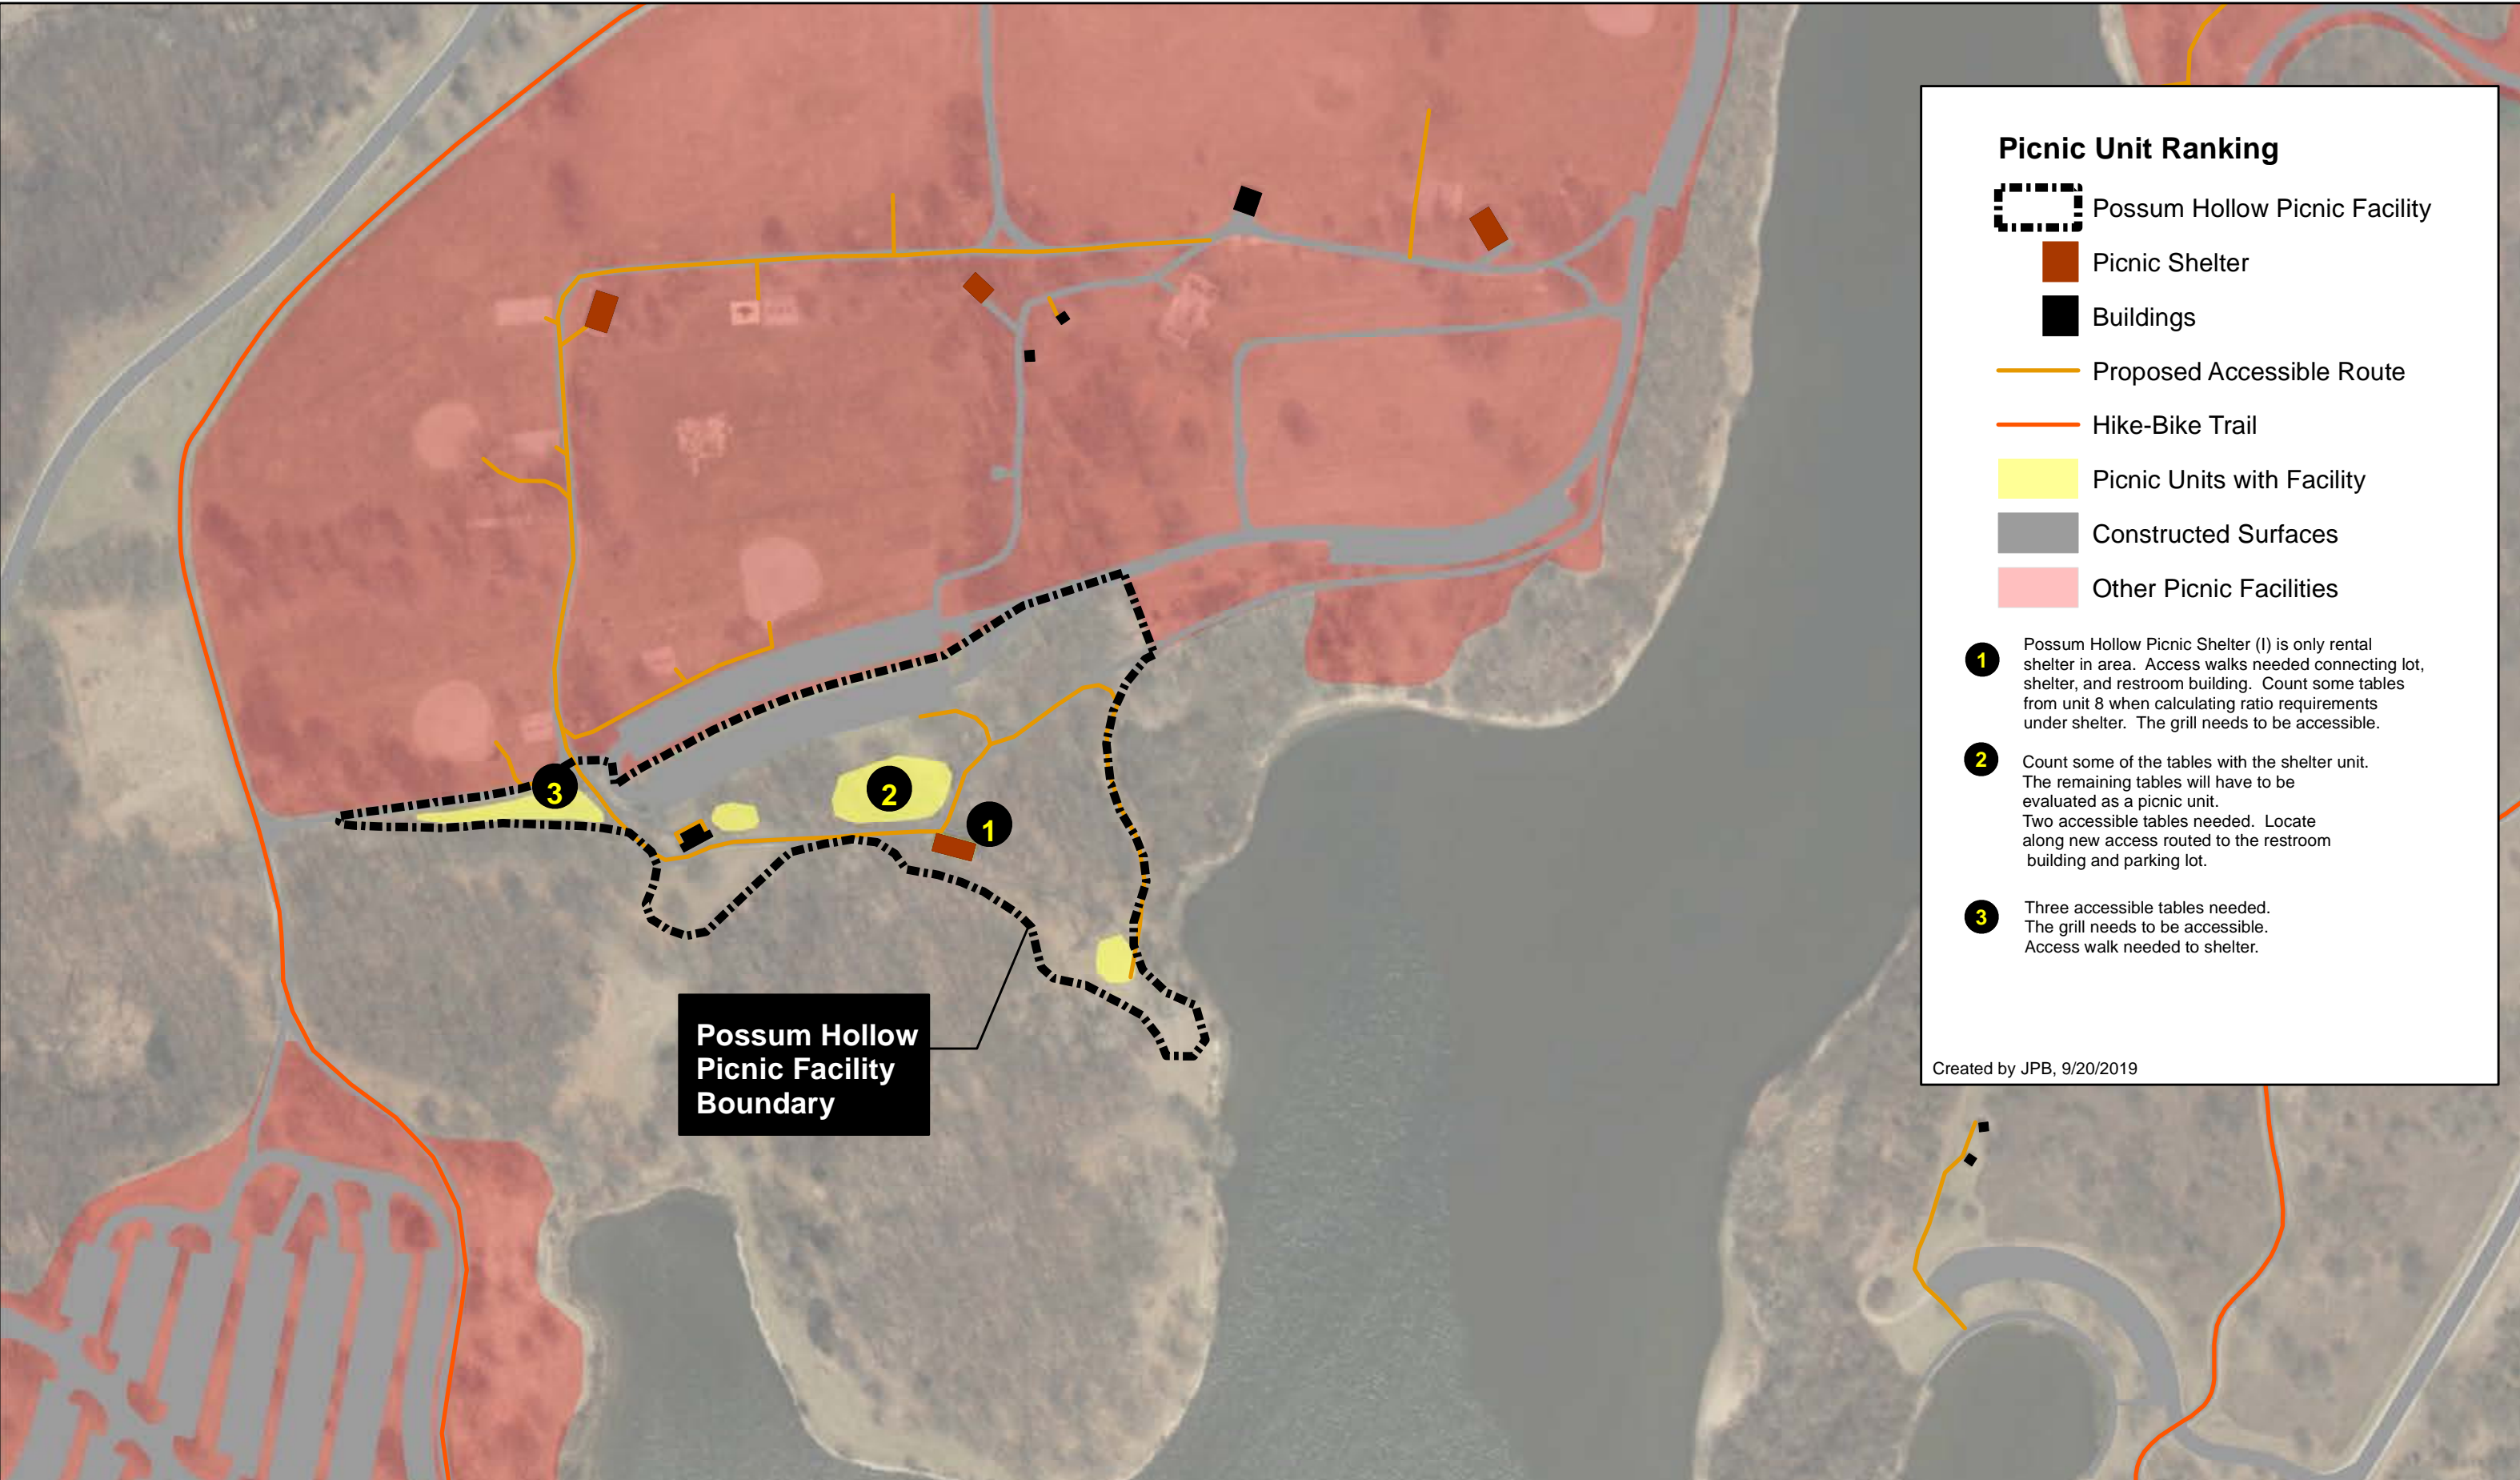
- Picnic Unit Ranking**
- Possum Hollow Picnic Facility
  - Picnic Shelter
  - Buildings
  - Proposed Accessible Route
  - Hike-Bike Trail
  - Picnic Units with Facility
  - Constructed Surfaces
  - Other Picnic Facilities

- 1** Possum Hollow Picnic Shelter (I) is only rental shelter in area. Access walks needed connecting lot, shelter, and restroom building. Count some tables from unit 8 when calculating ratio requirements under shelter. The grill needs to be accessible.
- 2** Count some of the tables with the shelter unit. The remaining tables will have to be evaluated as a picnic unit. Two accessible tables needed. Locate along new access routed to the restroom building and parking lot.
- 3** Three accessible tables needed. The grill needs to be accessible. Access walk needed to shelter.

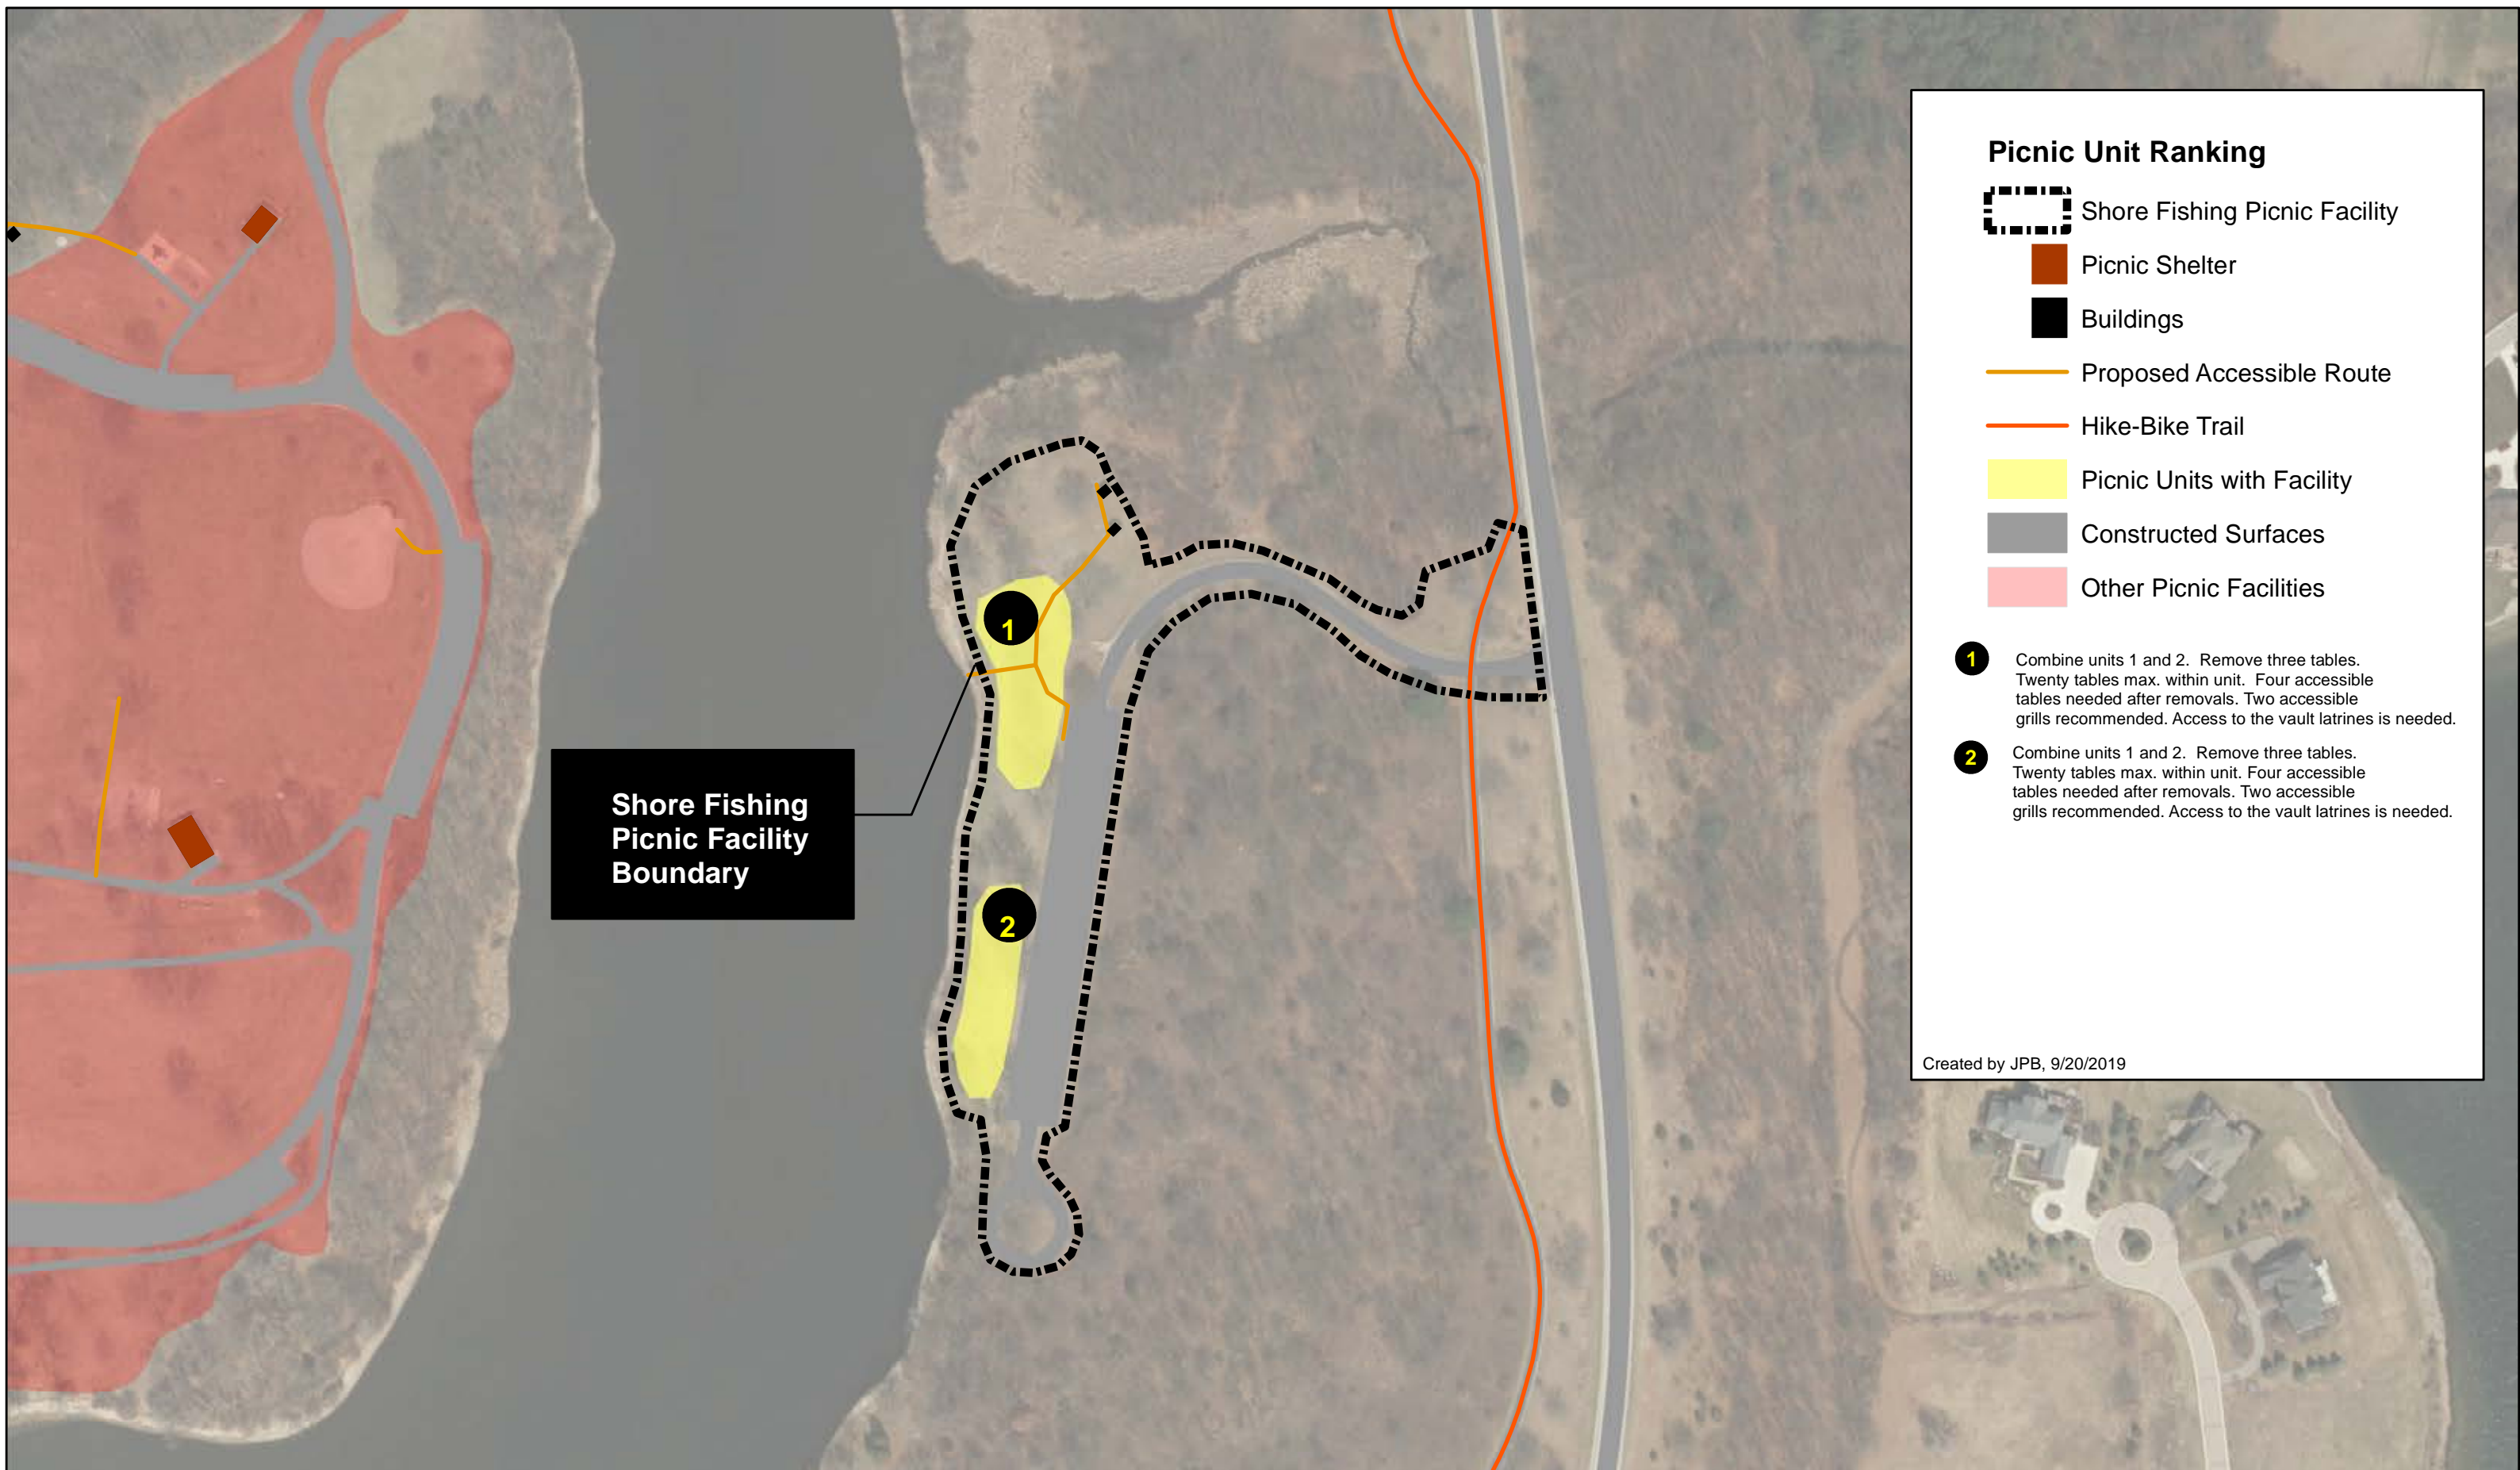
### Picnic Unit Ranking

- 1** Combine units 1 and 2. Remove three tables. Twenty tables max. within unit. Four accessible tables needed after removals. Two accessible grills recommended. Access to the vault latrines is needed.
- 2** Combine units 1 and 2. Remove three tables. Twenty tables max. within unit. Four accessible tables needed after removals. Two accessible grills recommended. Access to the vault latrines is needed.

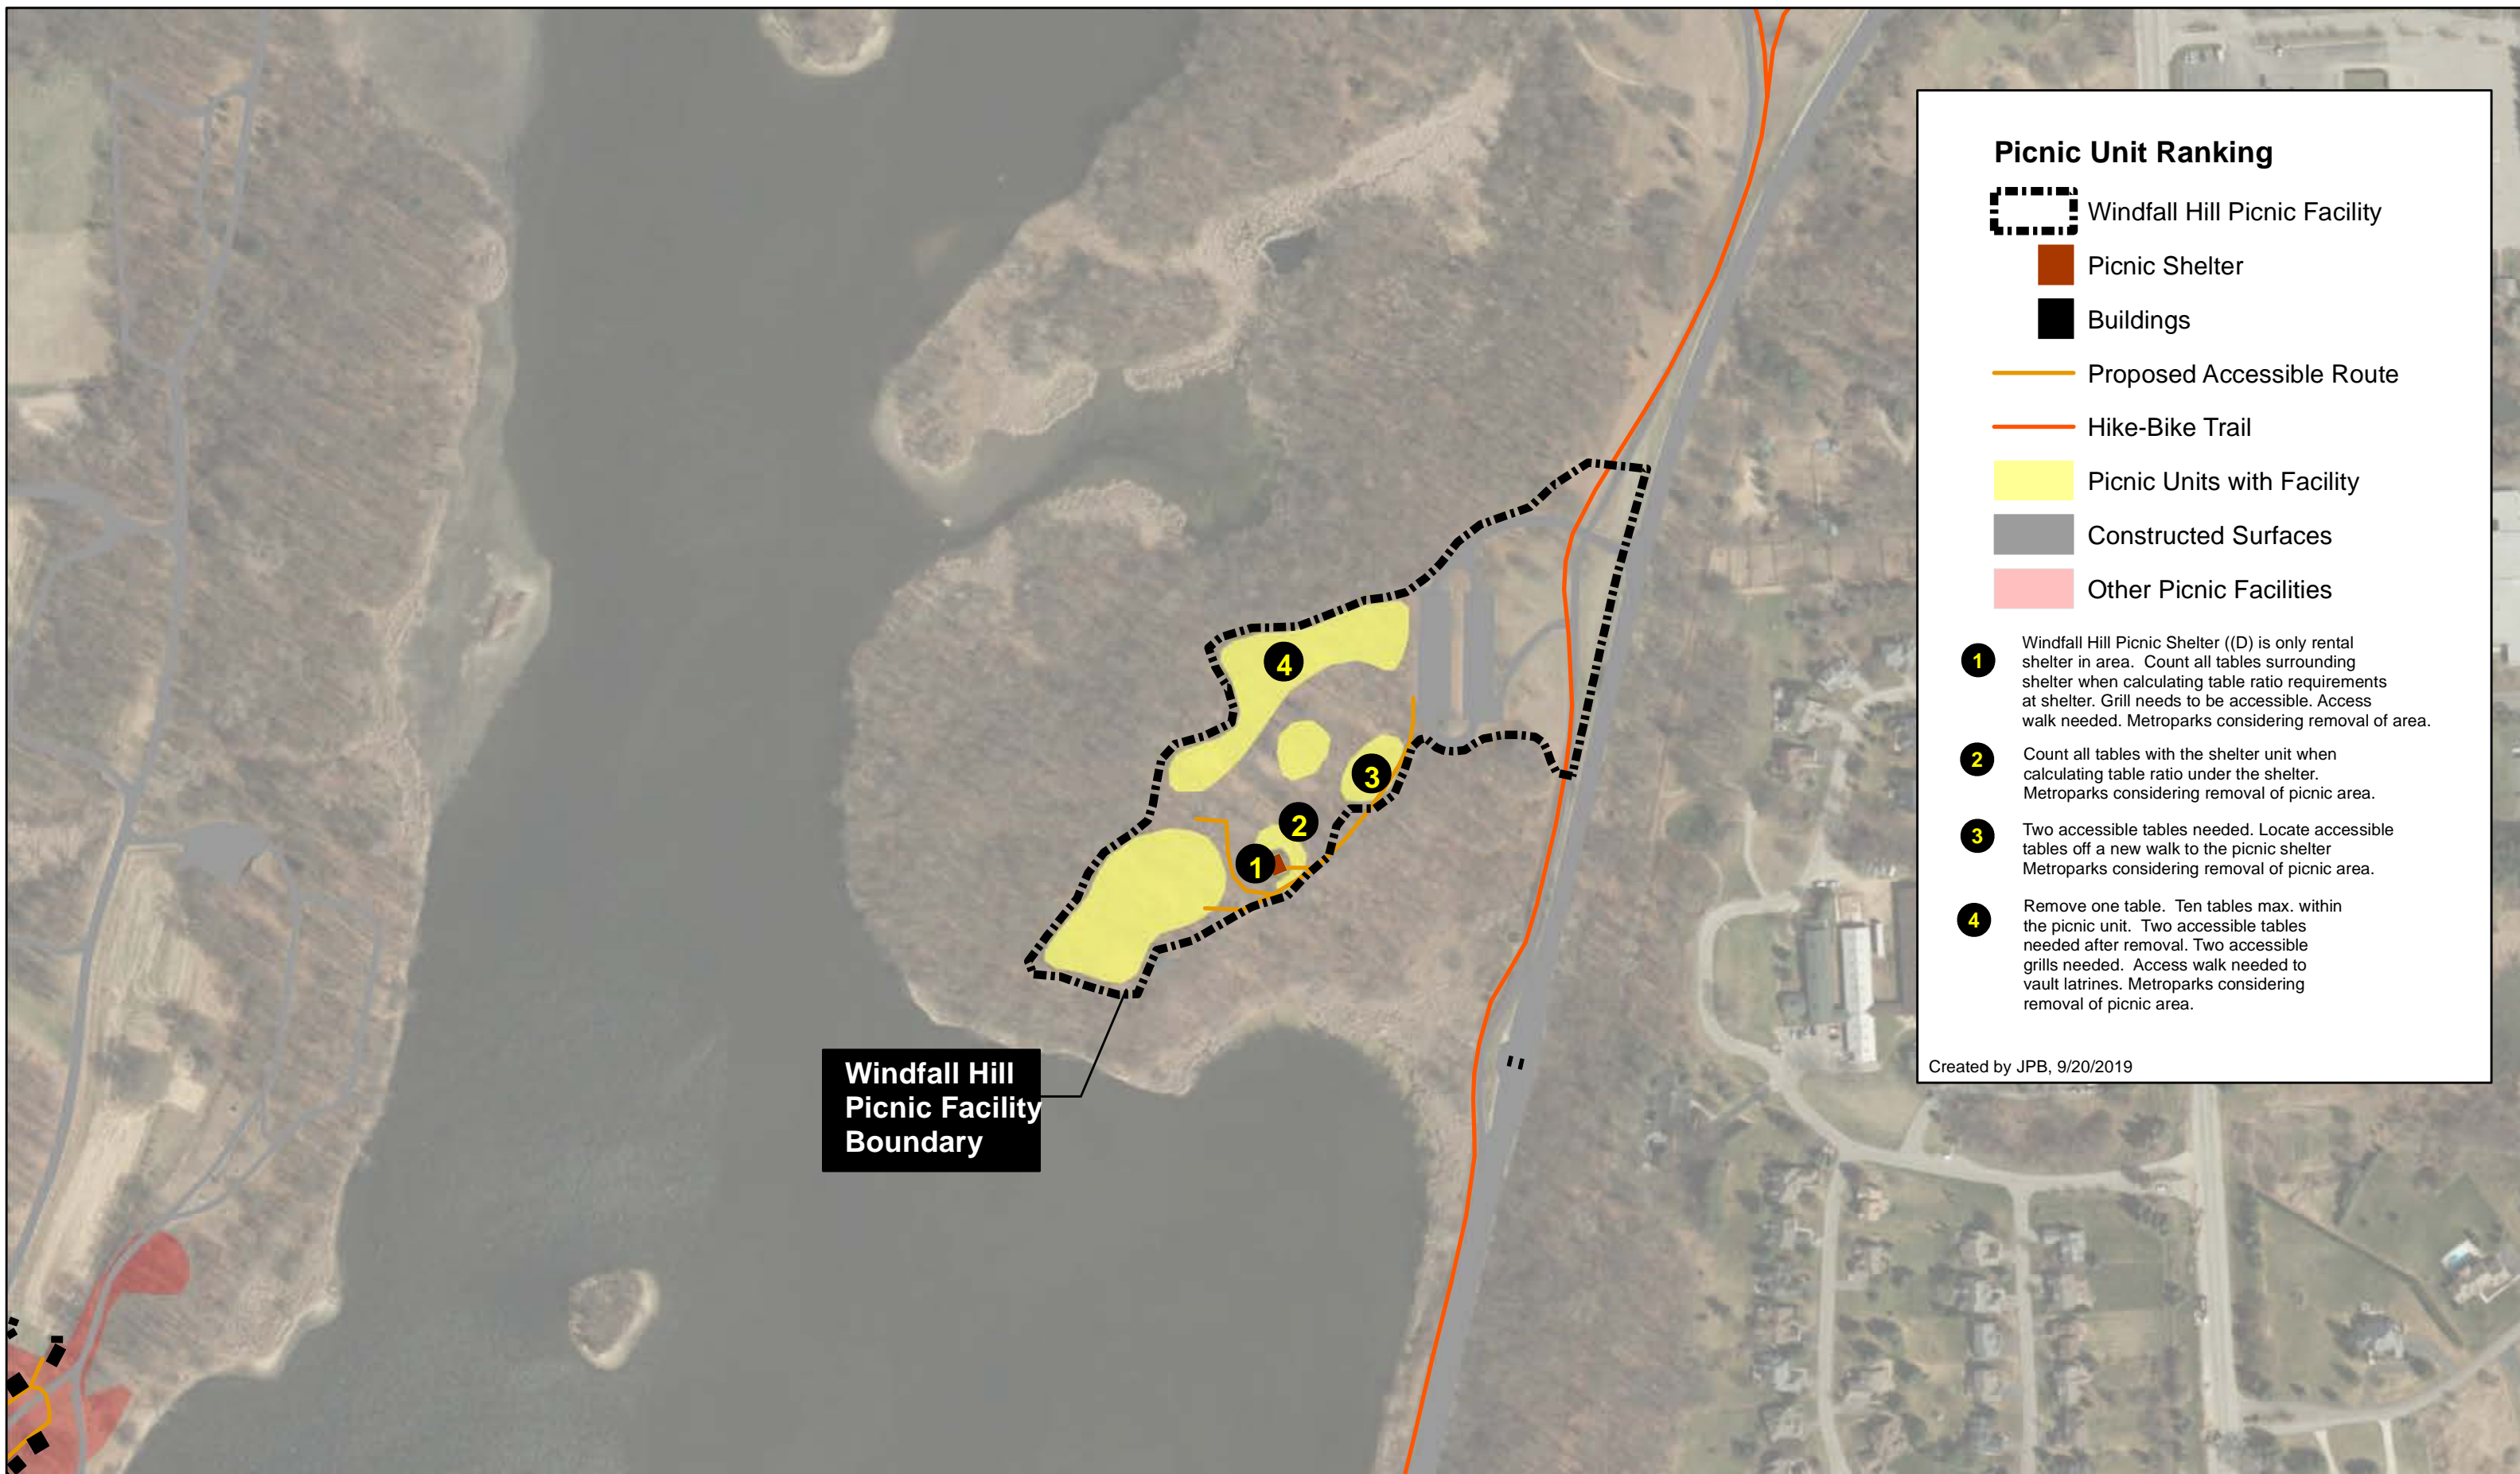
### Picnic Unit Ranking

- 1** Windfall Hill Picnic Shelter ((D) is only rental shelter in area. Count all tables surrounding shelter when calculating table ratio requirements at shelter. Grill needs to be accessible. Access walk needed. Metroparks considering removal of area.
- 2** Count all tables with the shelter unit when calculating table ratio under the shelter. Metroparks considering removal of picnic area.
- 3** Two accessible tables needed. Locate accessible tables off a new walk to the picnic shelter. Metroparks considering removal of picnic area.
- 4** Remove one table. Ten tables max. within the picnic unit. Two accessible tables needed after removal. Two accessible grills needed. Access walk needed to vault latrines. Metroparks considering removal of picnic area.
