# APPENDIX 3: PICNIC FACILITIES MAPS

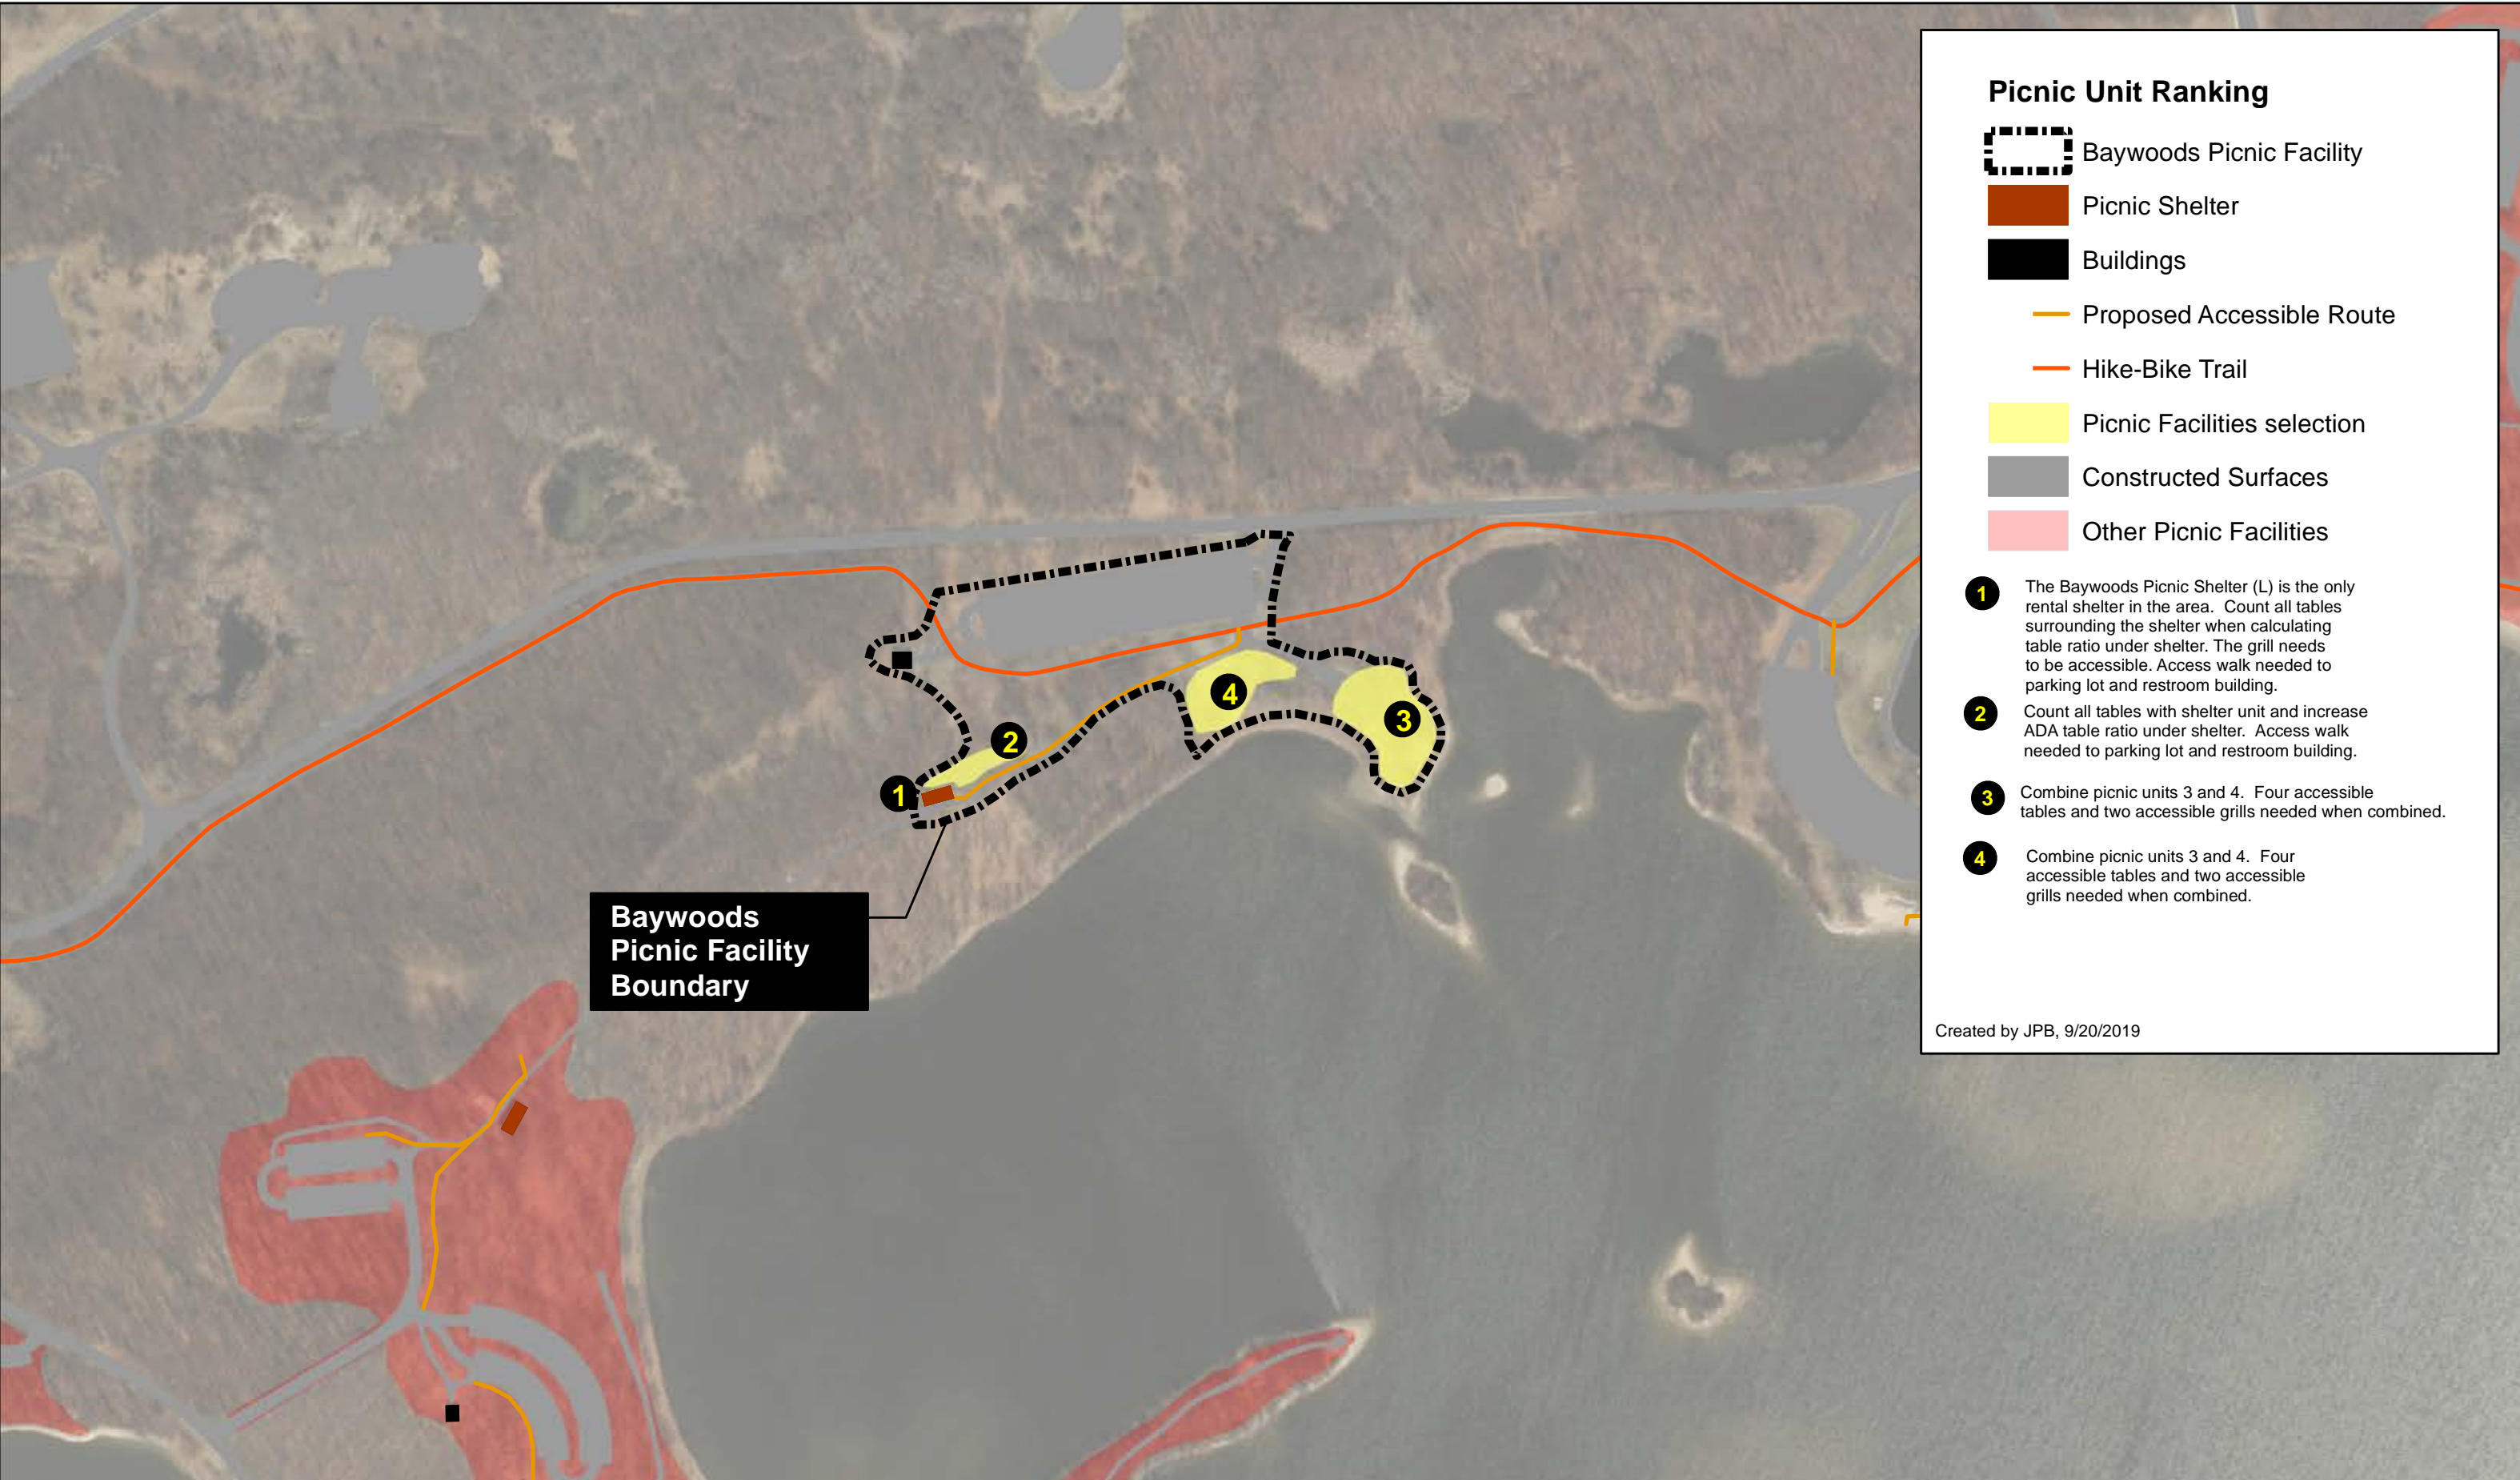
**Picnic Unit Ranking**

- 1** The Baywoods Picnic Shelter (L) is the only rental shelter in the area. Count all tables surrounding the shelter when calculating table ratio under shelter. The grill needs to be accessible. Access walk needed to parking lot and restroom building.
- 2** Count all tables with shelter unit and increase ADA table ratio under shelter. Access walk needed to parking lot and restroom building.
- 3** Combine picnic units 3 and 4. Four accessible tables and two accessible grills needed when combined.
- 4** Combine picnic units 3 and 4. Four accessible tables and two accessible grills needed when combined.

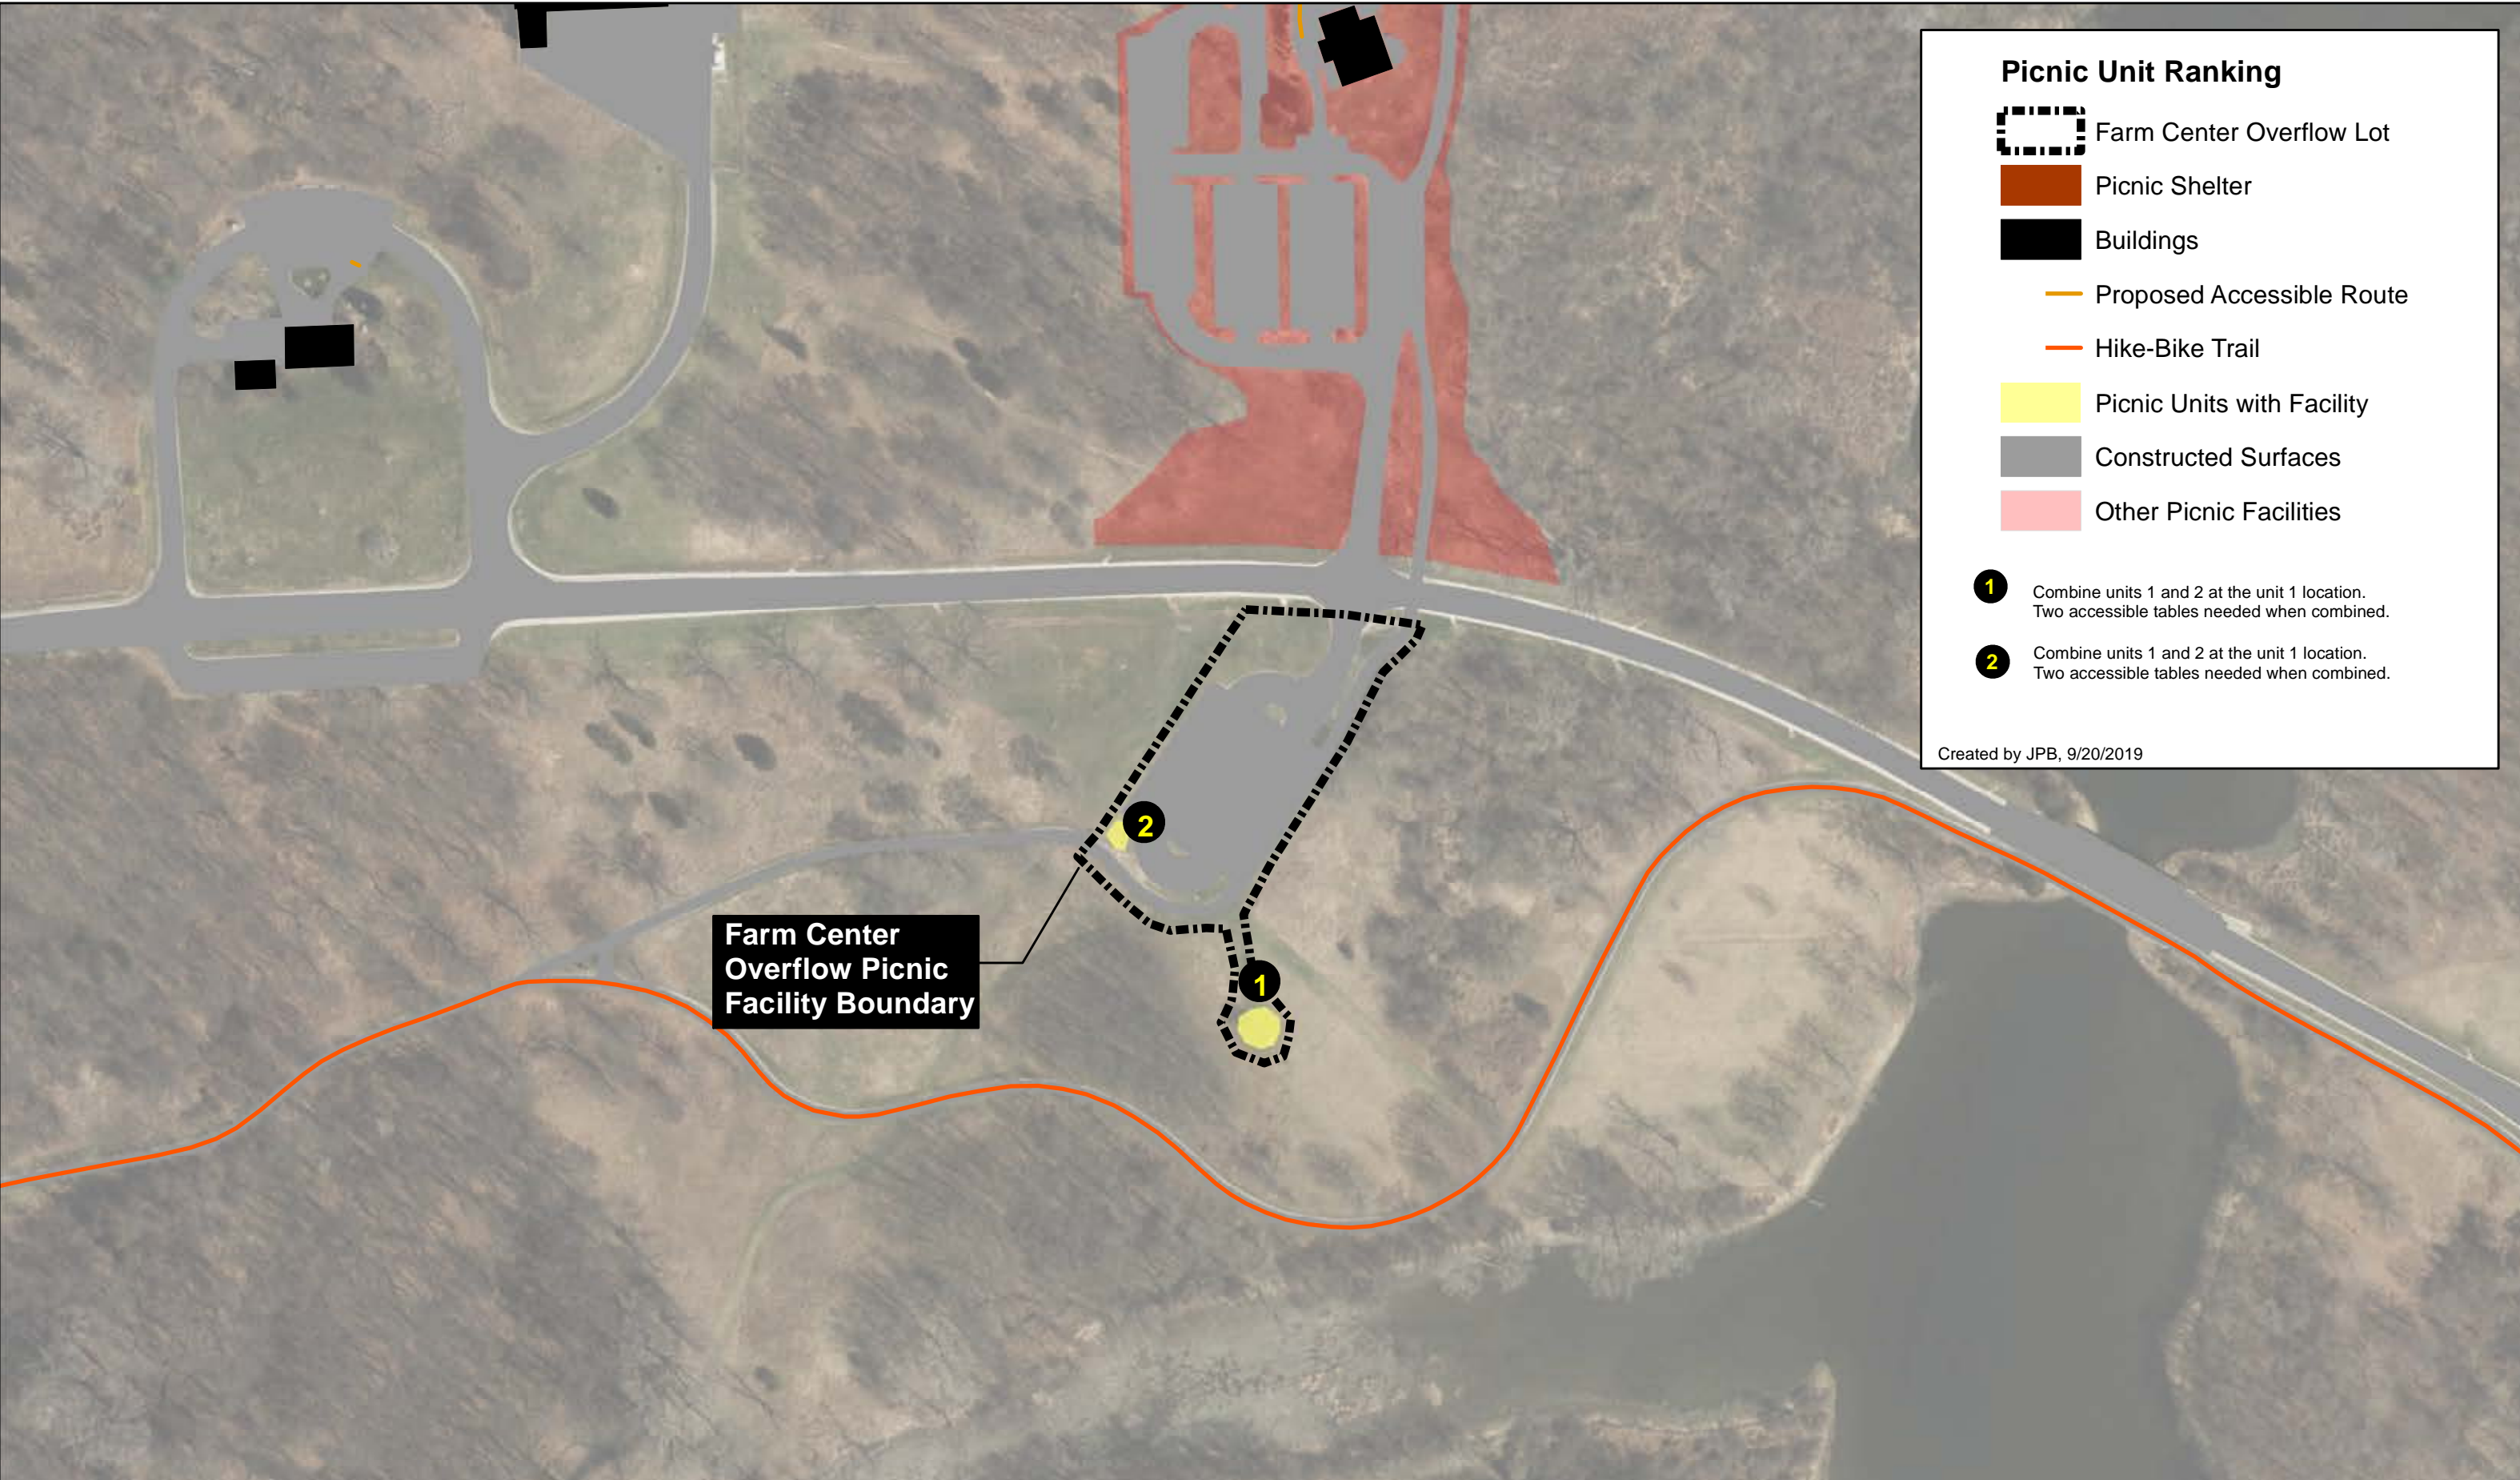
**Picnic Unit Ranking**

**1** Combine units 1 and 2 at the unit 1 location. Two accessible tables needed when combined.

**2** Combine units 1 and 2 at the unit 1 location. Two accessible tables needed when combined.

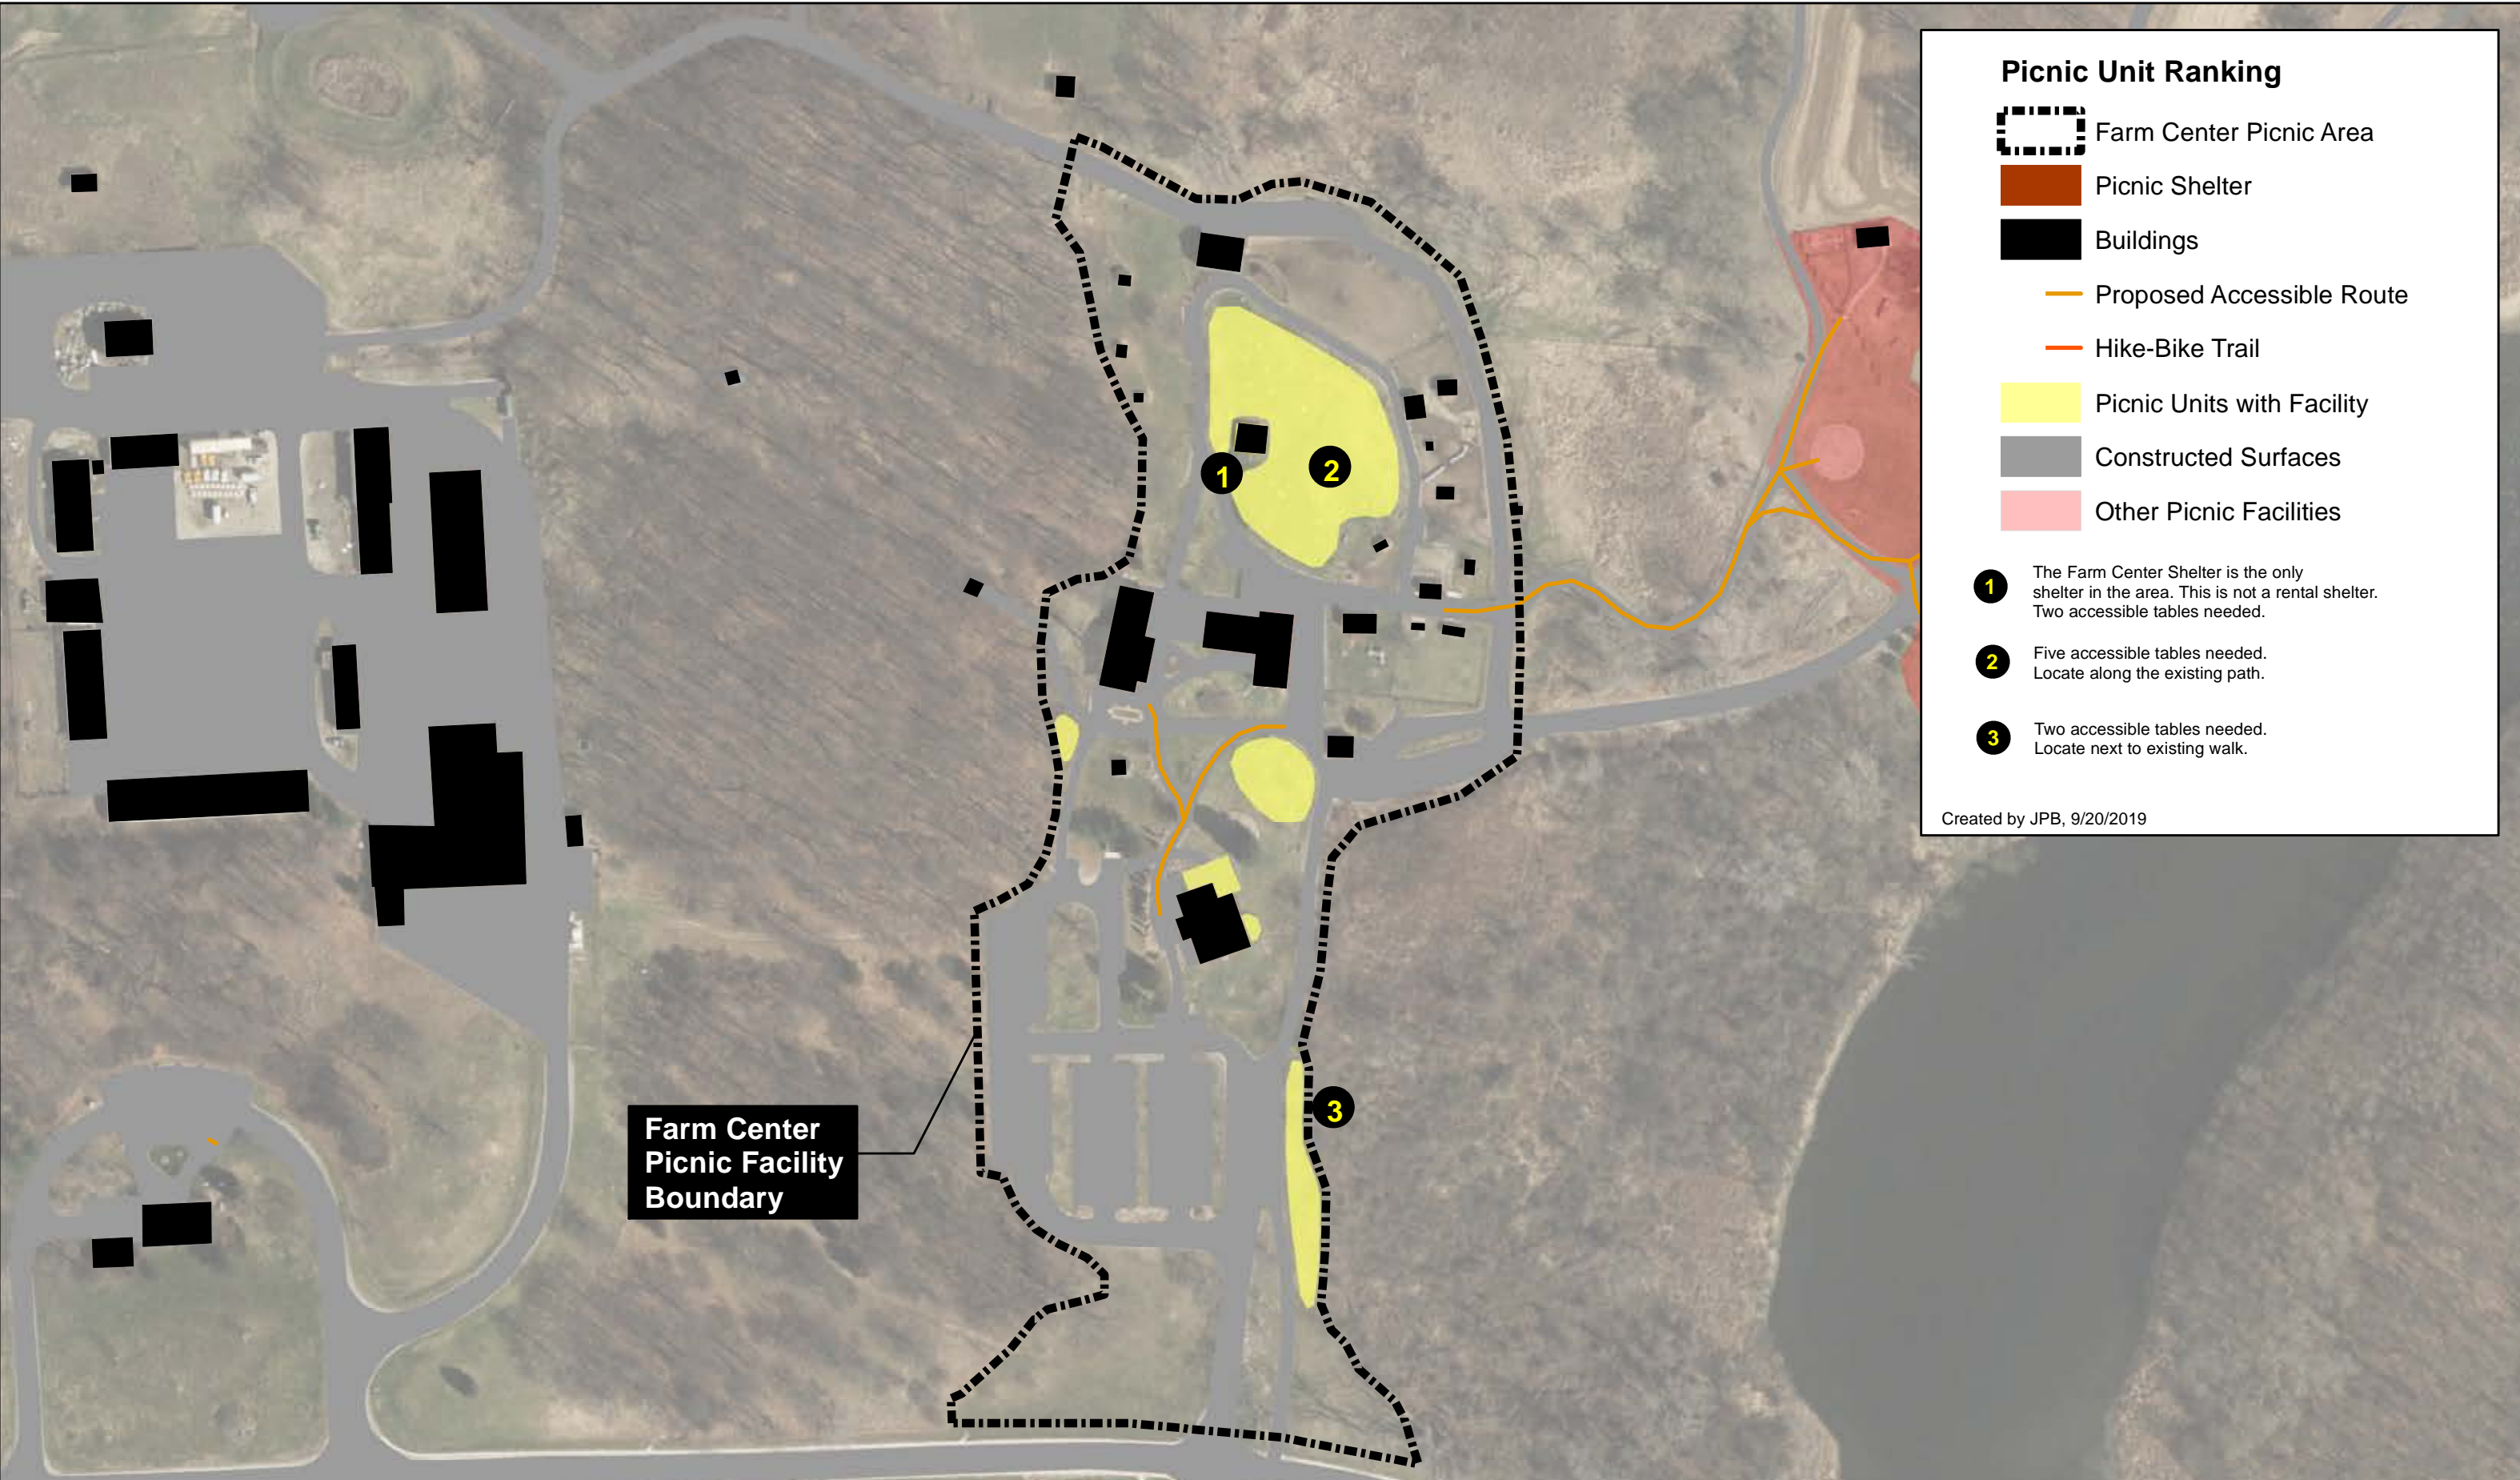
**Picnic Unit Ranking**

- 1** The Farm Center Shelter is the only shelter in the area. This is not a rental shelter. Two accessible tables needed.
- 2** Five accessible tables needed. Locate along the existing path.
- 3** Two accessible tables needed. Locate next to existing walk.

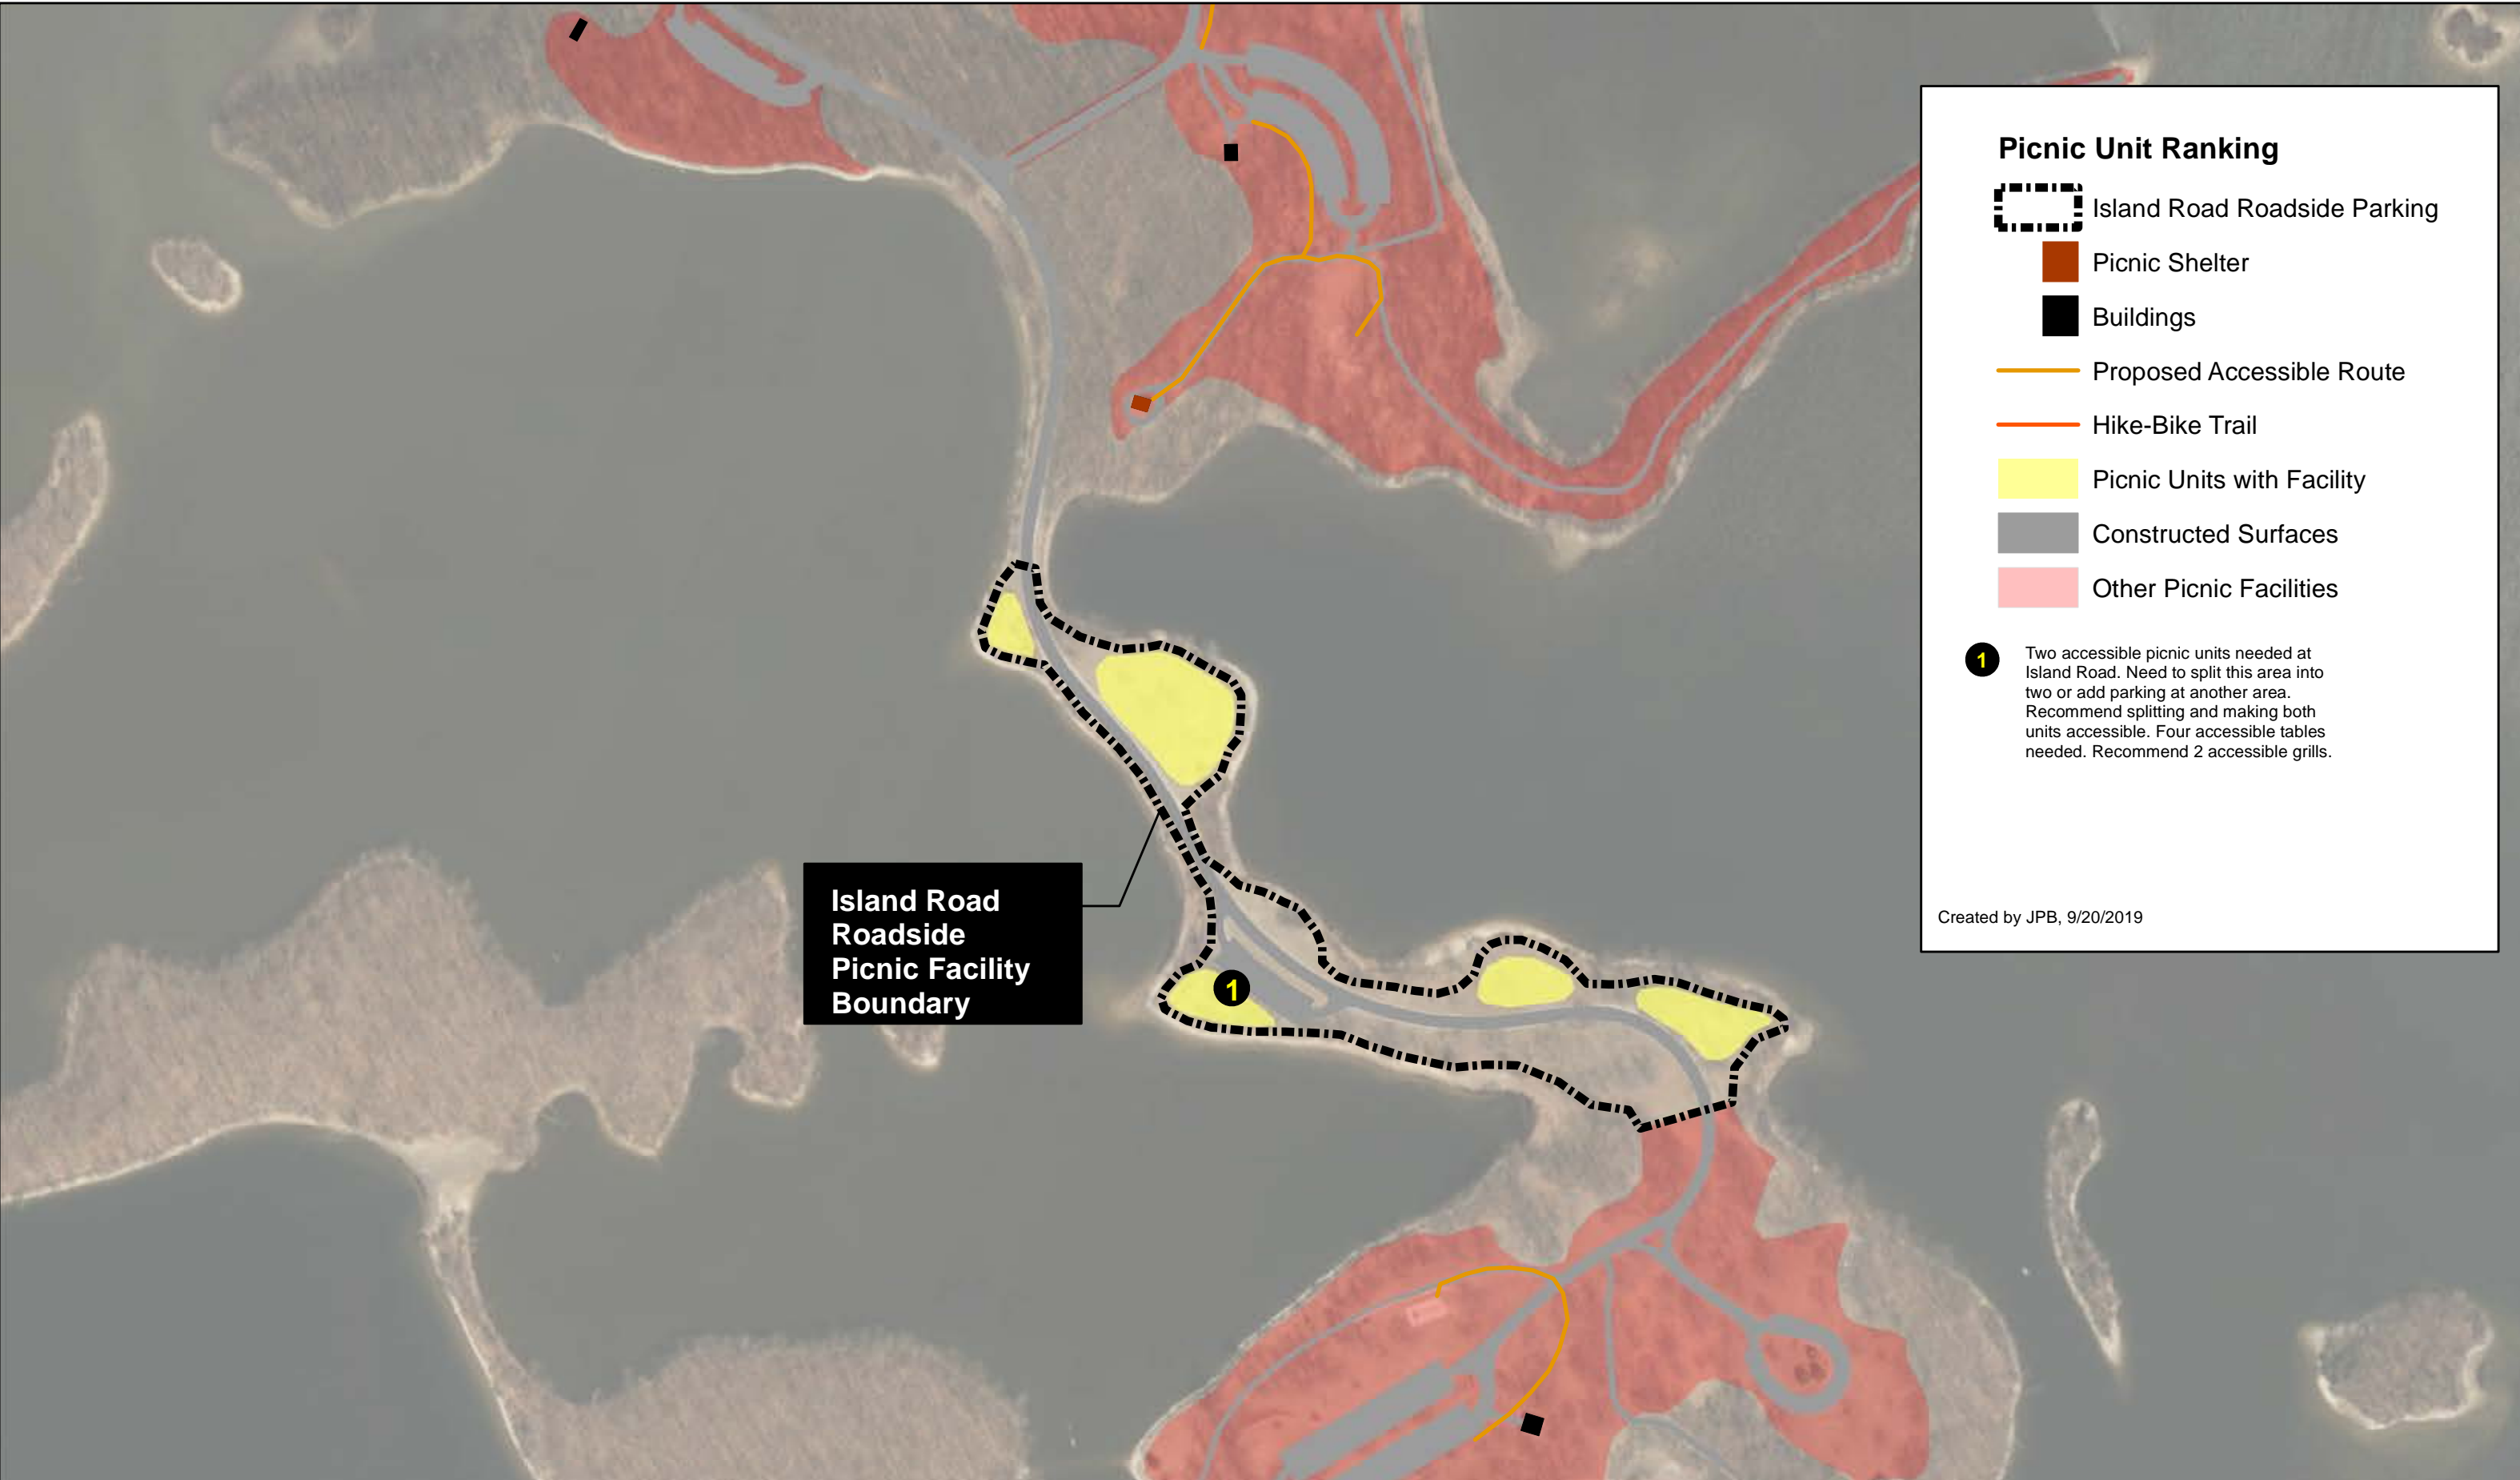
**Picnic Unit Ranking**

**1** Two accessible picnic units needed at Island Road. Need to split this area into two or add parking at another area. Recommend splitting and making both units accessible. Four accessible tables needed. Recommend 2 accessible grills.

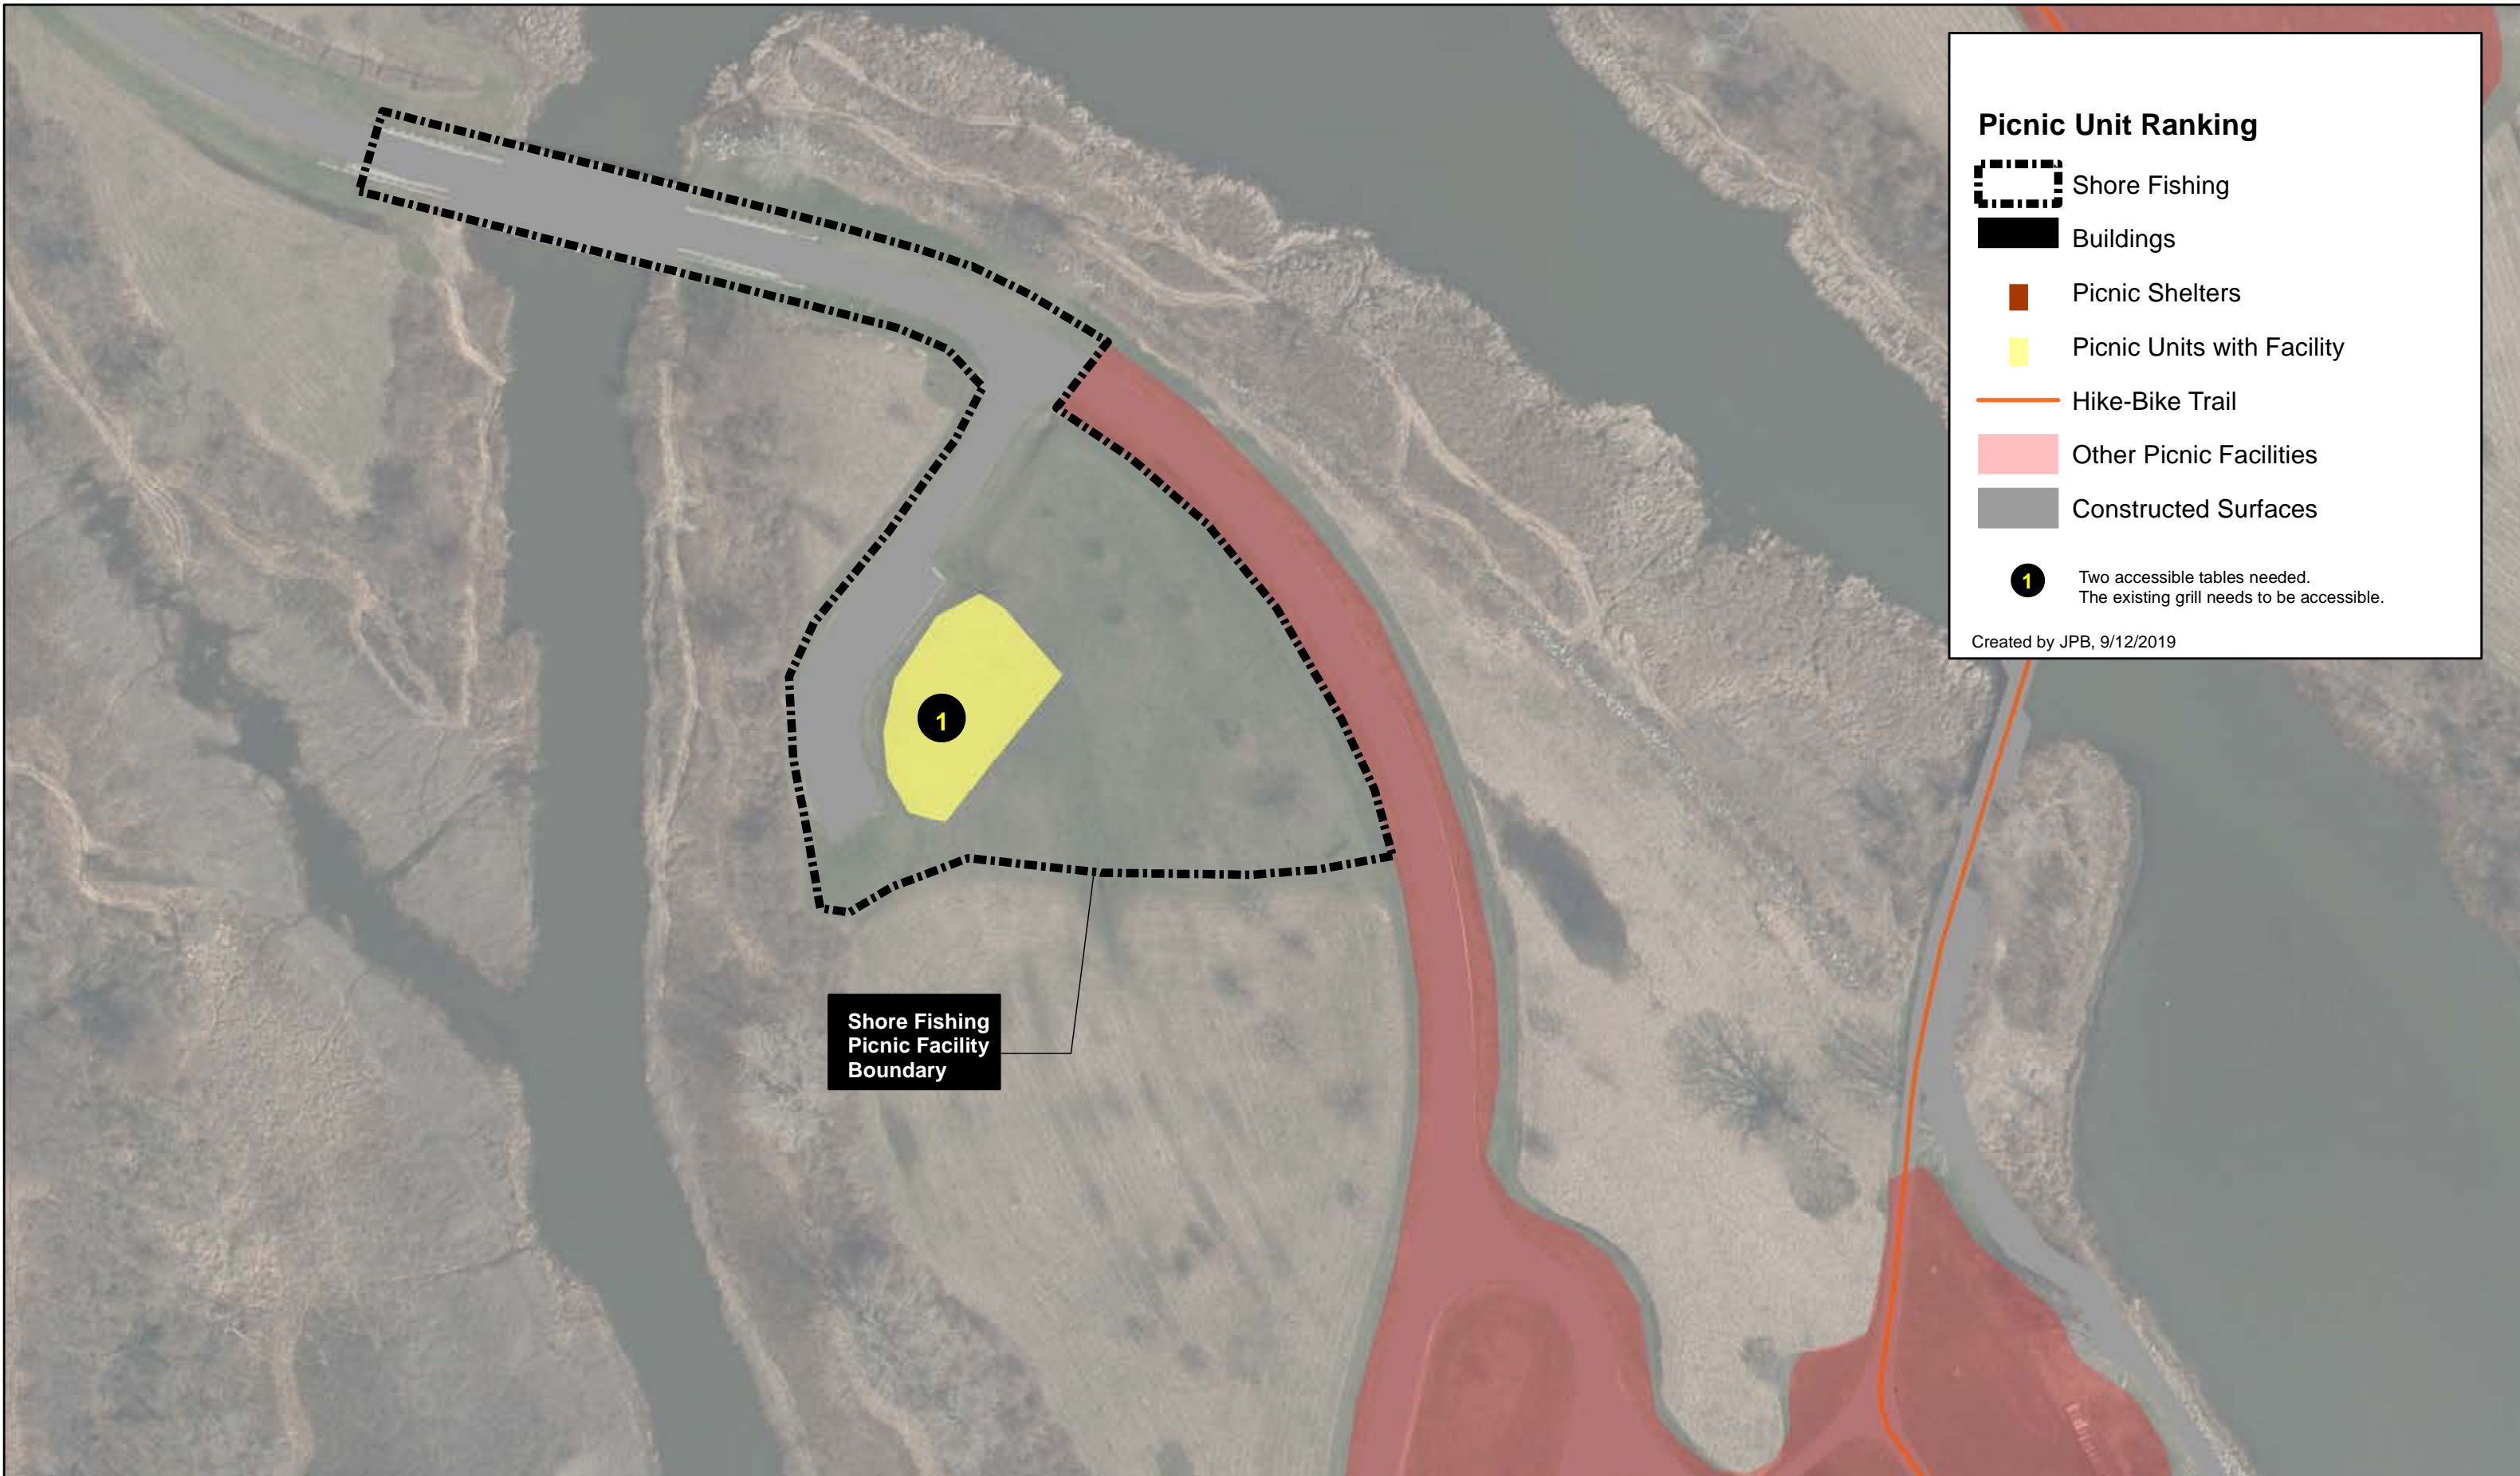
**Picnic Unit Ranking**

-   Shore Fishing
-   Buildings
-   Picnic Shelters
-   Picnic Units with Facility
-   Hike-Bike Trail
-   Other Picnic Facilities
-   Constructed Surfaces
-   Two accessible tables needed.  
The existing grill needs to be accessible.

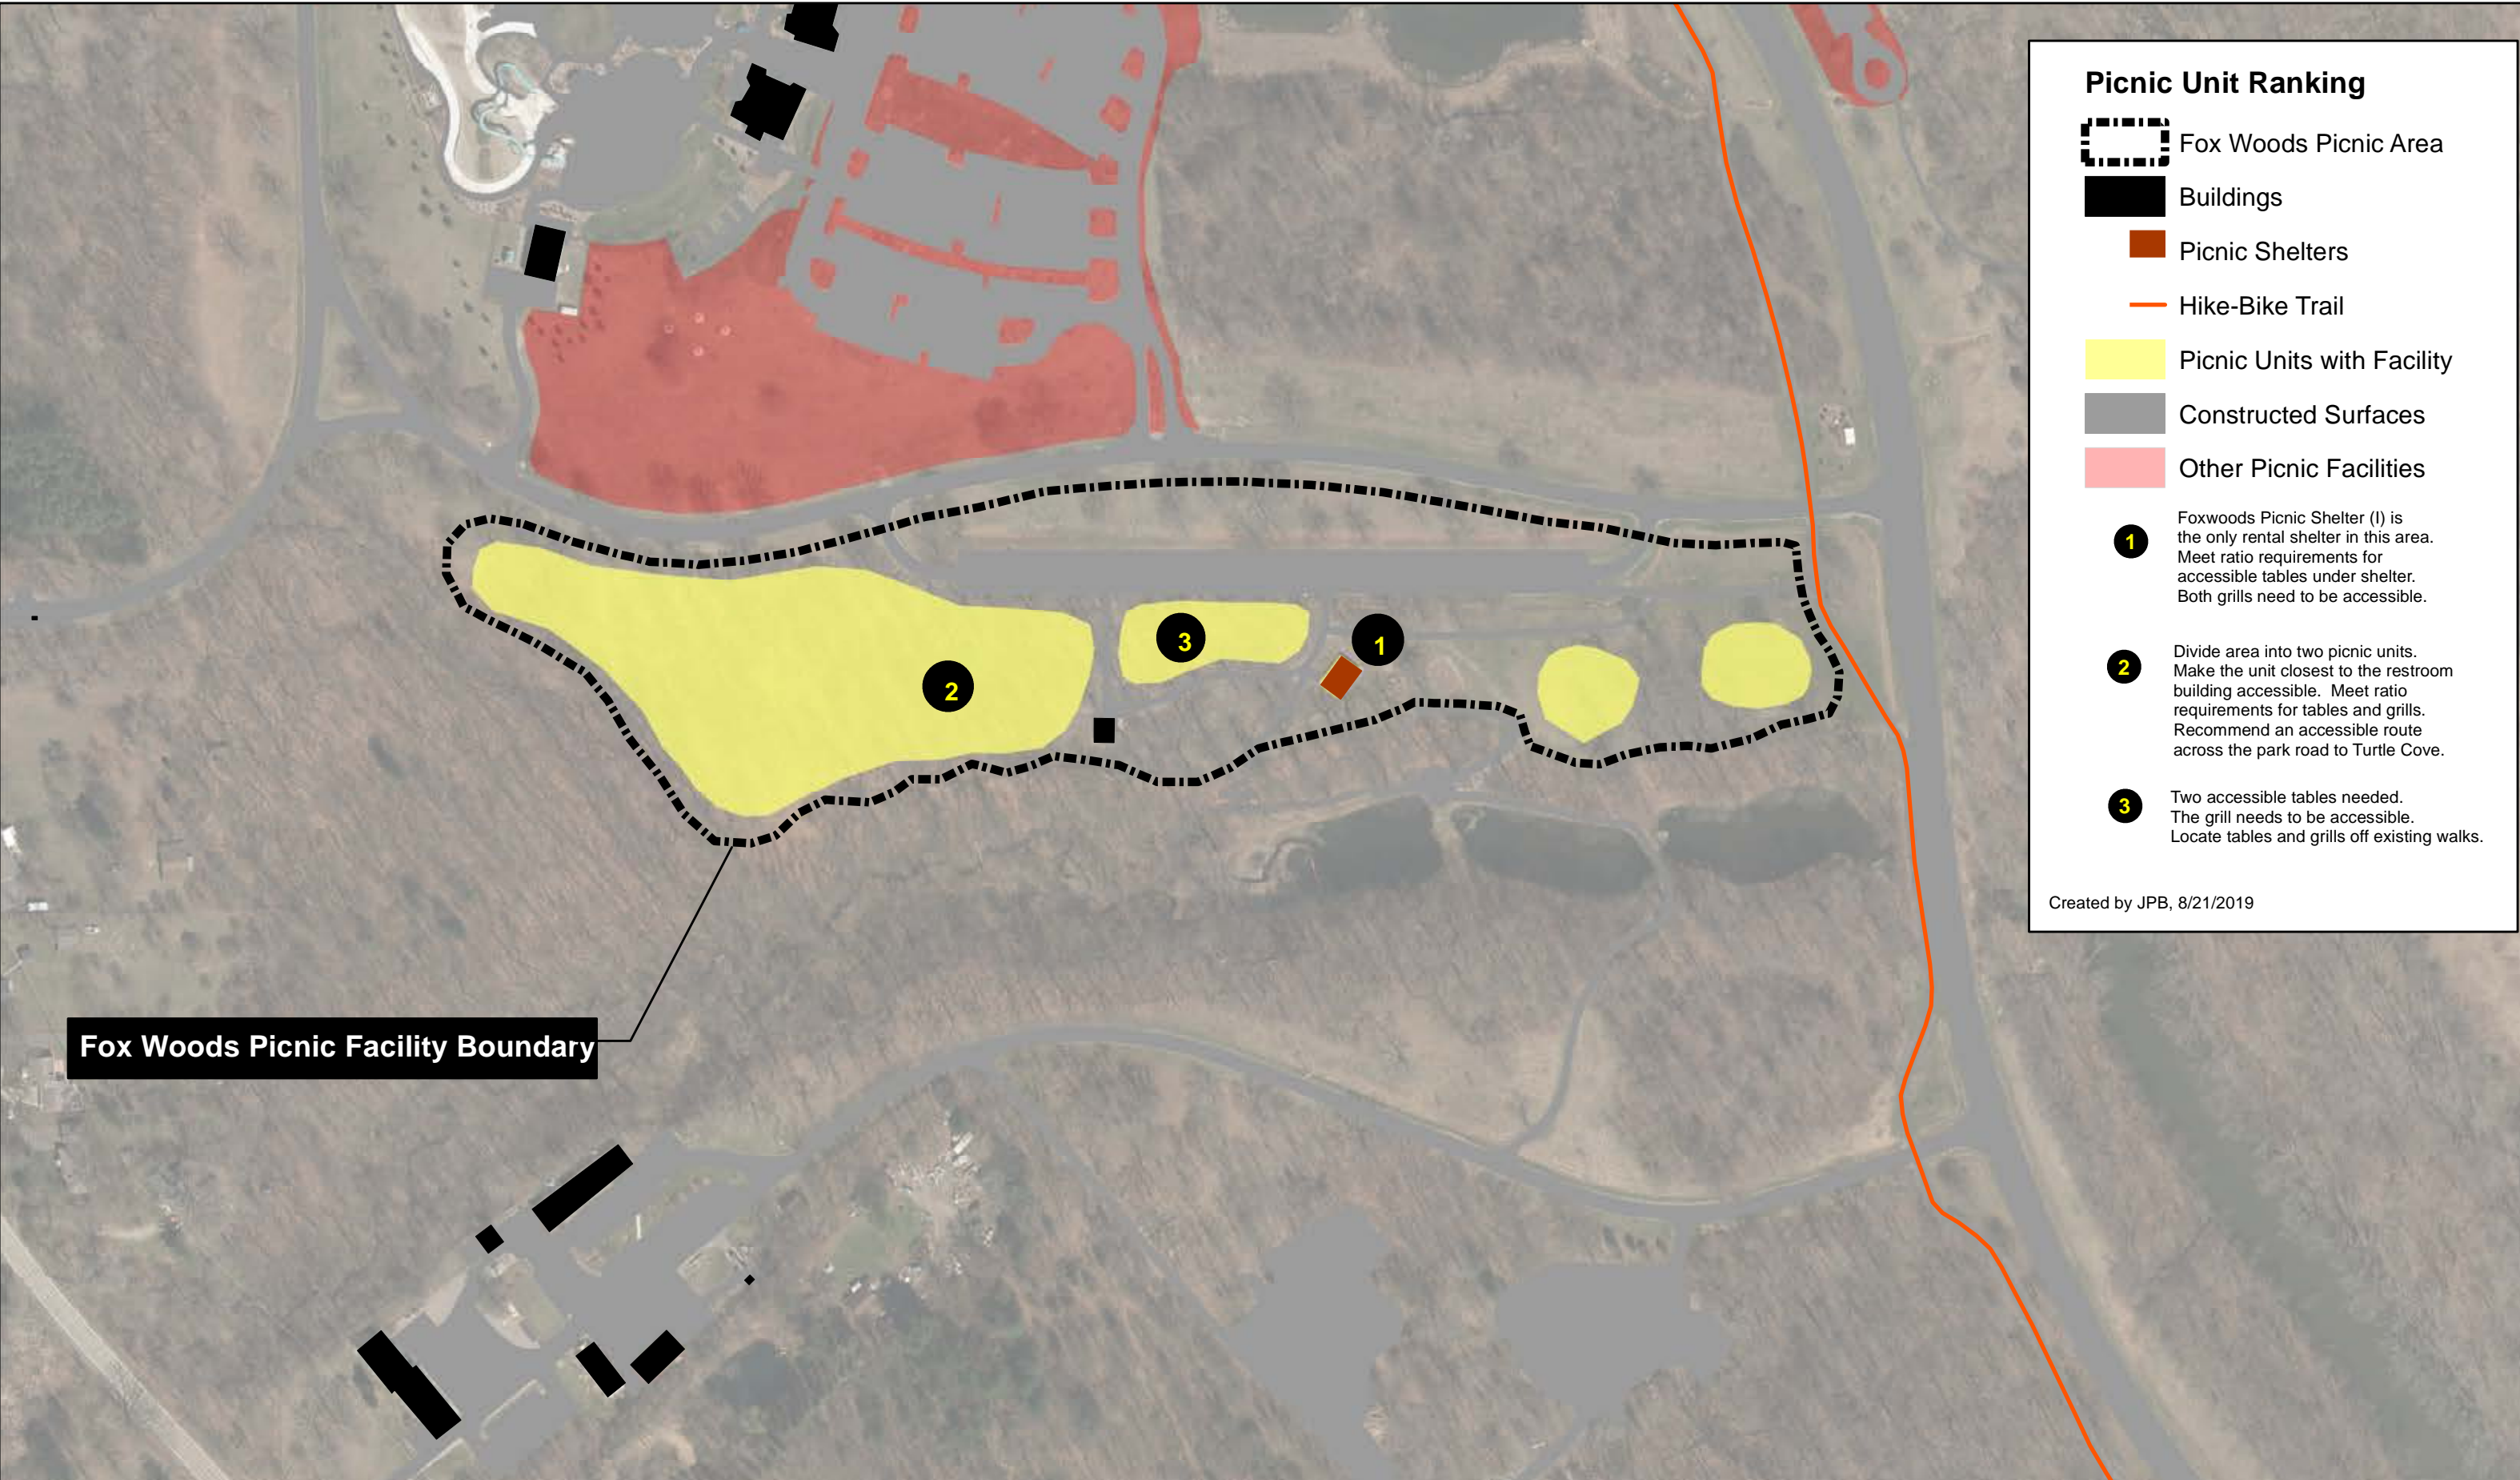
**Picnic Unit Ranking**

- 1** Foxwoods Picnic Shelter (I) is the only rental shelter in this area. Meet ratio requirements for accessible tables under shelter. Both grills need to be accessible.
- 2** Divide area into two picnic units. Make the unit closest to the restroom building accessible. Meet ratio requirements for tables and grills. Recommend an accessible route across the park road to Turtle Cove.
- 3** Two accessible tables needed. The grill needs to be accessible. Locate tables and grills off existing walks.
