# APPENDIX 3: PICNIC FACILITIES MAPS

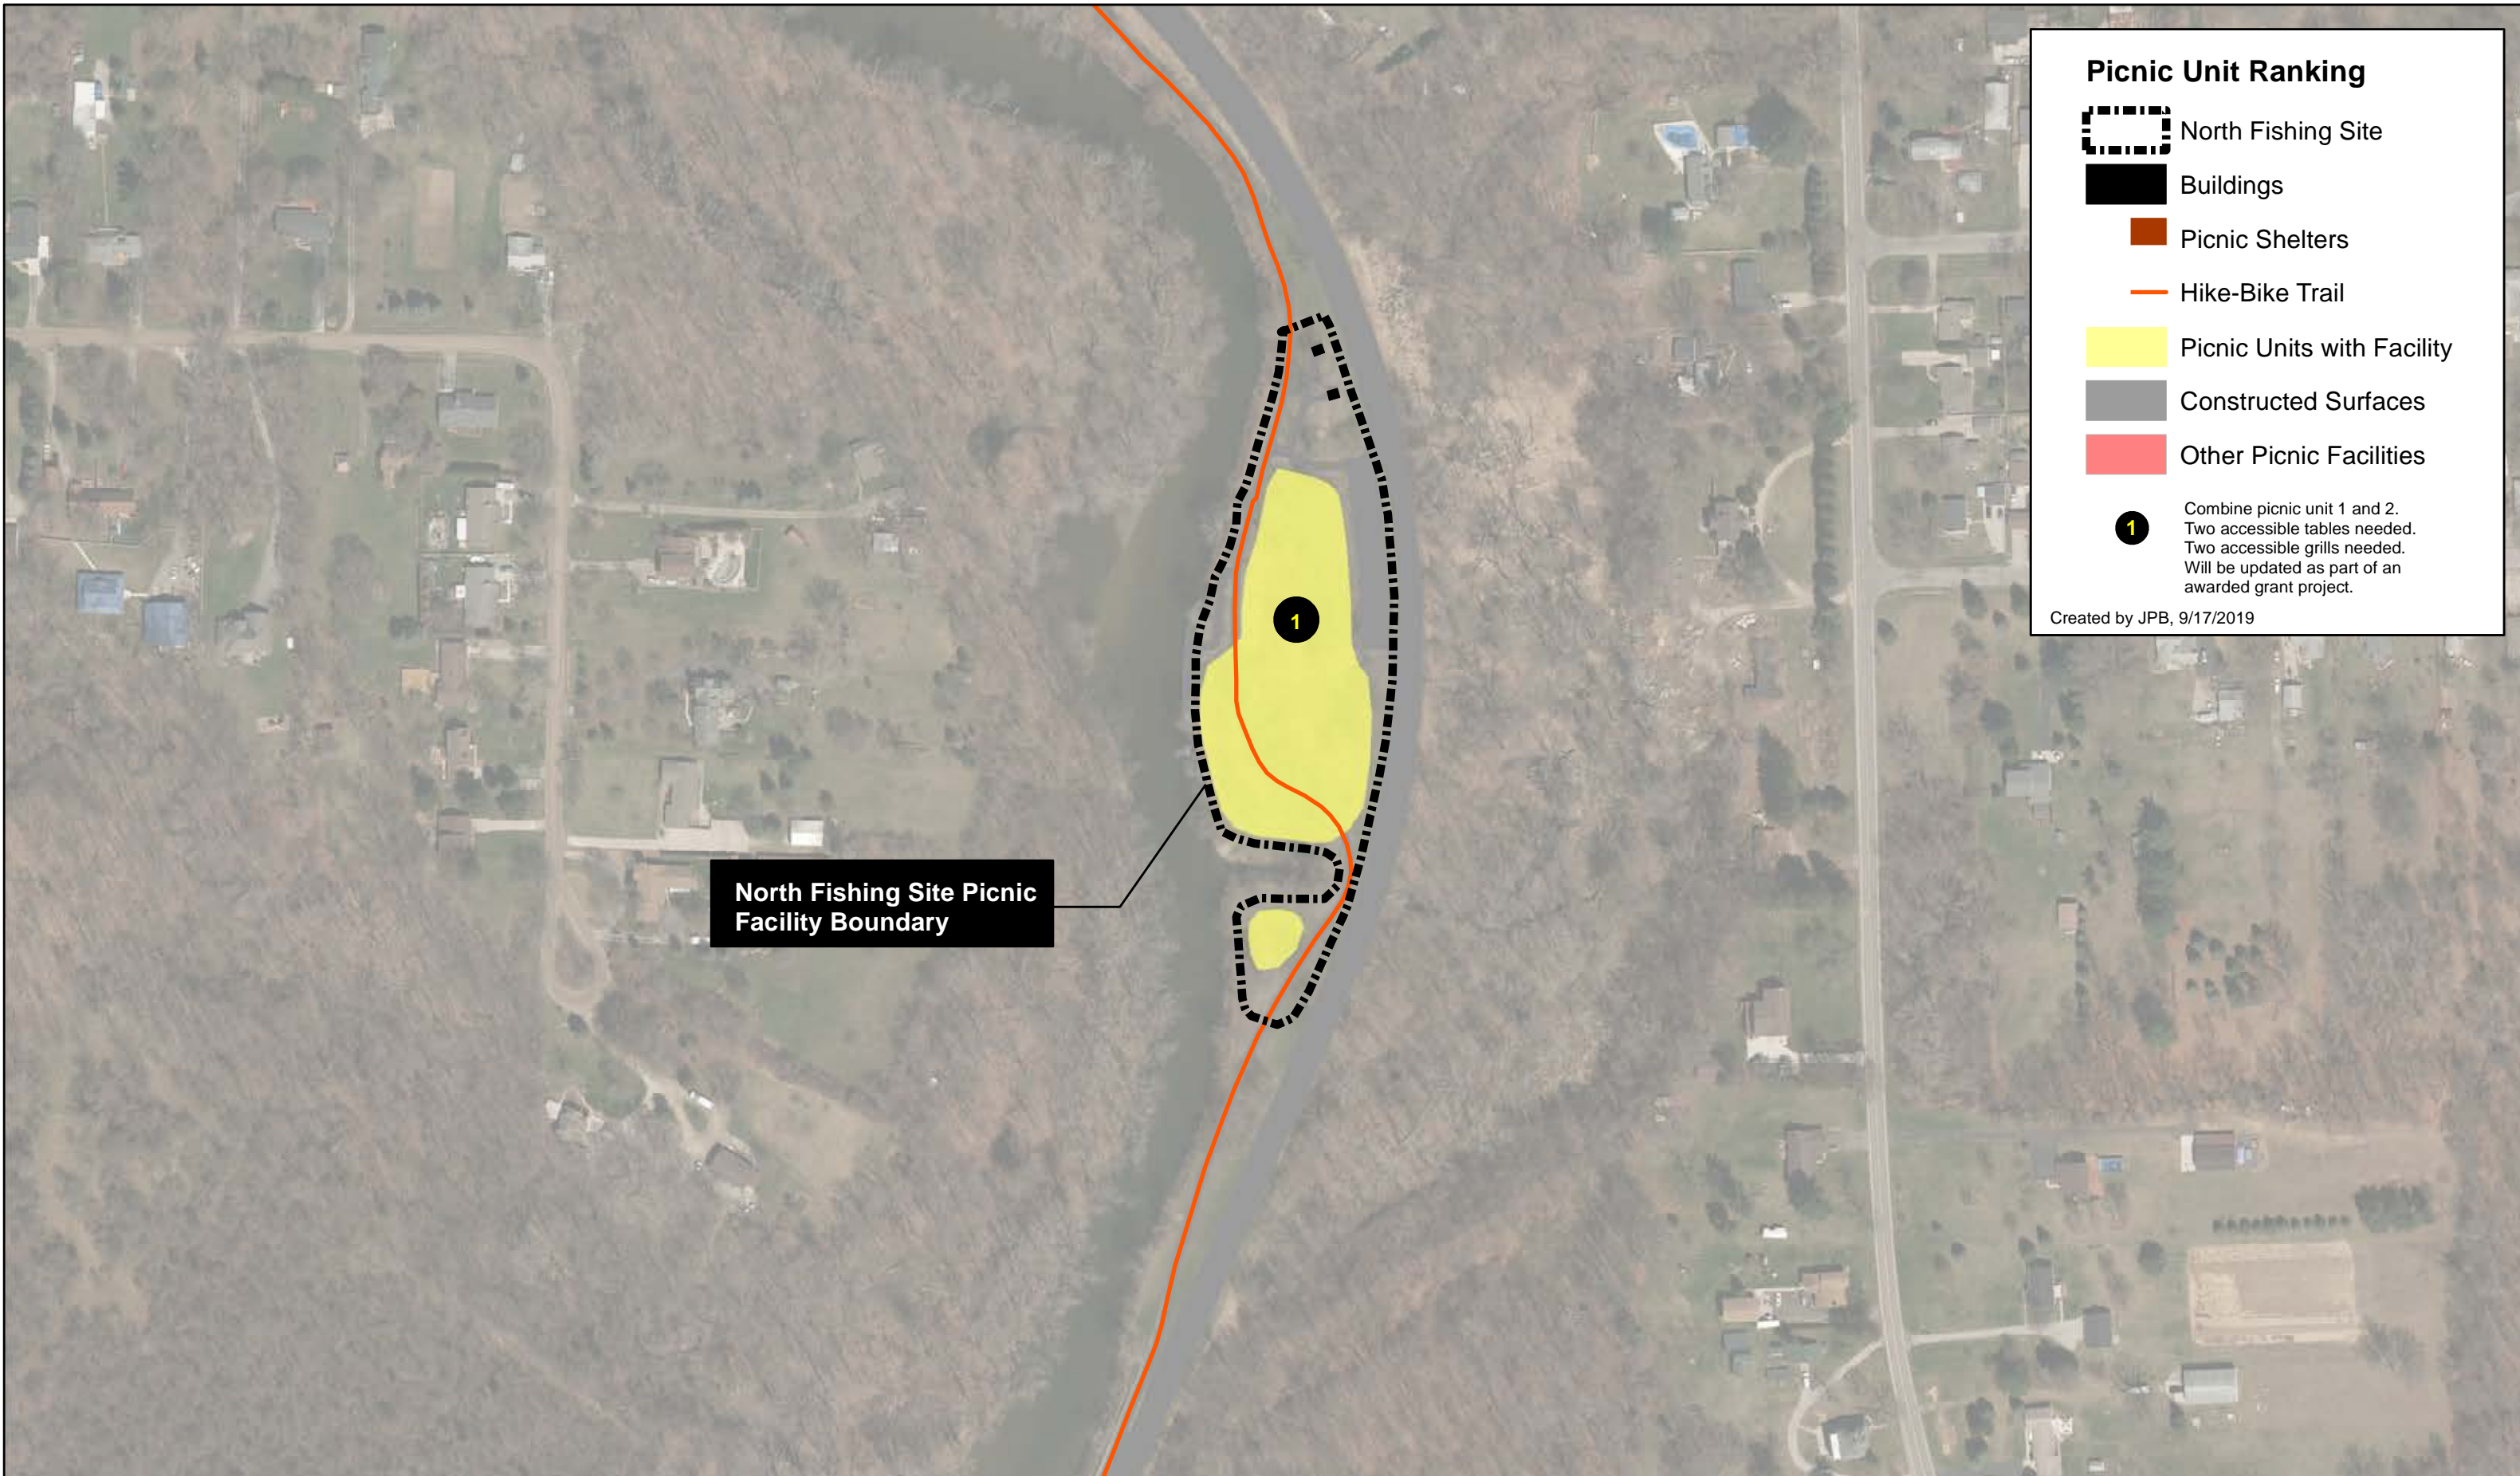
**Picnic Unit Ranking**

-   North Fishing Site
-   Buildings
-   Picnic Shelters
-   Hike-Bike Trail
-   Picnic Units with Facility
-   Constructed Surfaces
-   Other Picnic Facilities
-   Combine picnic unit 1 and 2.  
Two accessible tables needed.  
Two accessible grills needed.  
Will be updated as part of an  
awarded grant project.

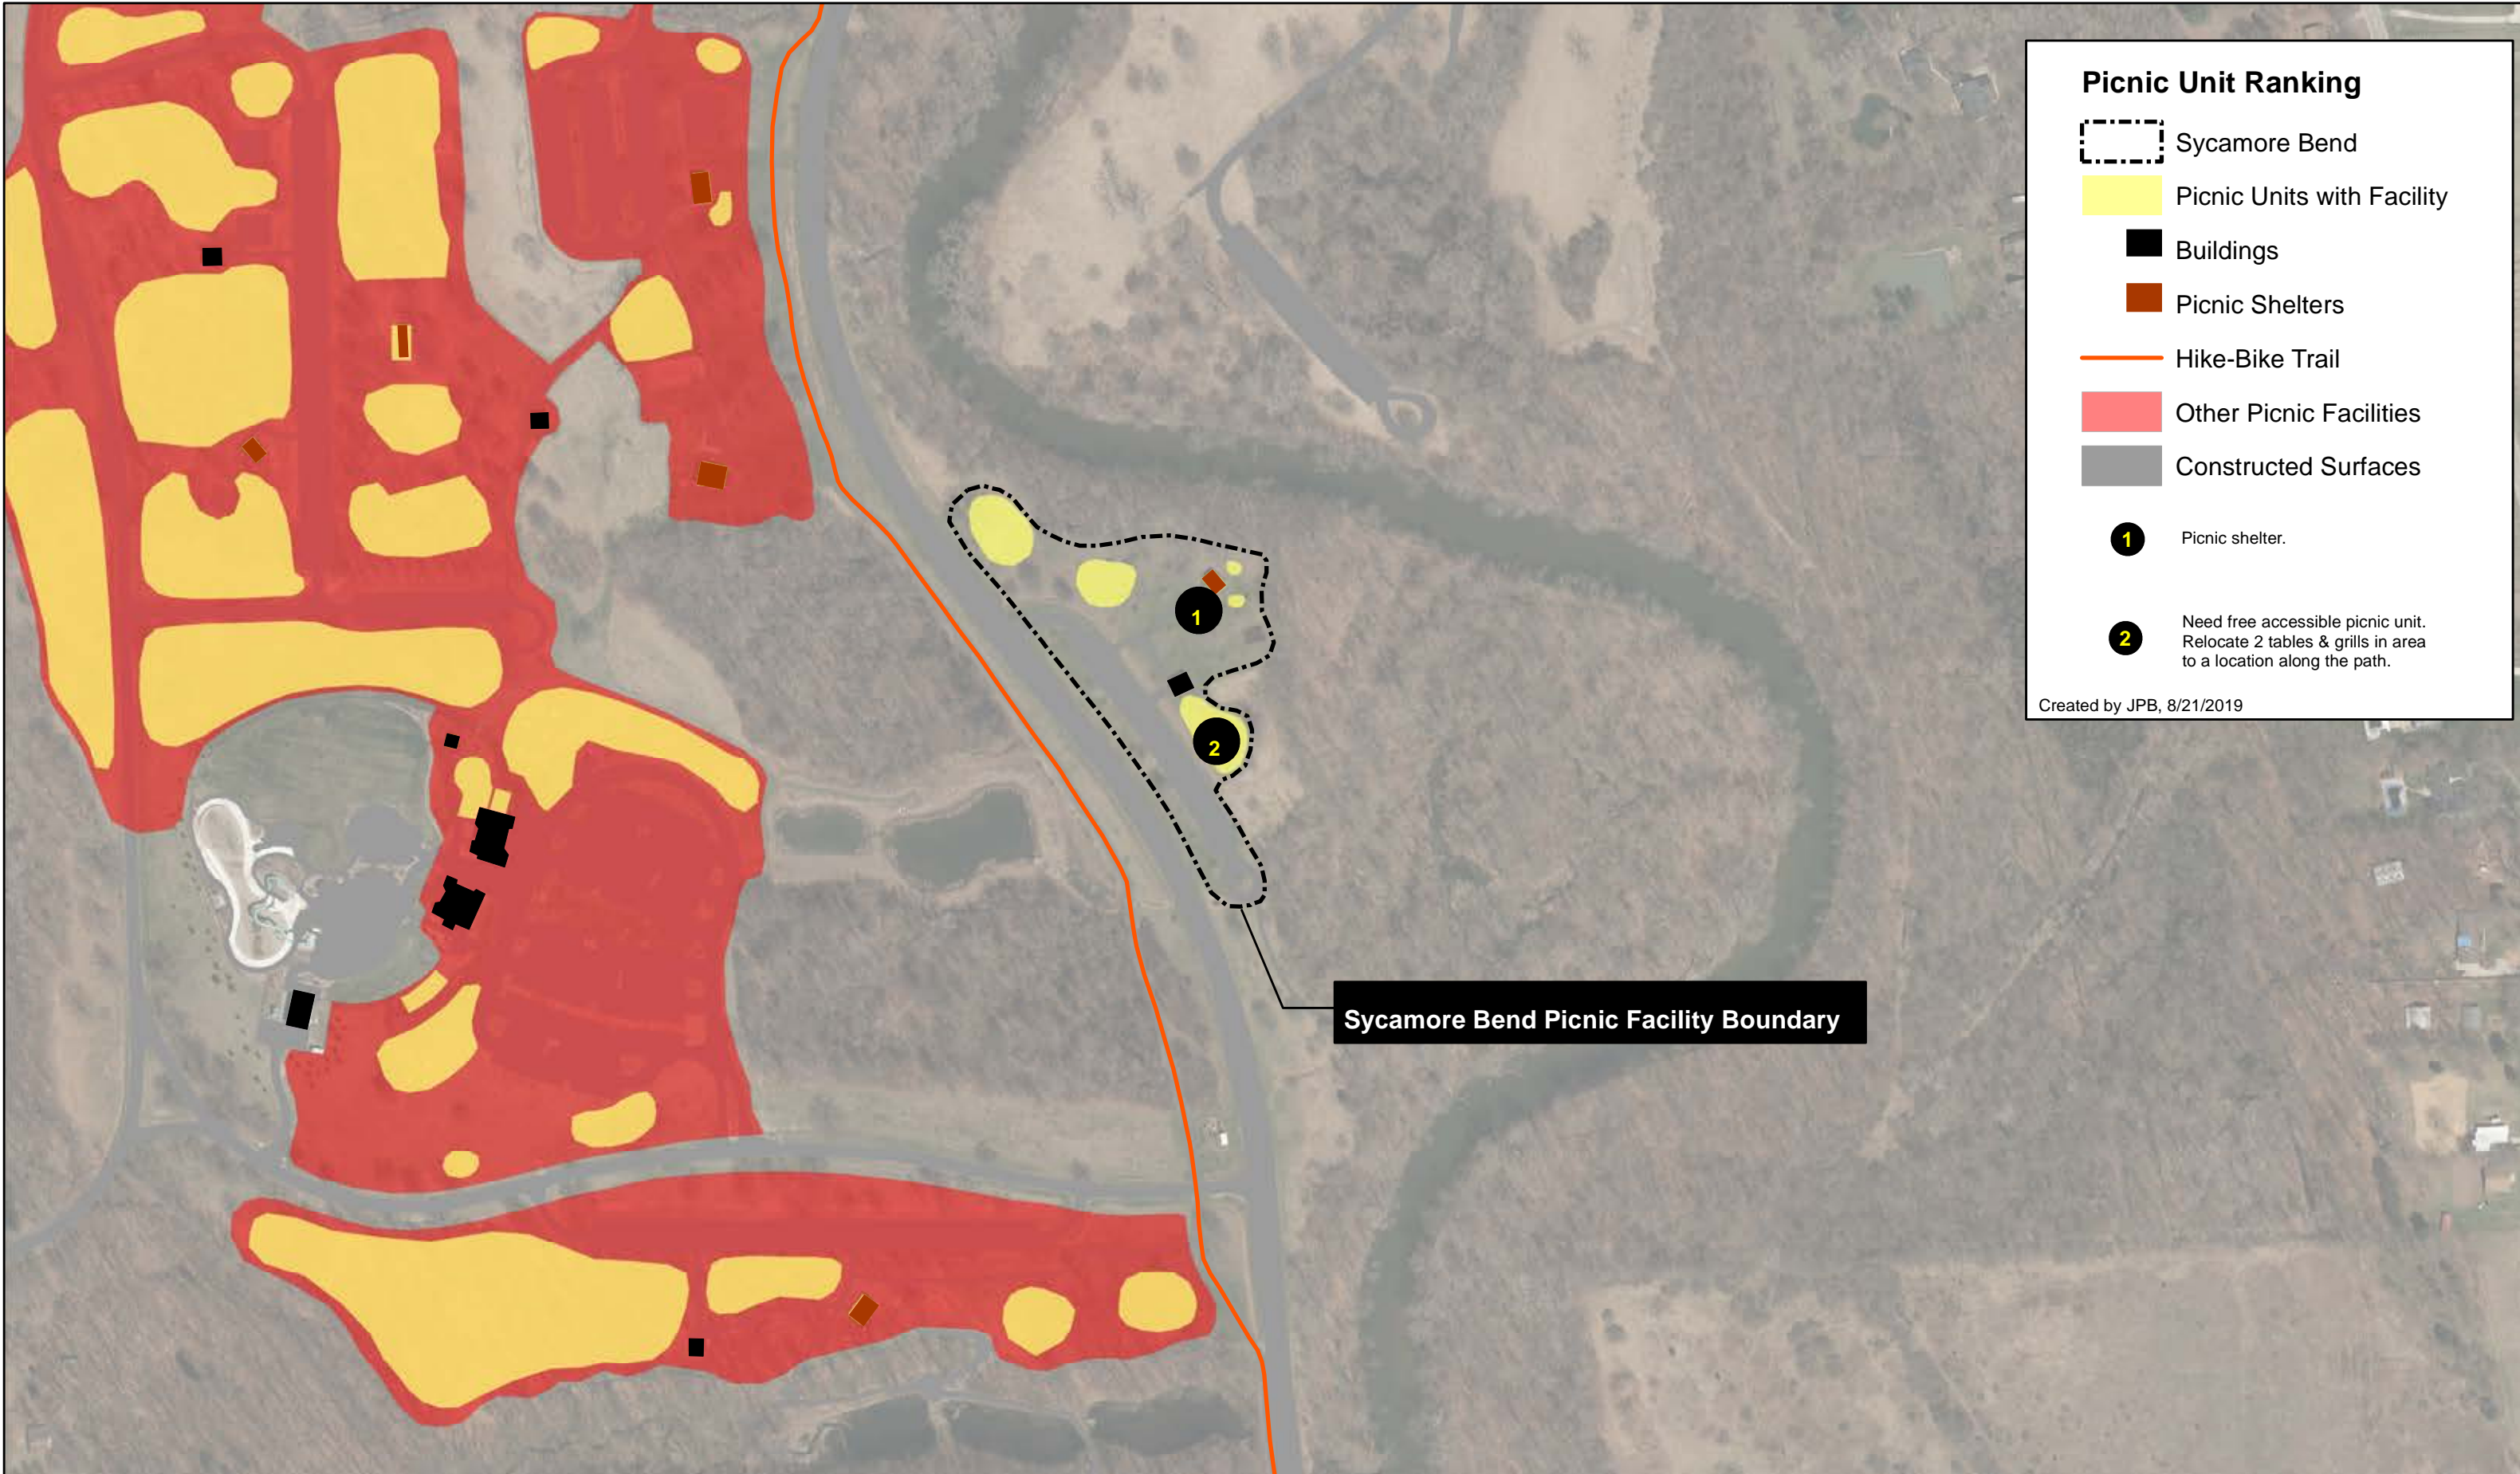
**Picnic Unit Ranking**

- Sycamore Bend
- Picnic Units with Facility
- Buildings
- Picnic Shelters
- Hike-Bike Trail
- Other Picnic Facilities
- Constructed Surfaces
- Picnic shelter.
- Need free accessible picnic unit. Relocate 2 tables & grills in area to a location along the path.

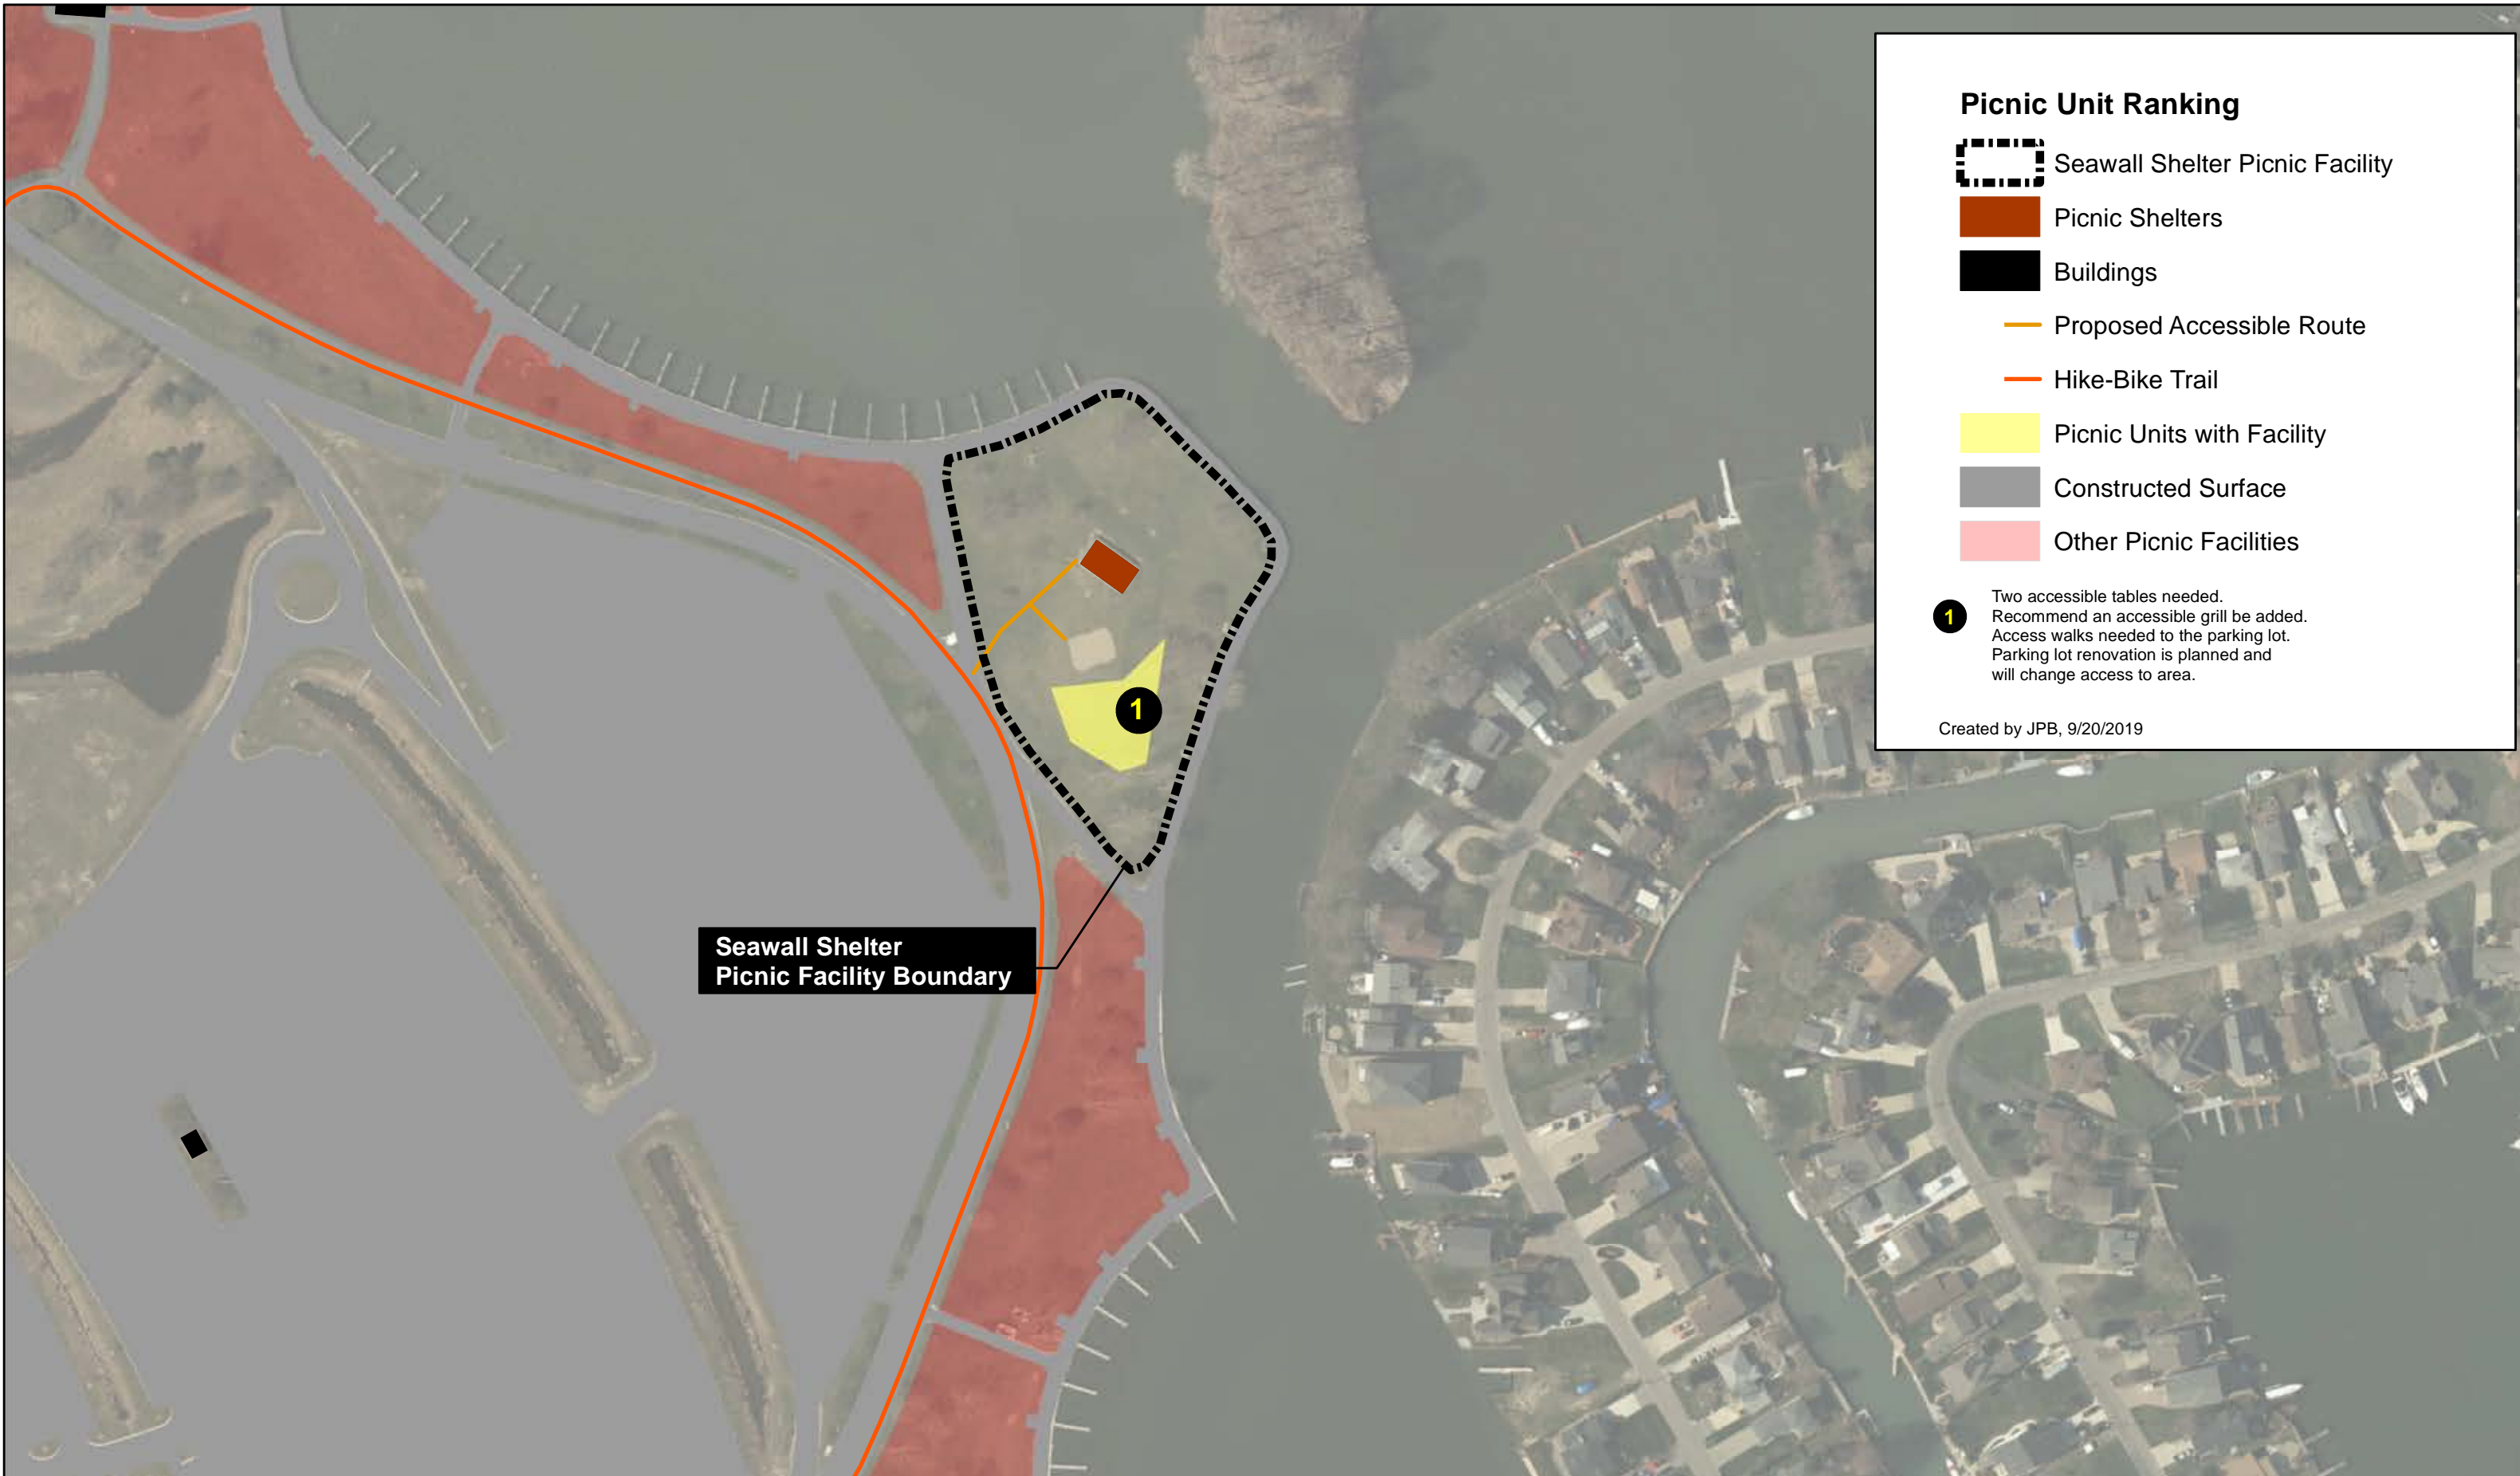
**Picnic Unit Ranking**

**1** Two accessible tables needed.  
Recommend an accessible grill be added.  
Access walks needed to the parking lot.  
Parking lot renovation is planned and  
will change access to area.

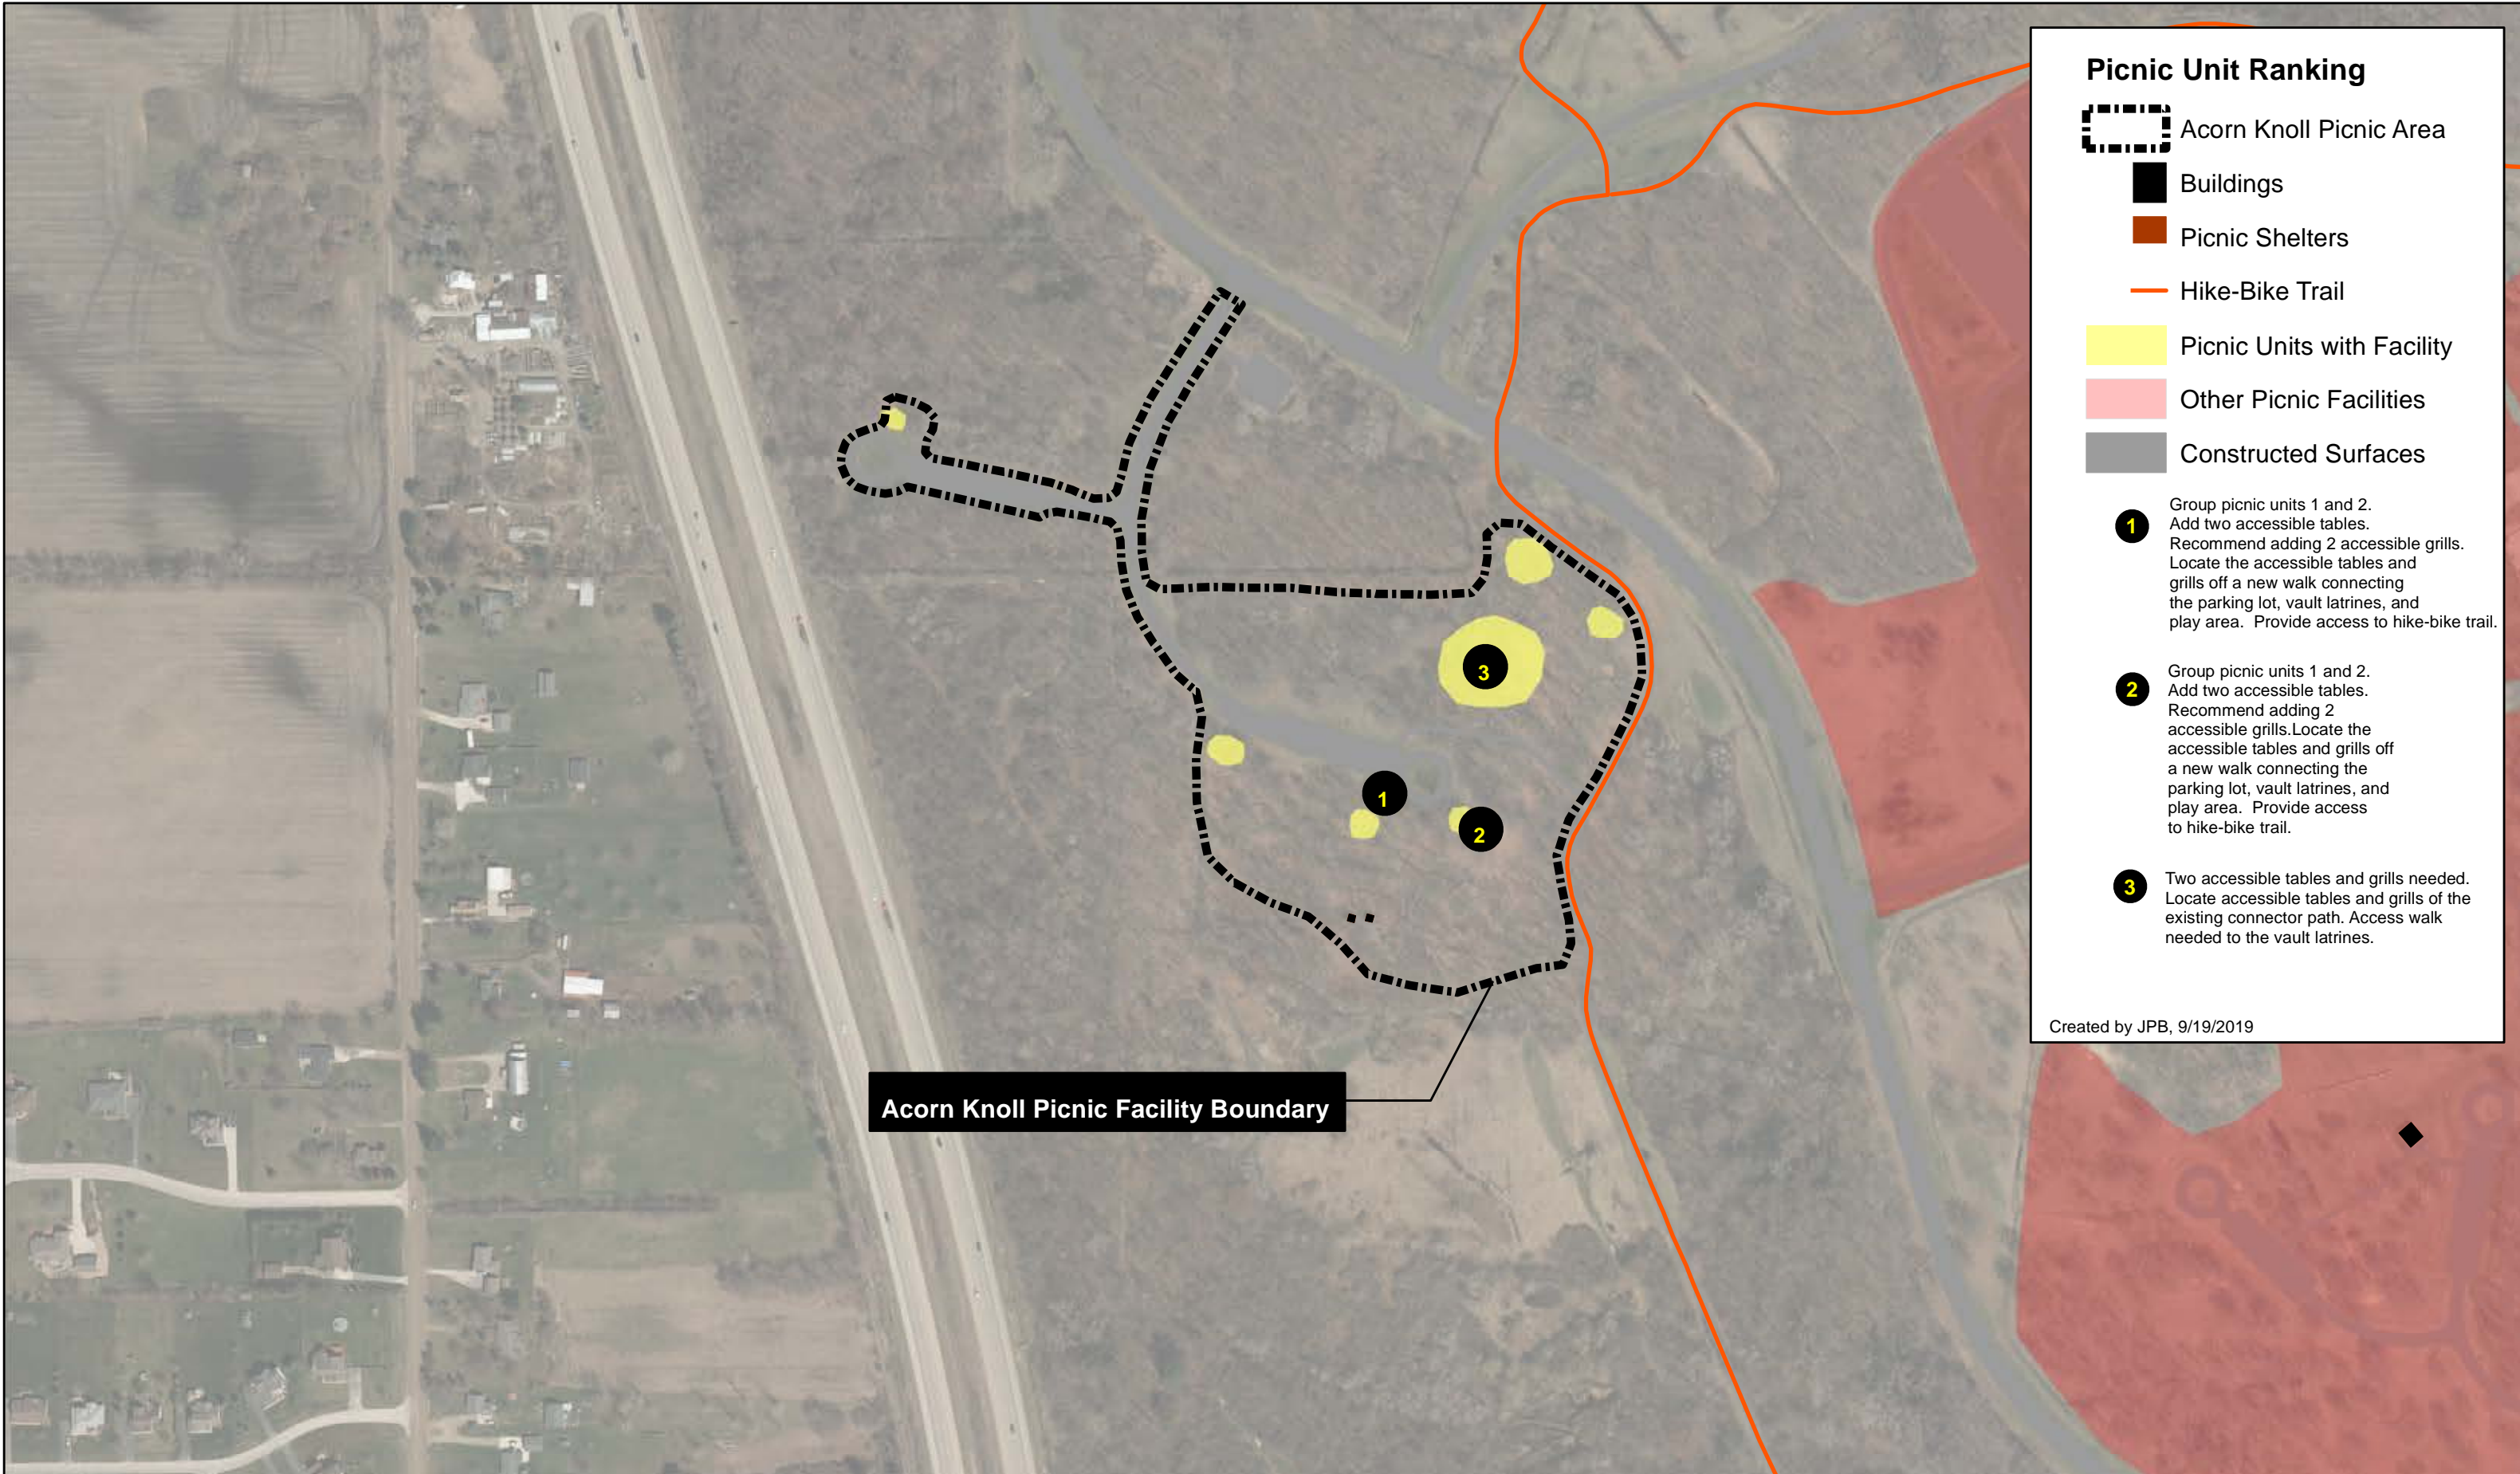
**Picnic Unit Ranking**

- 1** Group picnic units 1 and 2. Add two accessible tables. Recommend adding 2 accessible grills. Locate the accessible tables and grills off a new walk connecting the parking lot, vault latrines, and play area. Provide access to hike-bike trail.
- 2** Group picnic units 1 and 2. Add two accessible tables. Recommend adding 2 accessible grills. Locate the accessible tables and grills off a new walk connecting the parking lot, vault latrines, and play area. Provide access to hike-bike trail.
- 3** Two accessible tables and grills needed. Locate accessible tables and grills of the existing connector path. Access walk needed to the vault latrines.
