SUBJECT: Flat Rock Dam, Dam ID No. 556; Wayne County

**DAM SAFETY INSPECTION REPORT
FLAT ROCK DAM – DAM ID NO. 556
HURON RIVER
WAYNE COUNTY – SW 1/4 SECTION 31, T 04S, R 10E**

FLAT ROCK DAM
WAYNE COUNTY
DAM ID NO. 556
APPENDIX B – INSPECTION PHOTOS

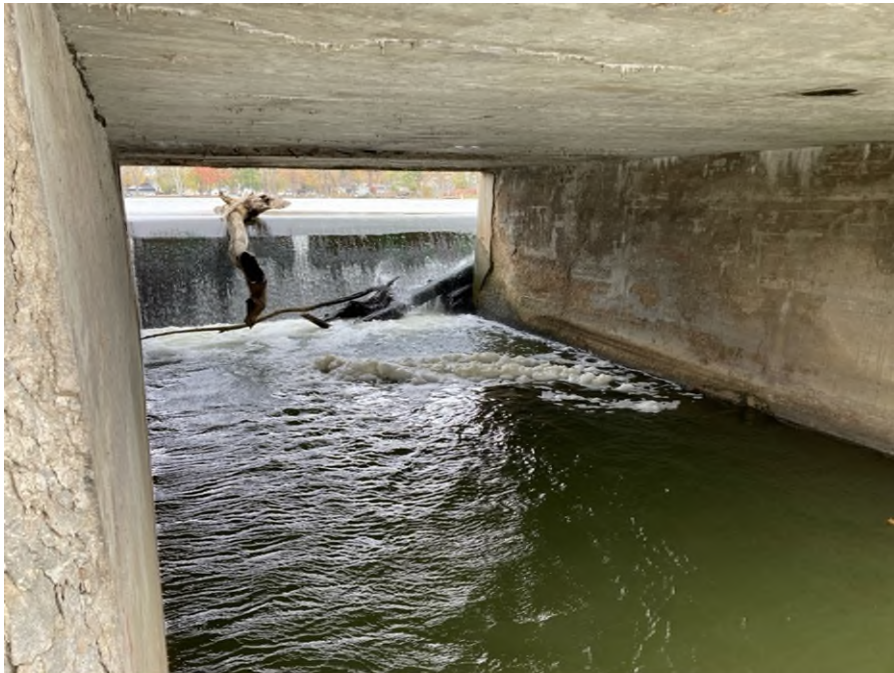
Photo #7: Principal Spillway Weir Wall.

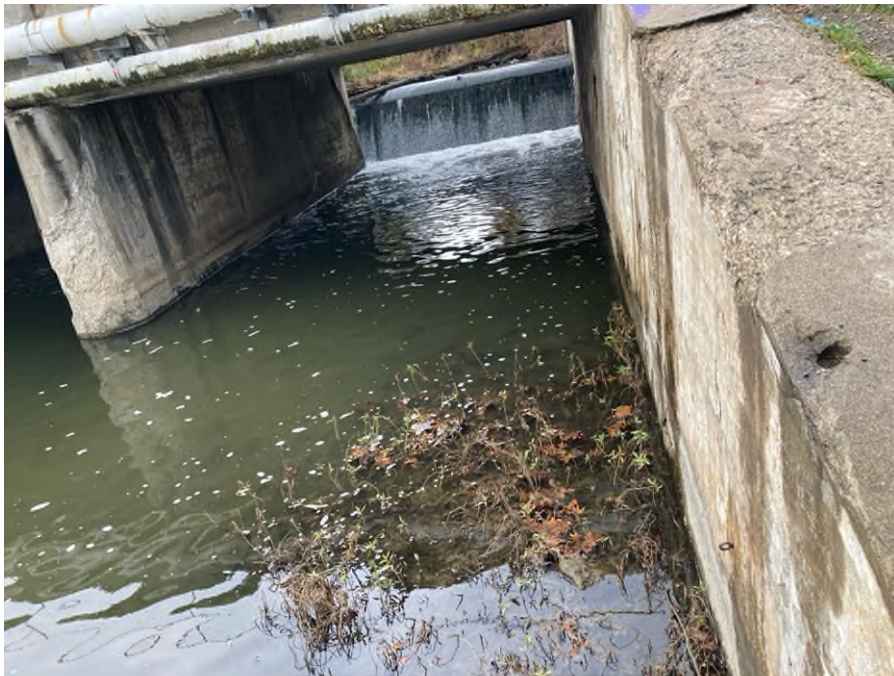
Photo #8: Principal Spillway Abutment Left Wall.

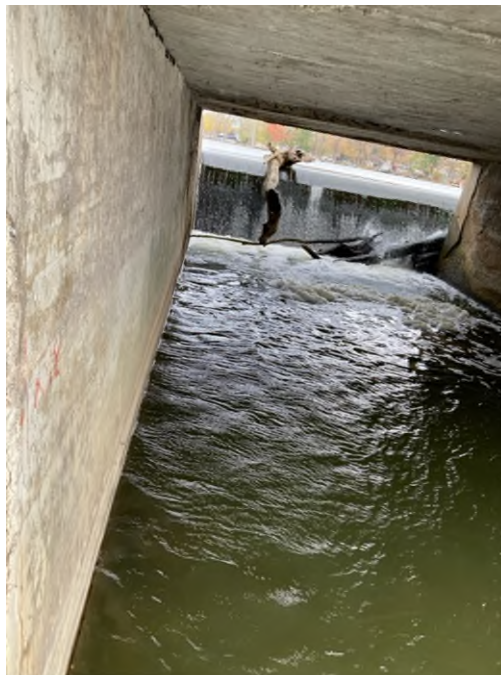
Photo #10: Principal Spillway Abutment Right Wall.

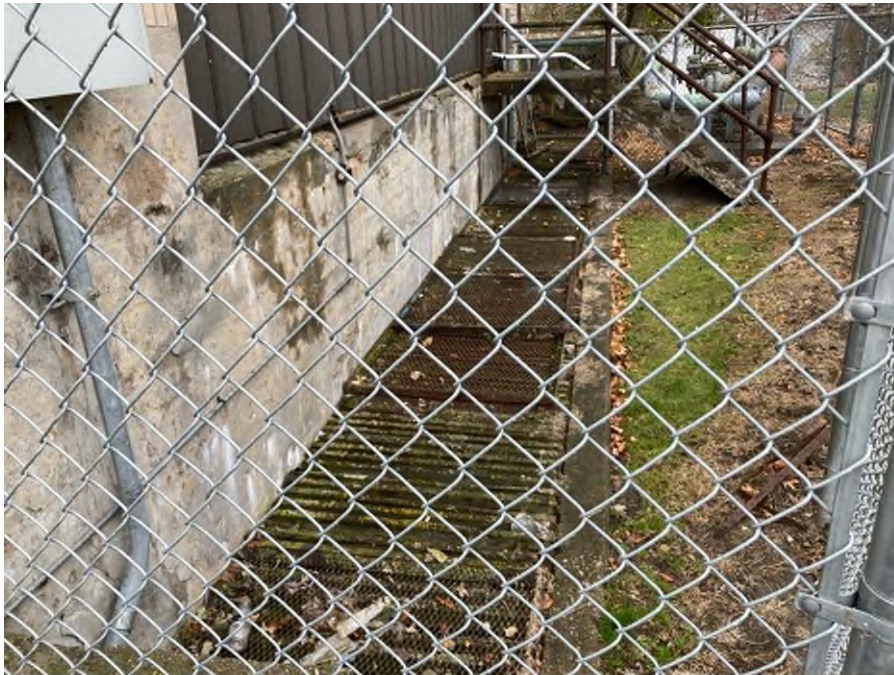
Photo #13: Auxiliary Spillway Left Chute.

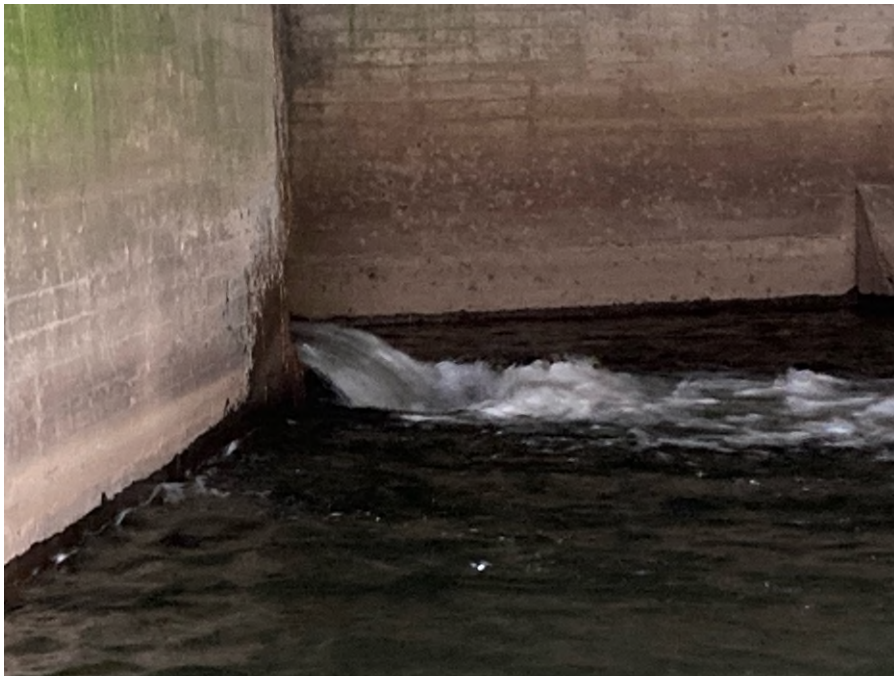
Photo #14: Auxiliary Spillway Right Chute Outlet.

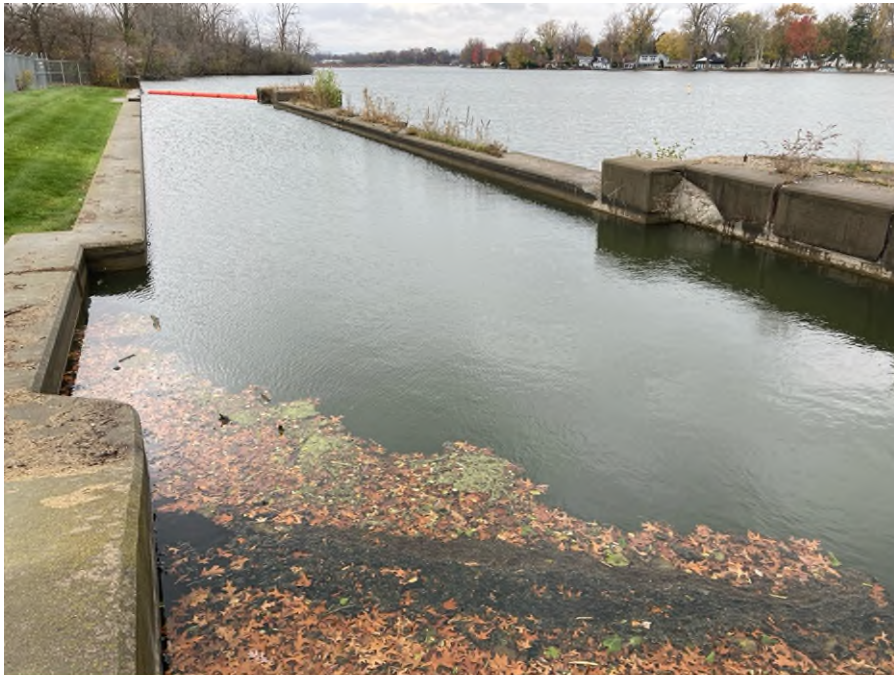
Photo #15: Fish Ladder Upstream.

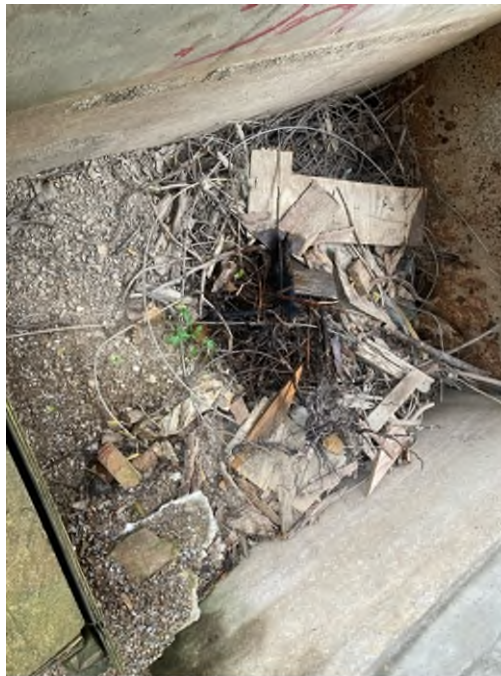
Photo #16: Fish Ladder Abandoned Conduit.
Issue: Depression, Action: Maintenance.

- a Principal Spillway: Abutment - Right Wall
 - b Principal Spillway: Bridge
- 3 **Depression (Action: Maintenance):** Reshape and stabilize area affected by depression. Remove vegetation and unsuitable fill material. Regrade the area to the original grade with material that matches the adjacent material. Install surface protection that matches the adjacent surface protection. After the depressions are filled the area should be monitored for another depression. If another depression is observed the Dam Safety Unit should be notified. Complete action by December 31, 2024.

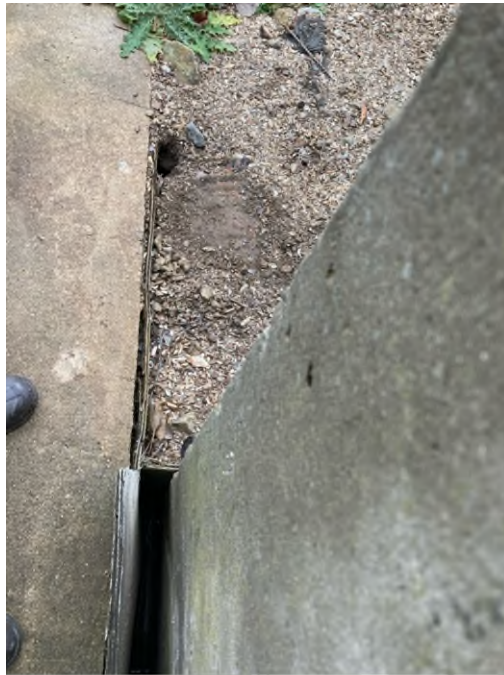
Photo #17: Fish Ladder Abandoned Conduit.
Issue: Sink Hole, Action: Maintenance.

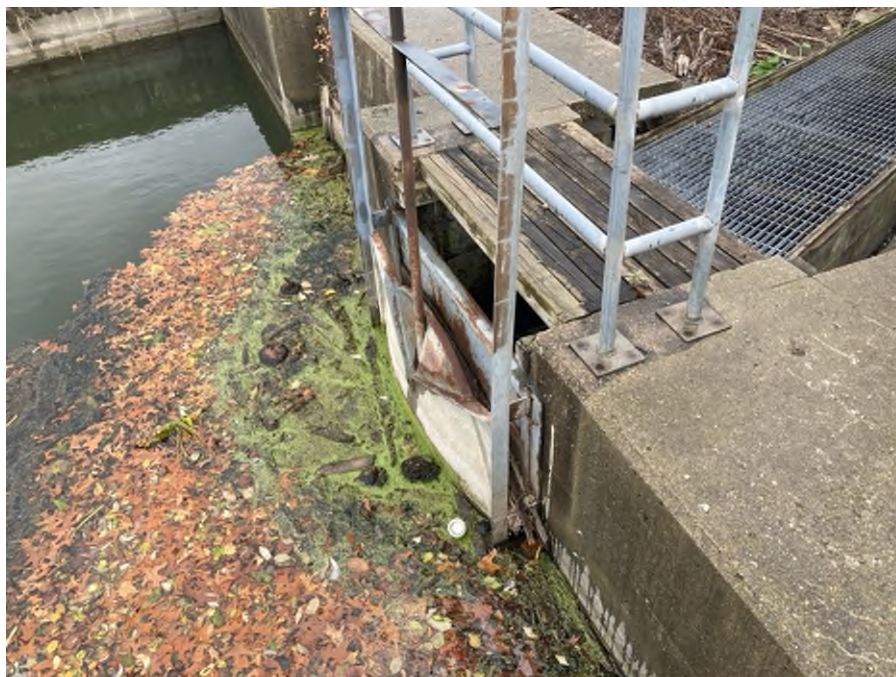
Photo #18: Fish Ladder Inlet Gate.

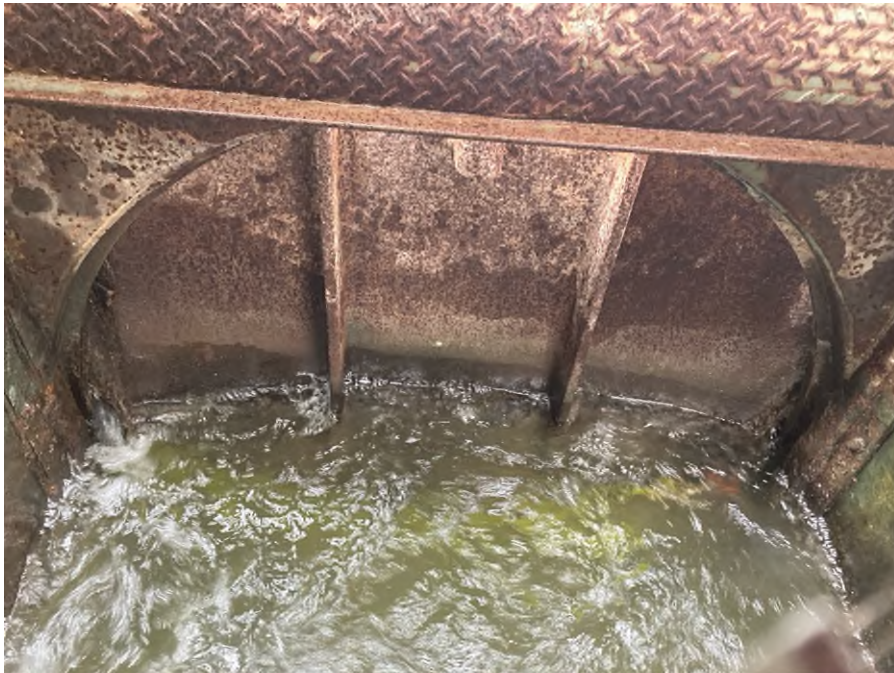
Photo #19: Fish Ladder Inlet Gate.

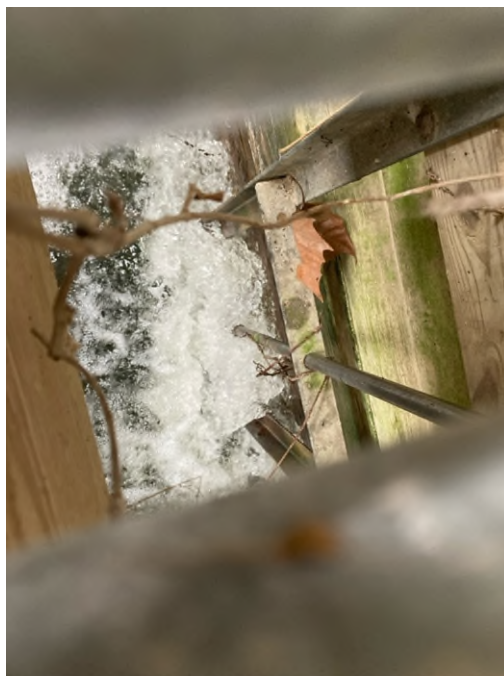
Photo #20: Fish Ladder Outlet 1 Gate.

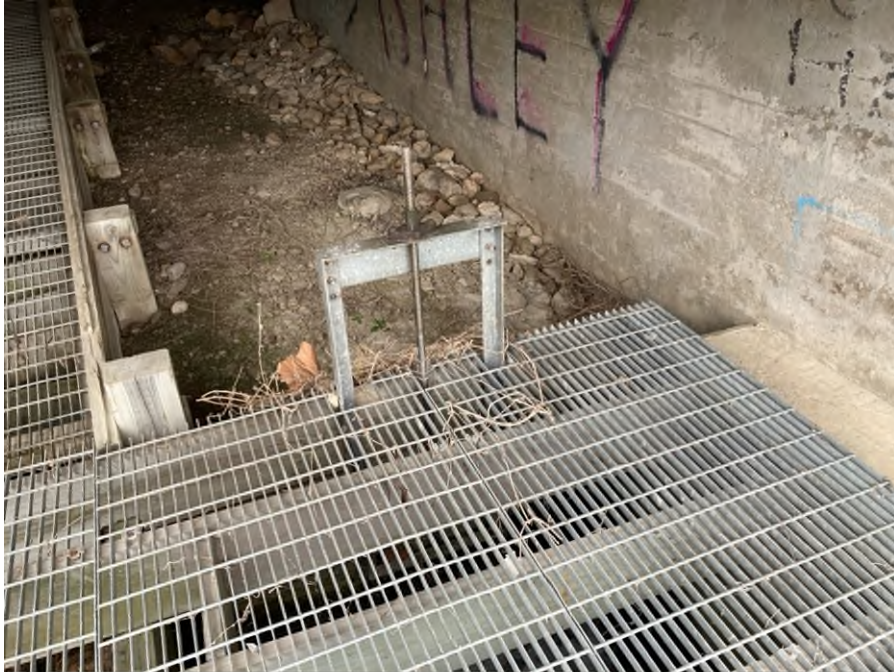
Photo #21: Fish Ladder Outlet 1 Gate.

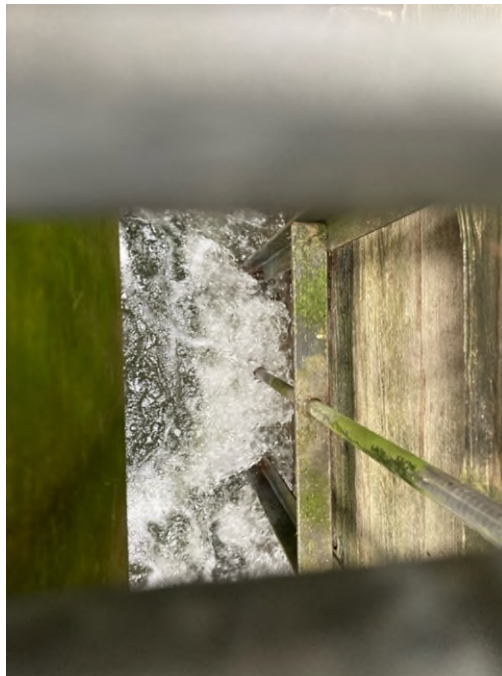
Photo #22: Fish Ladder Outlet 2 Gate.

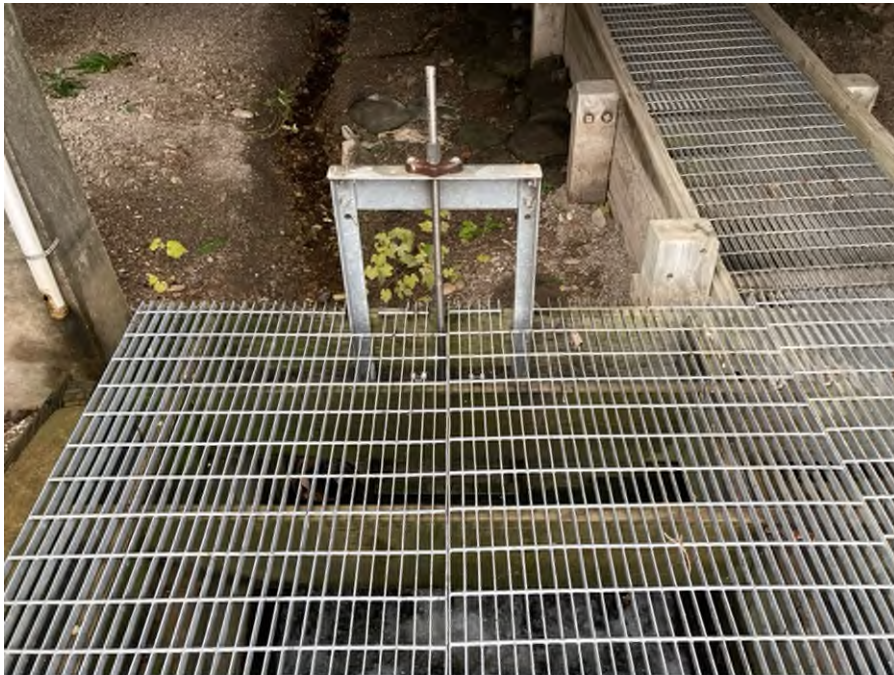
Photo #23: Fish Ladder Outlet 2 Gate.

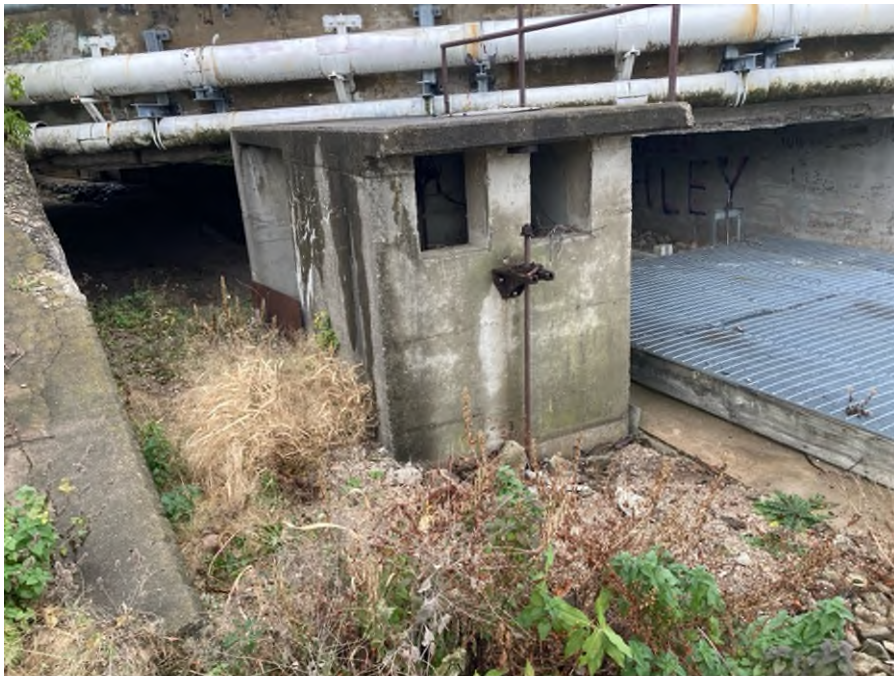
Photo #24: Fish Ladder Abandoned Gate.

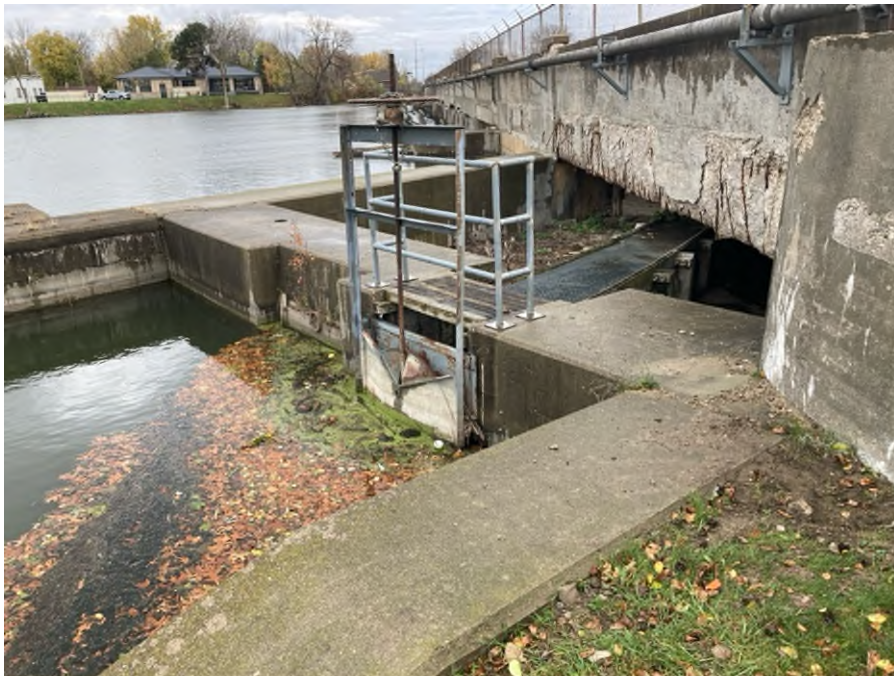
Photo #26: Fish Ladder Chute Inlet.

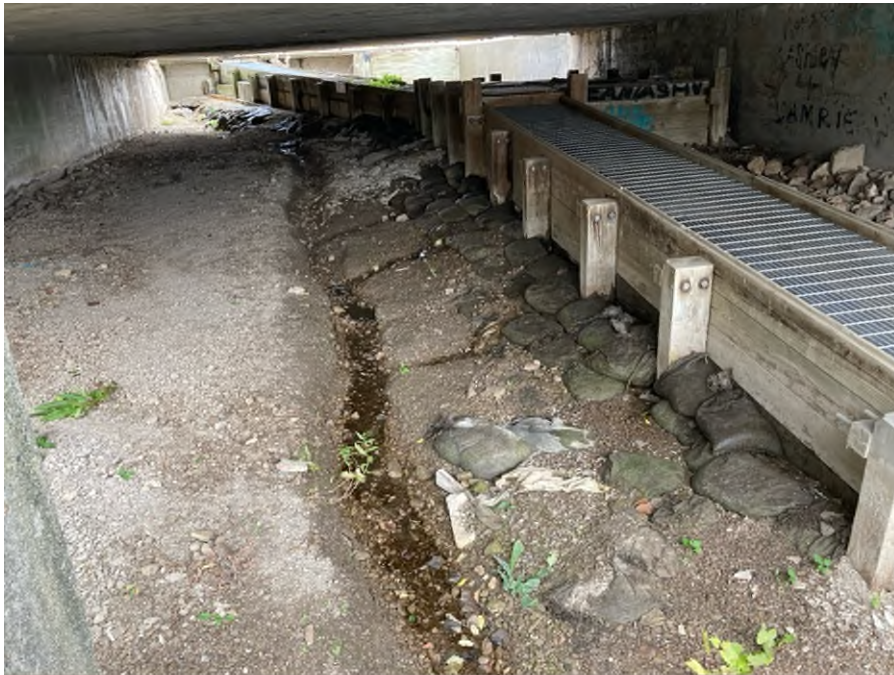
Photo #27: Fish Ladder Chute.
Issue: Seepage, Action: Monitor.
Type: Flow.

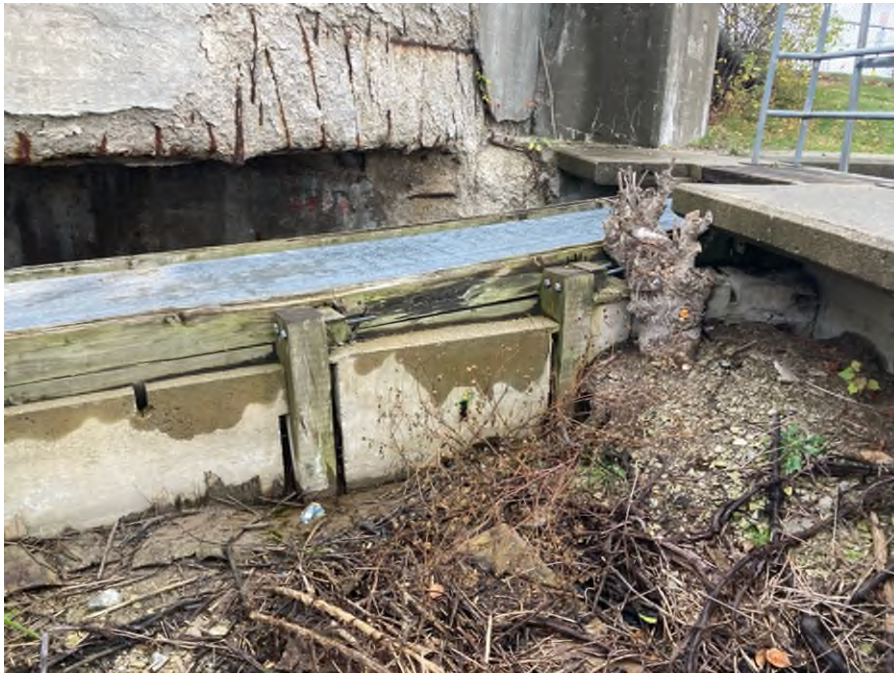
Photo #29: Fish Ladder Chute.

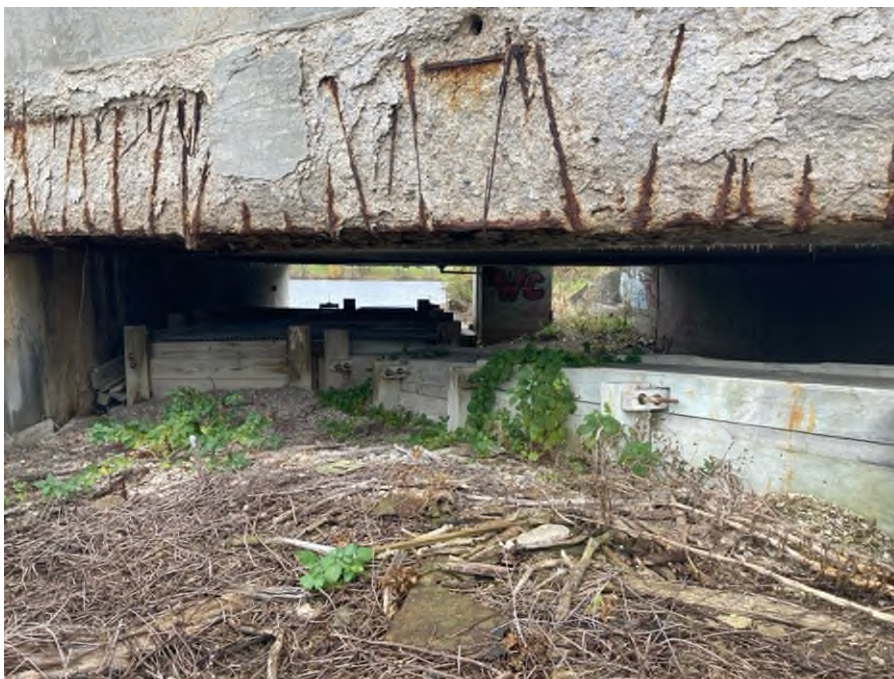
Photo #30: Fish Ladder Chute.

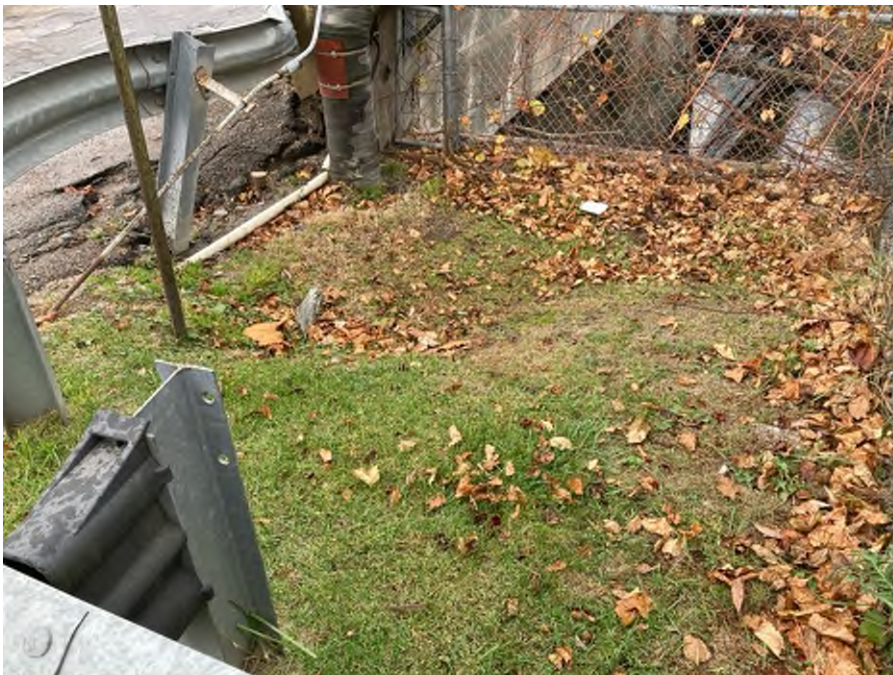
Photo #32: Embankment Upstream Slope.
Issue: Depression, Action: Maintenance.

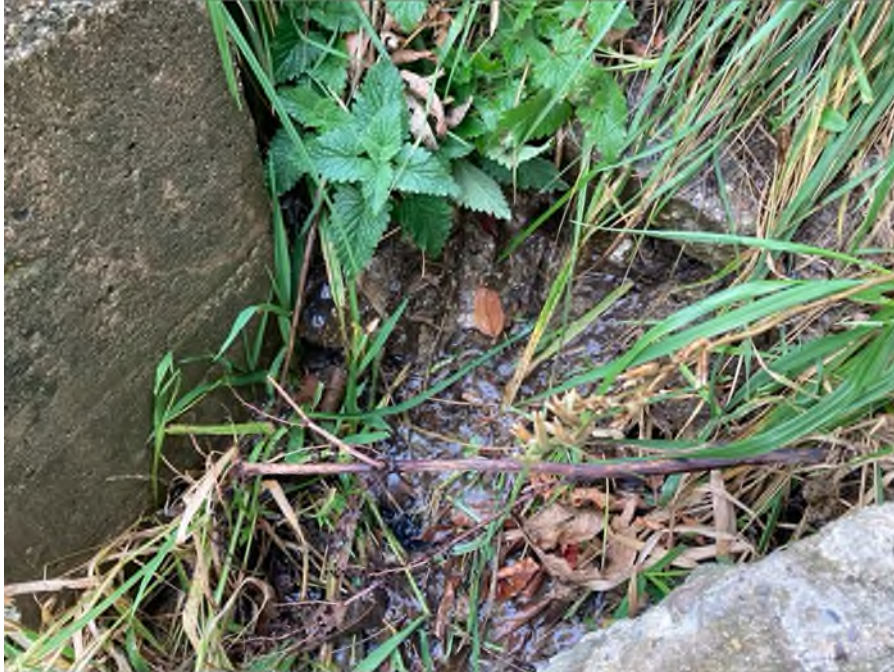
Photo #33: Embankment Downstream Slope. Might be from storm sewer.
Issue: Seepage, Action: Monitor.
Type: Flow.

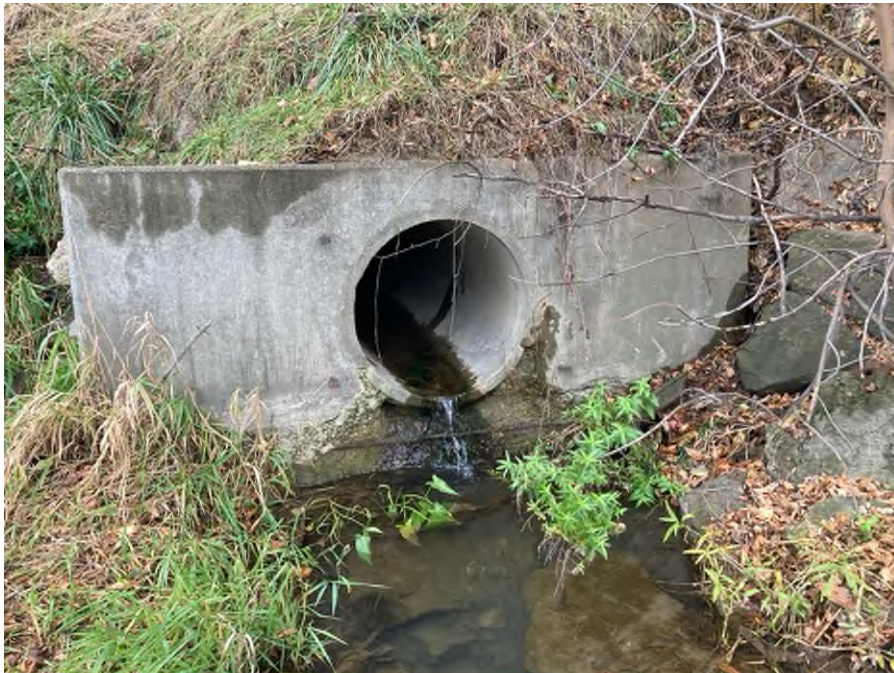
Photo #35: Embankment Downstream Slope. Drainage pipe for roads.

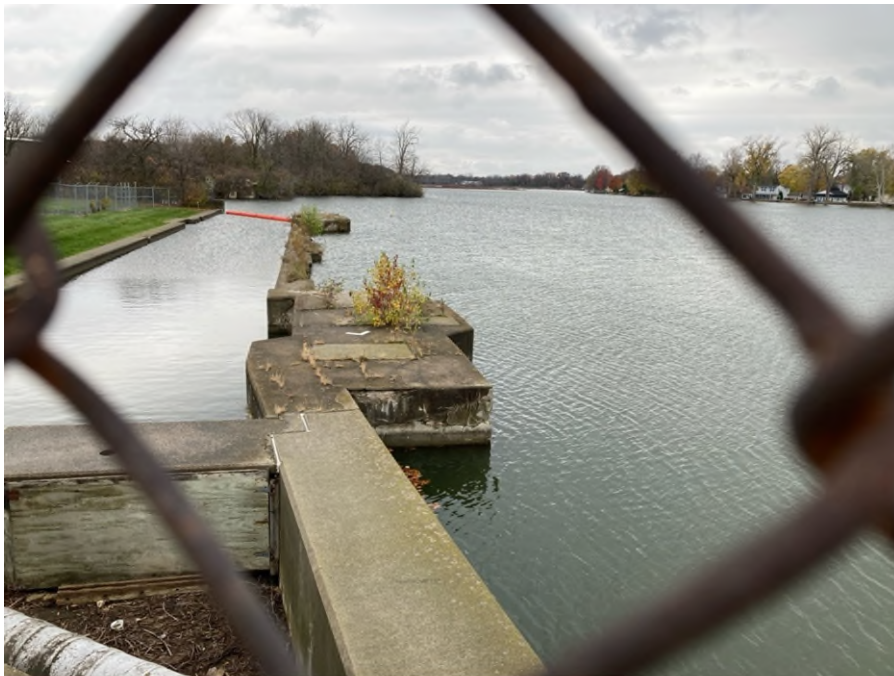
Photo #36: Impoundment.

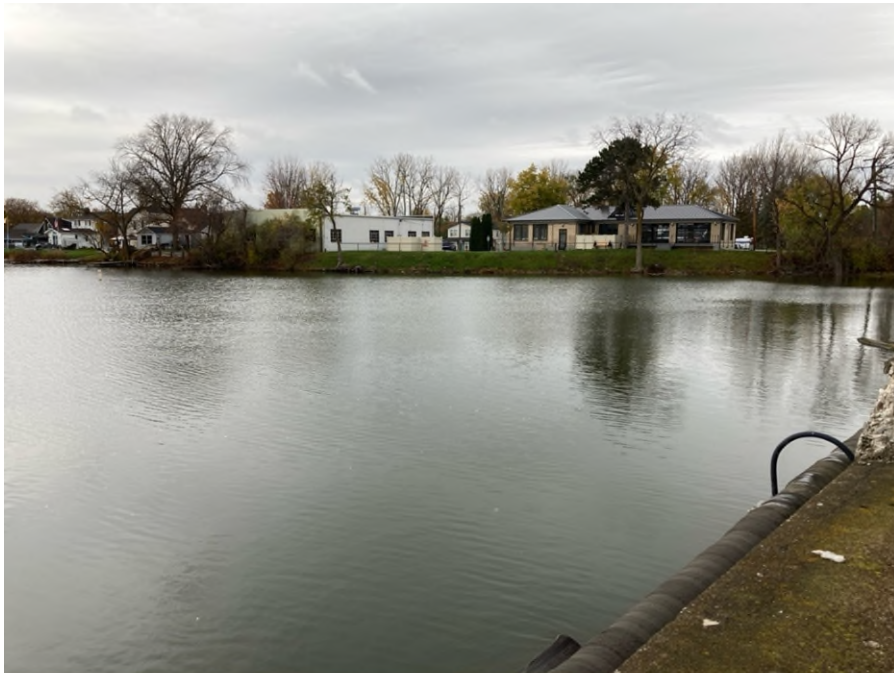
Photo #37: Impoundment.

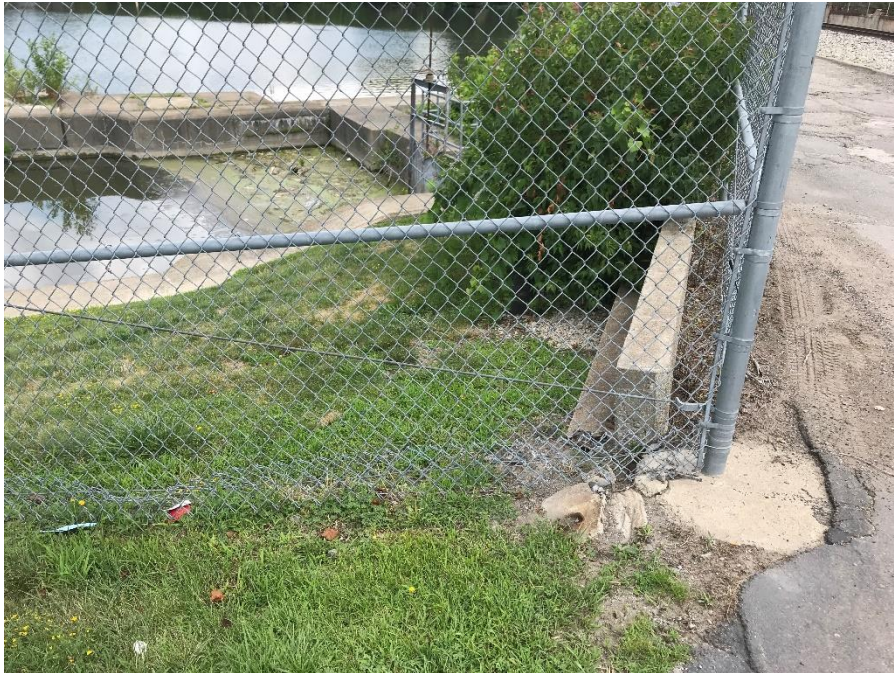
The dam's earthen abutments, shown in Photographs 1 through 6, are in fair condition. No sloughs, slumps, differential settlement, cracking, or major erosion was observed. However, both abutments have small trees and brush growing near the spillway structure walls, as shown in Photographs 1, 3, and 4. Trees and brush can provide shortened seepage pathways along their root systems that can lead to internal erosion (piping) of abutment fill material, cause large section loss in the event of a blow down, provide a haven for burrowing animals, and obscure underlying deficiencies. Therefore, all trees and brush should be removed from the earthen abutments. This recommendation has been repeated since the 2011 inspection report and should be completed as soon as reasonably possible. After clearing, both abutments should be mowed a minimum of two times per year to prevent further establishment of woody vegetation and to facilitate visual inspection.

**Photograph 1 – Upstream face of right abutment viewed from right
Note the brush growth**

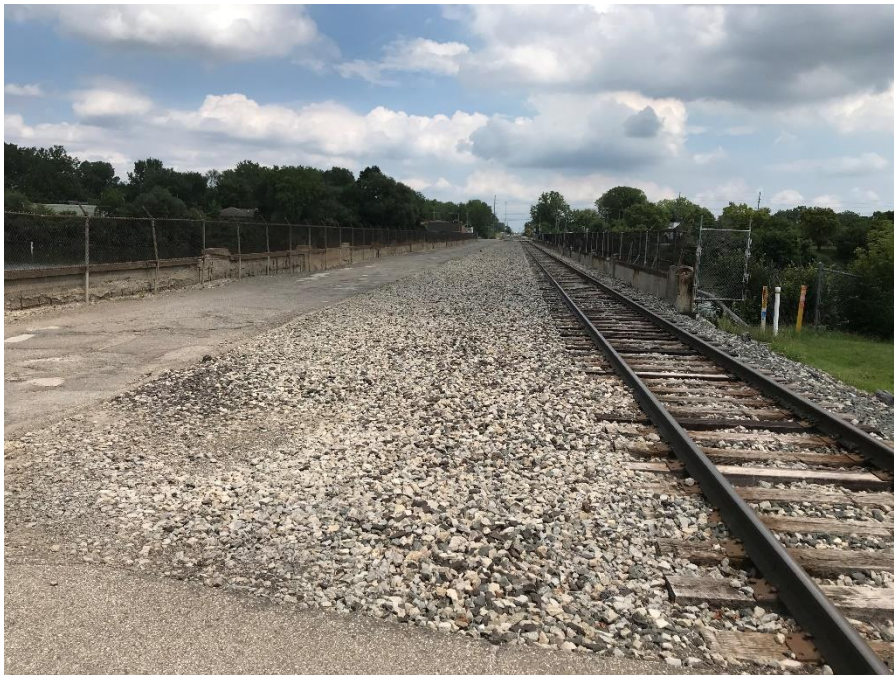
Photograph 2 – Abutment crest viewed from right

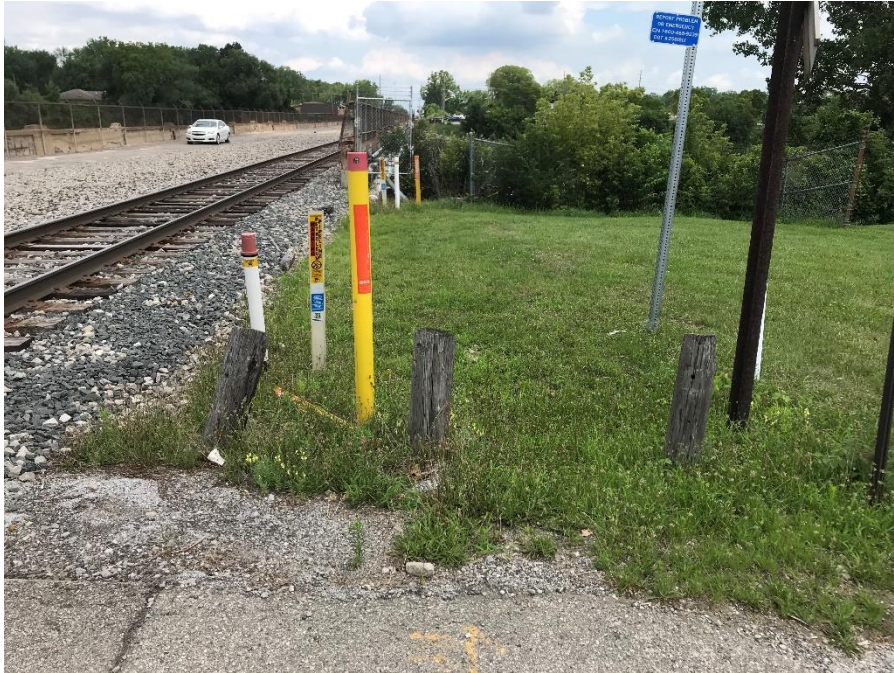
**Photograph 3 – Downstream face of right abutment viewed from right
Note the trees and brush**

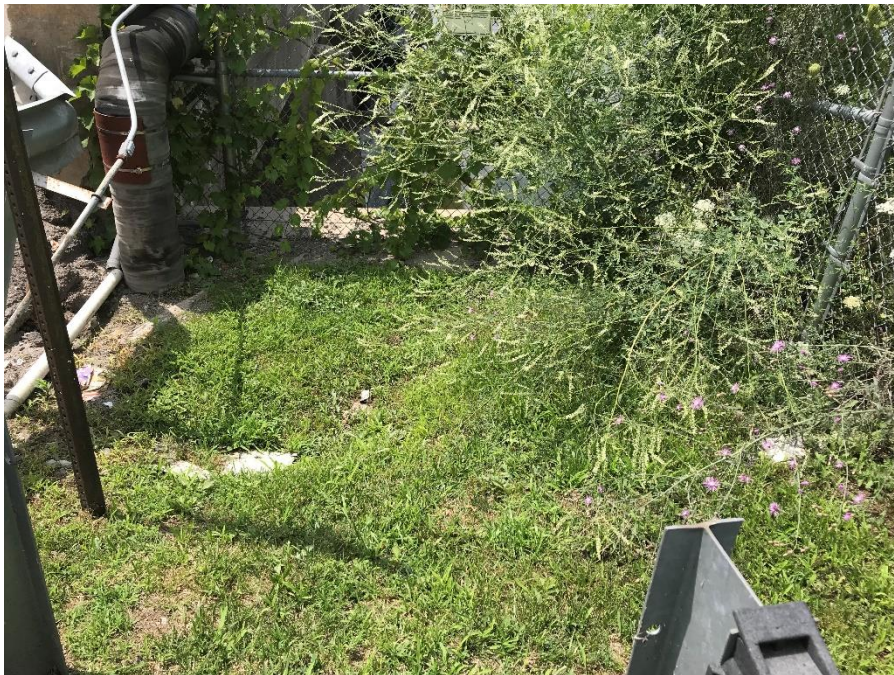
**Photograph 4 – Upstream face of left abutment viewed from left
Note the tall weeds and brush**

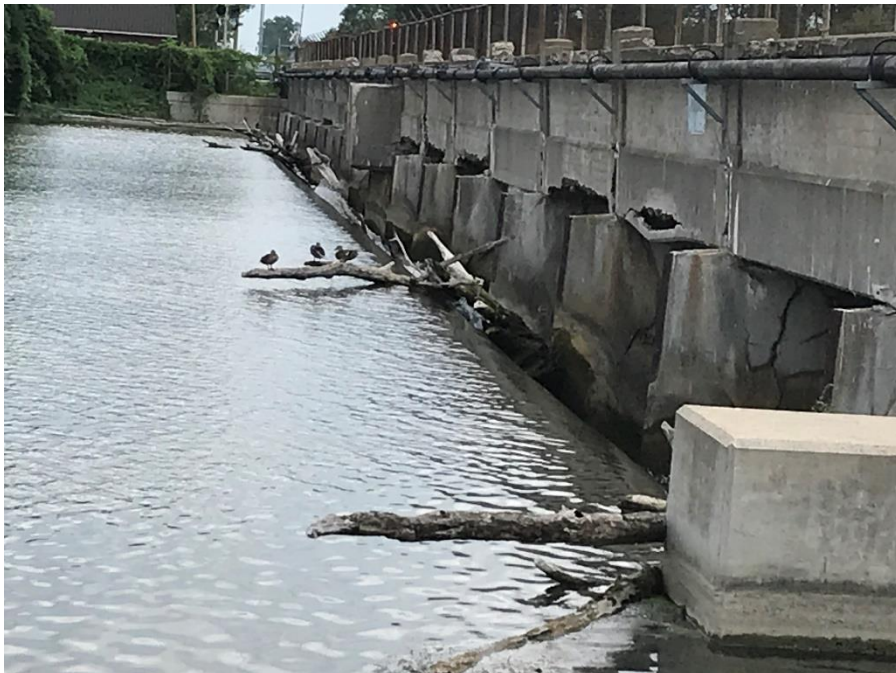
**Photograph 8 – Spillway crest viewed from right
Note the minor debris build up and delamination of bridge beams**

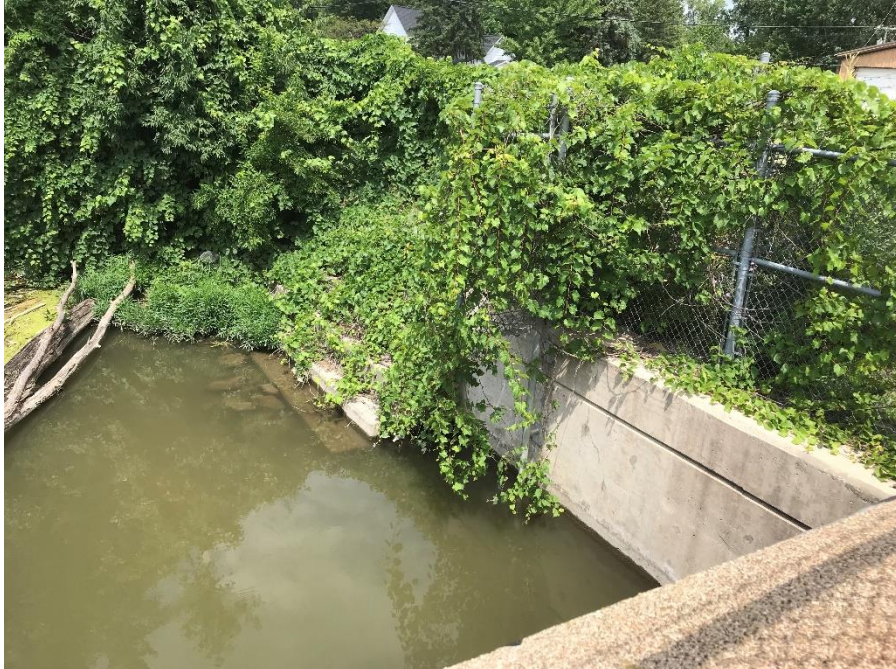
**Photograph 10 – Left upstream abutment wall
Note the overgrowth of vegetation**

3. Remove all vegetation from the left wall of the abandoned lock system. This recommendation is repeated from the 2014 inspection report and should be completed as soon as reasonably possible.

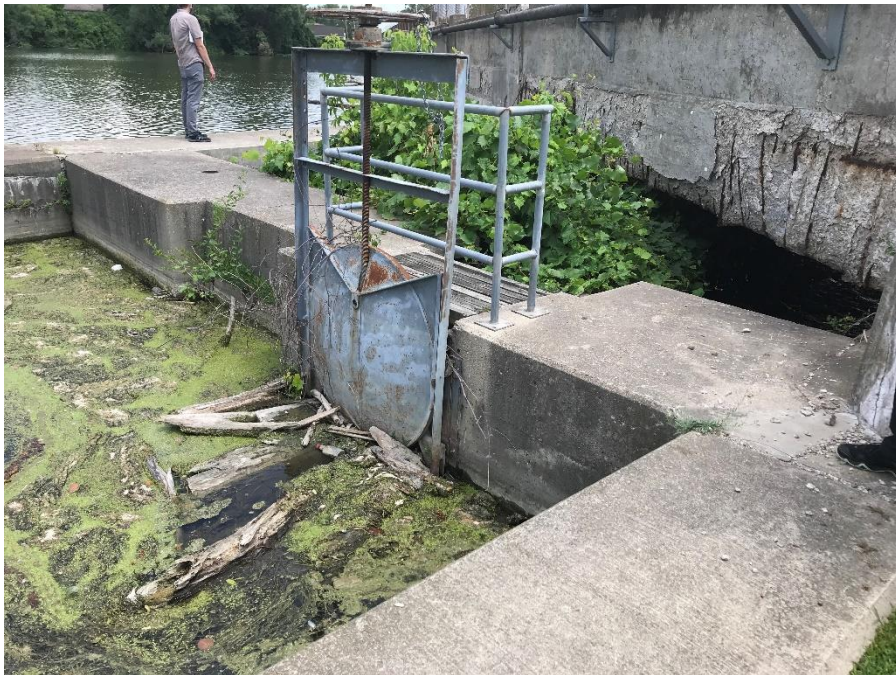
**Photograph 18 – Right lock gate and operator
Note that this gate acts as the inlet to the DNR fish ladder**

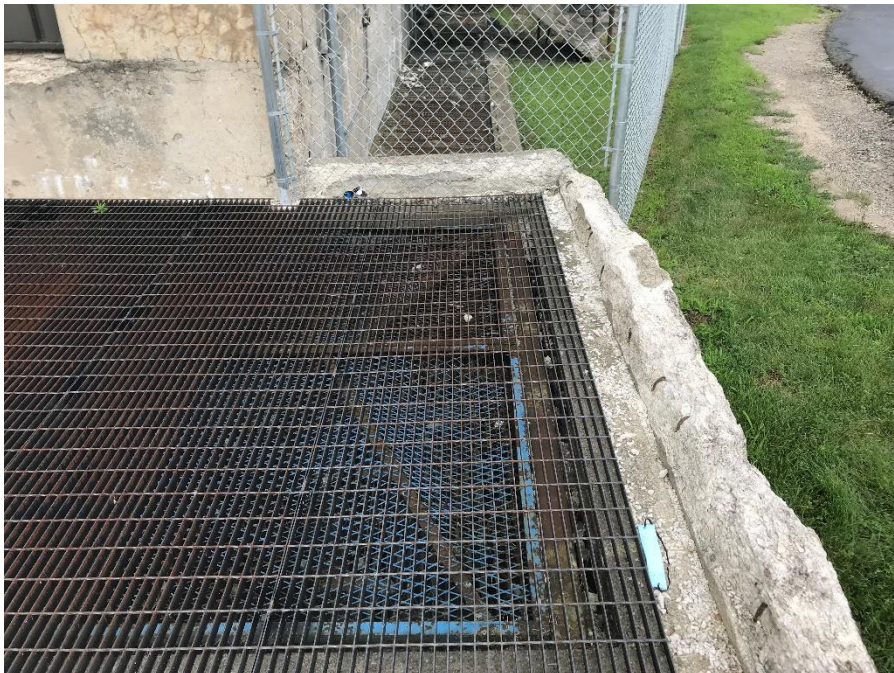
**Photograph 24 – Bypass channel at left of powerhouse
Note that there was flow through this channel during this inspection**

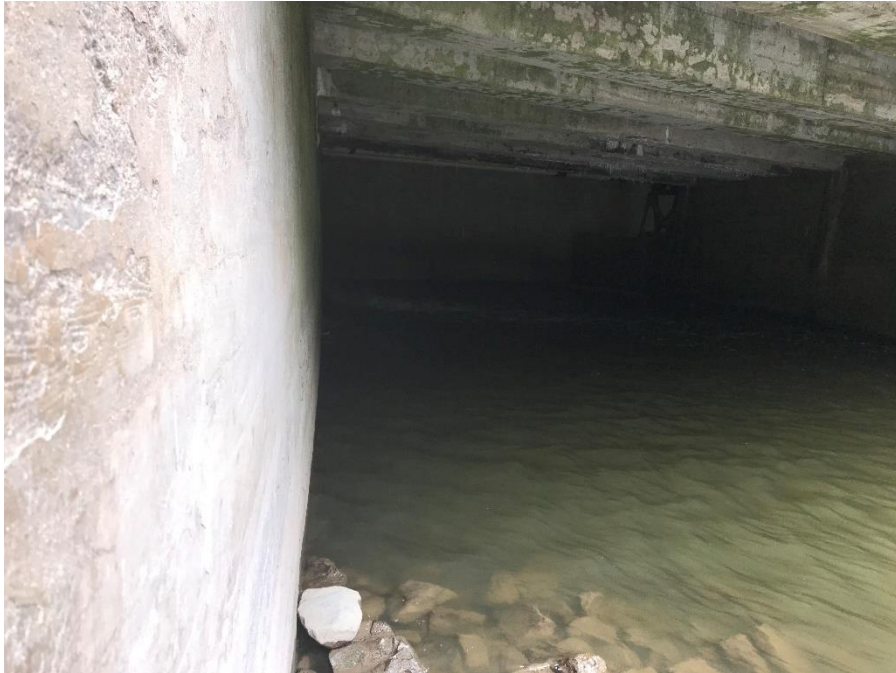
**Photograph 25 – Powerhouse outlet viewed from downstream
Note the flow from the right**

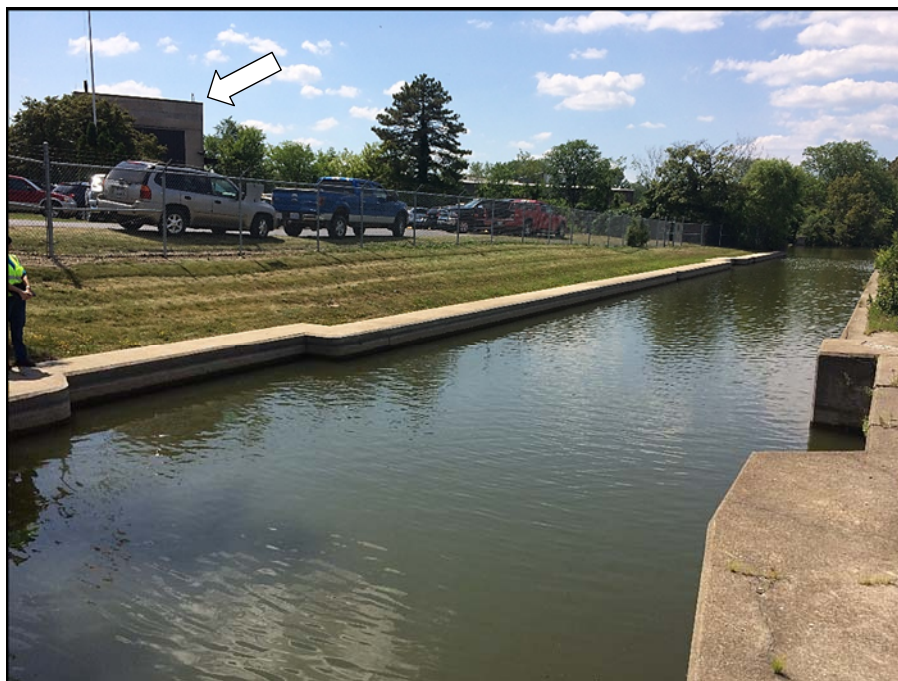
**Photograph 6 – Earthen needle section located between lock and powerhouse
Note the arrow indicating the location of the former powerhouse**

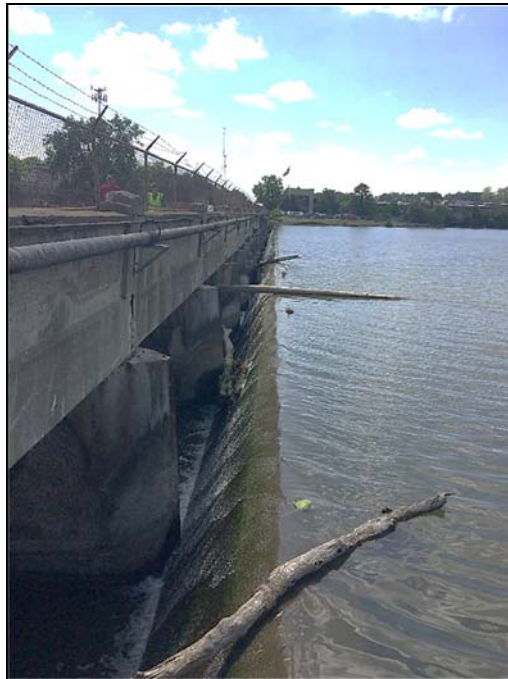
**Photograph 7 – Principal spillway crest viewed from left
Note the minor buildup of woody debris**

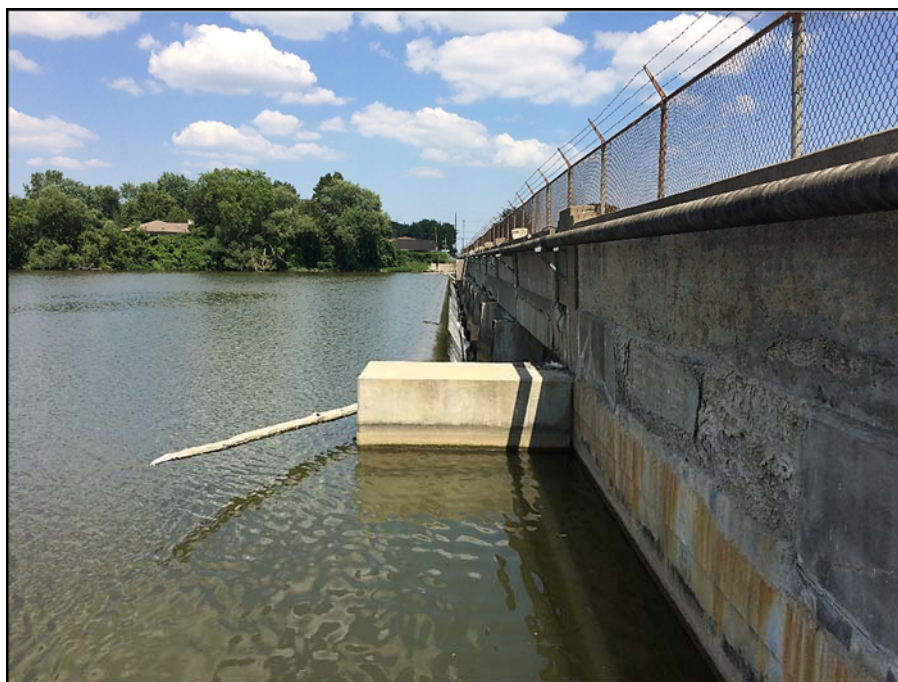
**Photograph 10 – Upstream right spillway abutment wall
Note that a portion of this wall was recently
reconstructed**

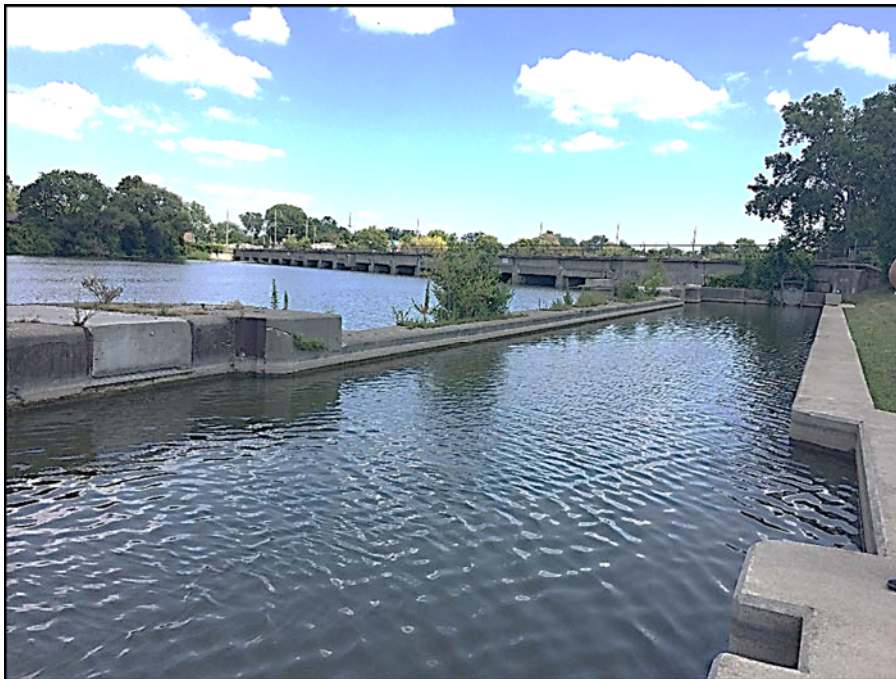
**Photograph 15 – Abandoned lock viewed from upstream
Note that the right wall was recently reconstructed**

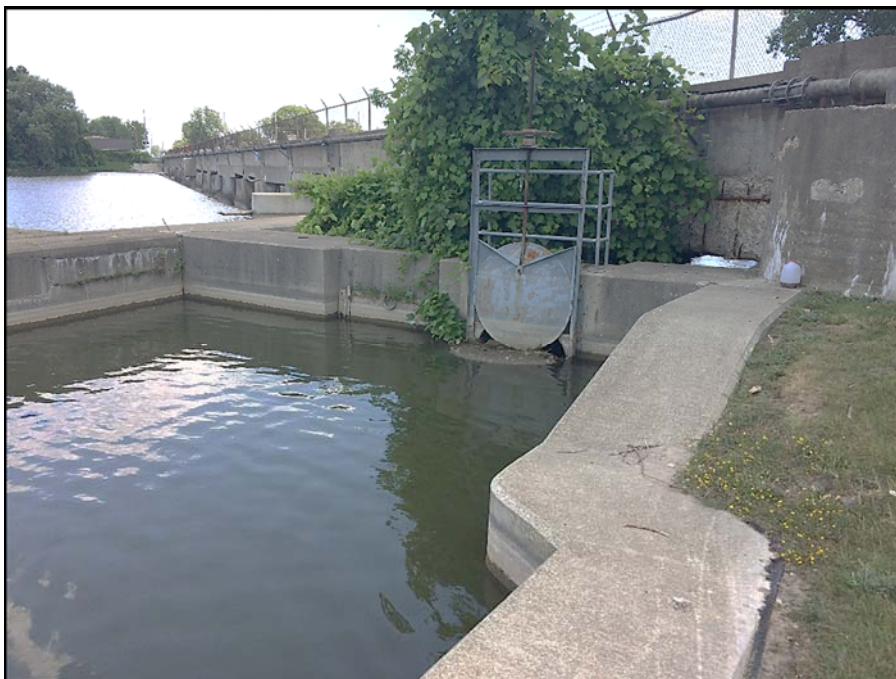
**Photograph 16 – Abandoned lock gates
Note that the right sluice gate feeds the
fish ladder**

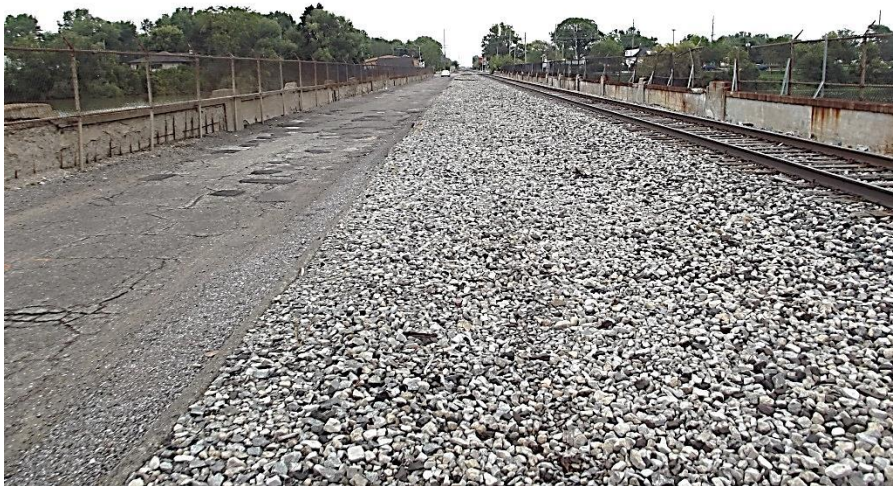
Photograph 2 – Embankment crest viewed from right.
