SUBJECT: Flat Rock Dam, Dam ID No. 556; Wayne County

**DAM SAFETY INSPECTION REPORT
FLAT ROCK DAM – DAM ID NO. 556
HURON RIVER
WAYNE COUNTY – SW 1/4 SECTION 31, T 04S, R 10E**

FLAT ROCK DAM
WAYNE COUNTY
DAM ID NO. 556
APPENDIX B – INSPECTION PHOTOS

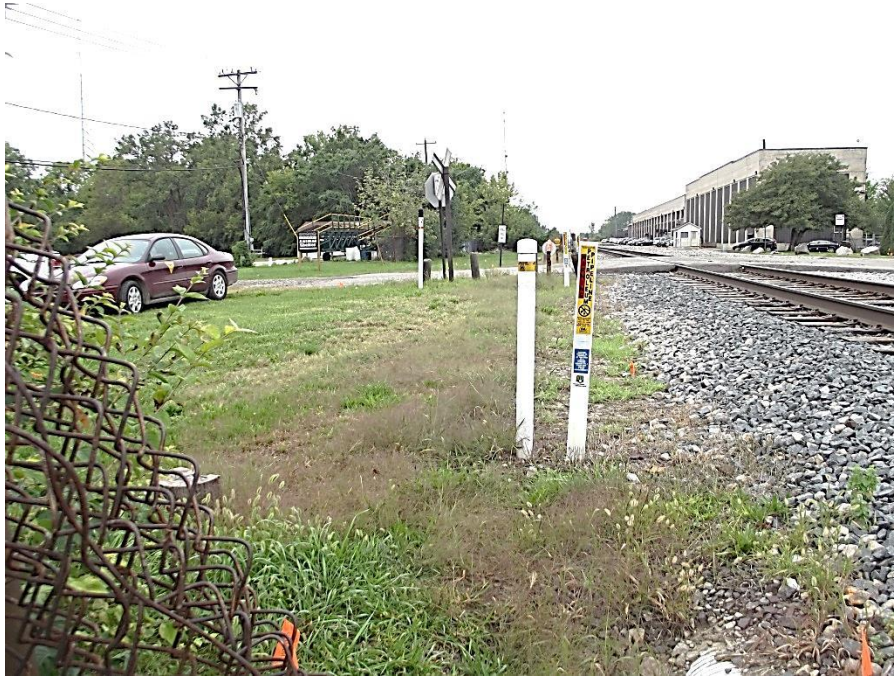
Photograph 3 – Downstream face of right embankment viewed from left.

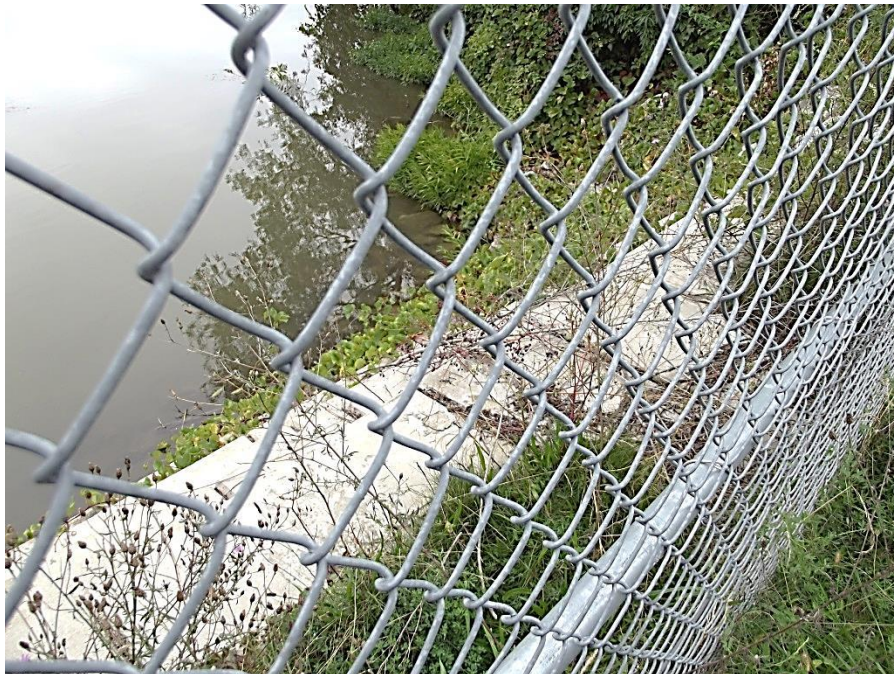
Photograph 4 – Upstream face of left embankment viewed from left.

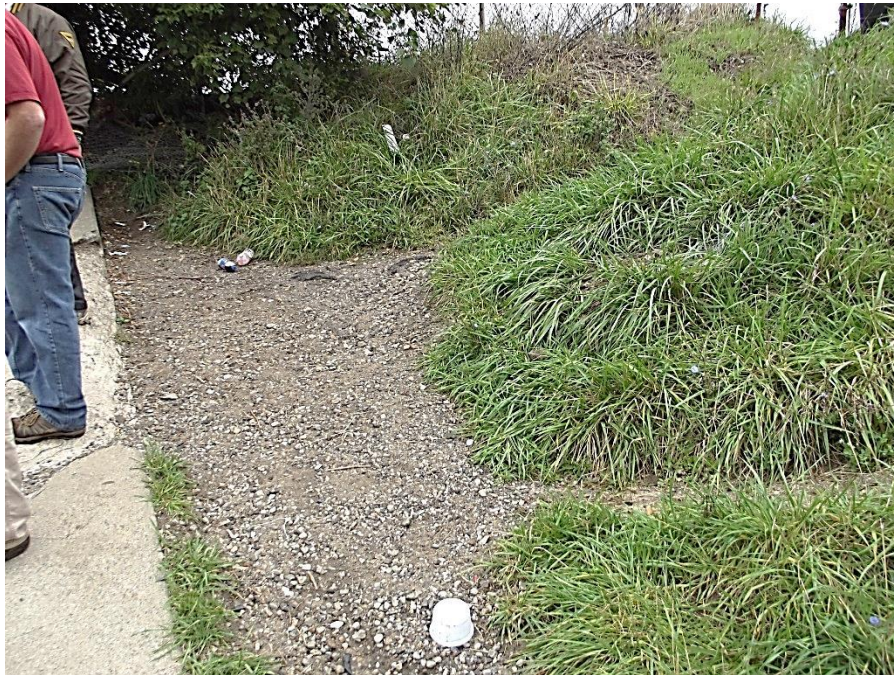
Additionally, some minor foot traffic erosion is present along the downstream face of the left embankment, as shown in Photograph 5. This condition does not currently pose a threat to the stability of the embankment, but was noted in the 2011 inspection report and should be backfilled, compacted, and seeded as soon as reasonably possible to prevent further erosion from developing.

**Photograph 5 – Downstream face of left embankment viewed from left.
Note the foot traffic erosion.**

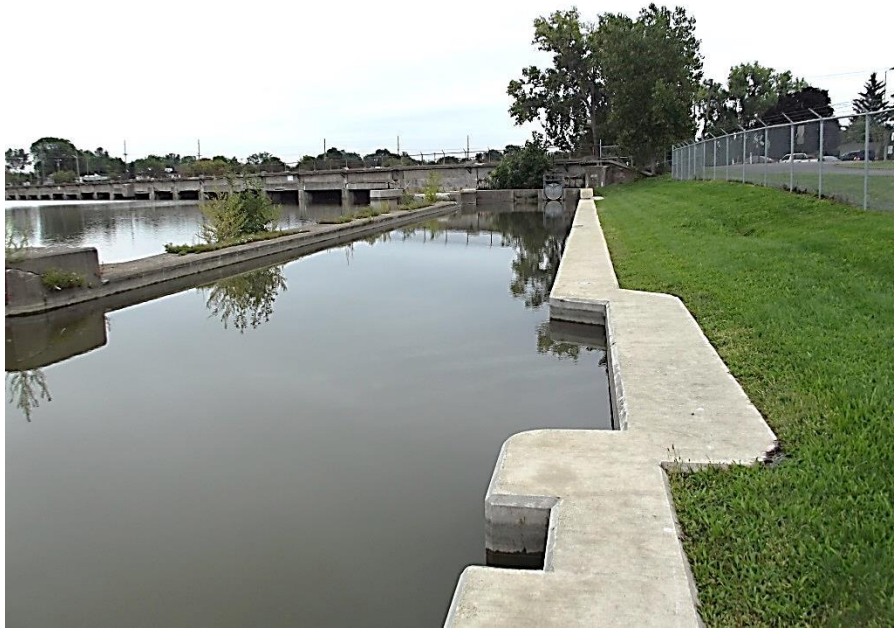
**Photograph 7 – Upstream right principal spillway abutment wall
viewed from upstream.**

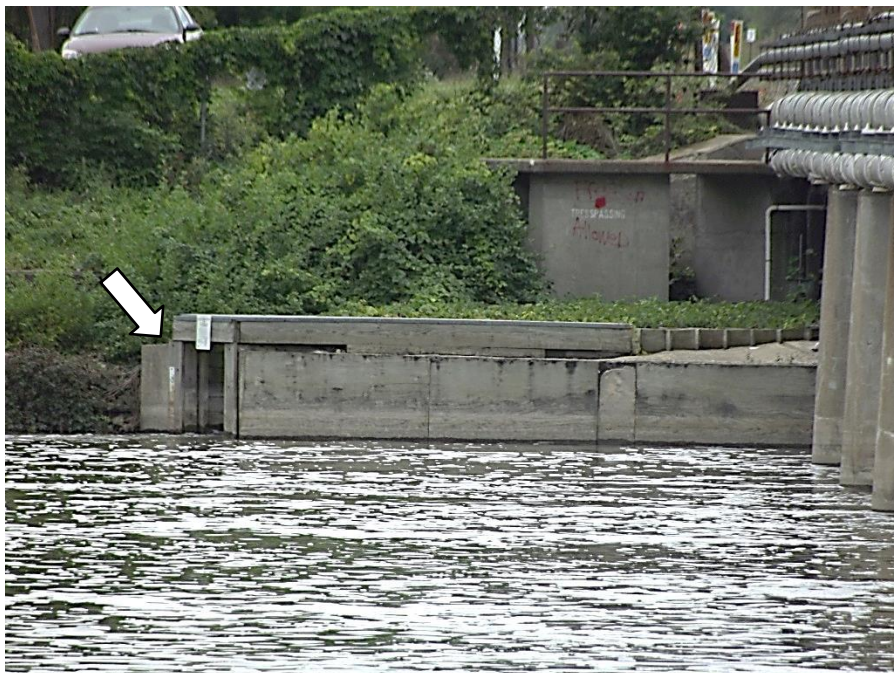
**Photograph 8 – Downstream right principal spillway abutment wall.
Note the outlet of the fish ladder.**

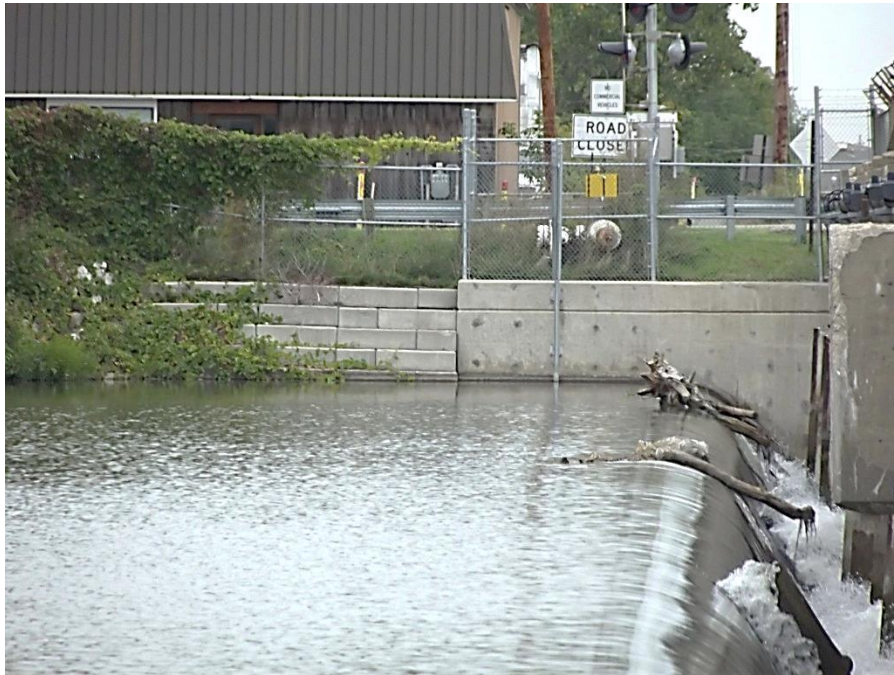
Photograph 9 – Upstream left principal spillway abutment wall viewed from right.

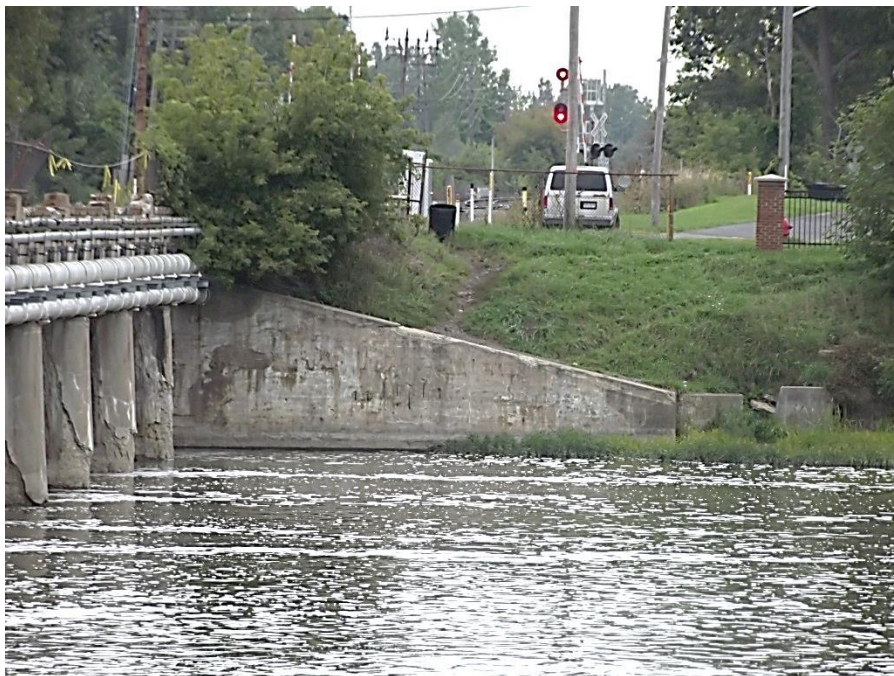
**Photograph 10 – Downstream left principal spillway abutment wall
viewed from right.**

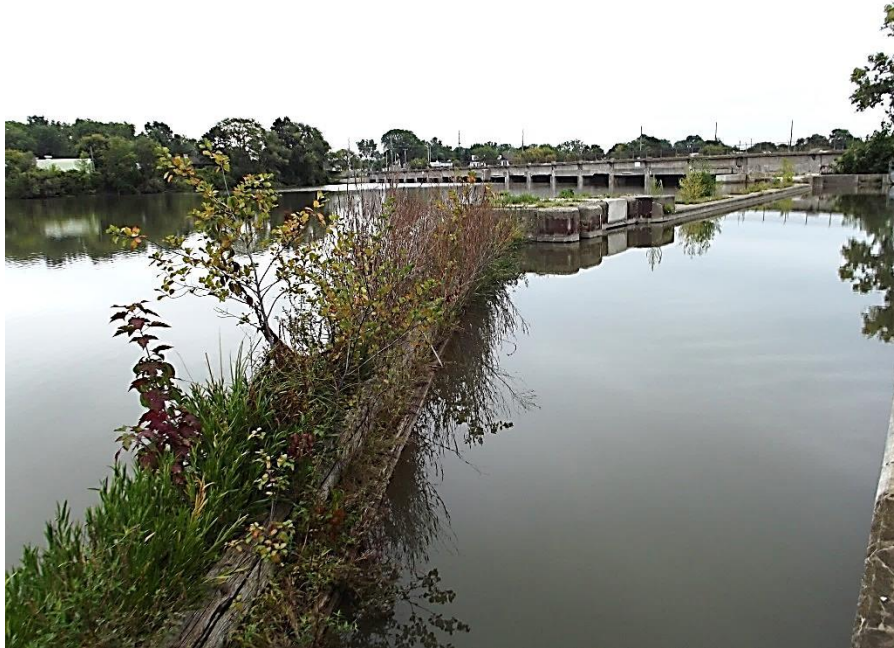
Photographs 11 through 14 show the abandoned lock system which exists immediately right of the principal overflow spillway. This structure is in fair overall condition. The right channel wall of the lock system serves as the right abutment of the principal spillway structure. This wall was repaired in 2007, under the authority of DEQ Permit No. 07-82-0168-P, and remains in excellent condition. The left channel wall was not repaired in 2007, and is in considerably worse condition. Moderate spalling and cracking are evident along the entire length of the left wall. Additionally, vegetation was observed to be growing from cracks in the concrete wall as well as from the log boom system at the inlet of the lock channel. This condition, shown in photographs 11 through 13, does not currently impact the stability of the structure; however if left uncorrected will accelerate the deterioration of the concrete and boom logs. Therefore, all vegetation should be removed from the left lock wall and log boom by October 1, 2015.

**Photograph 11 – Inlet to abandoned lock system viewed from upstream.
Note the overgrowth of vegetation at the log boom.**

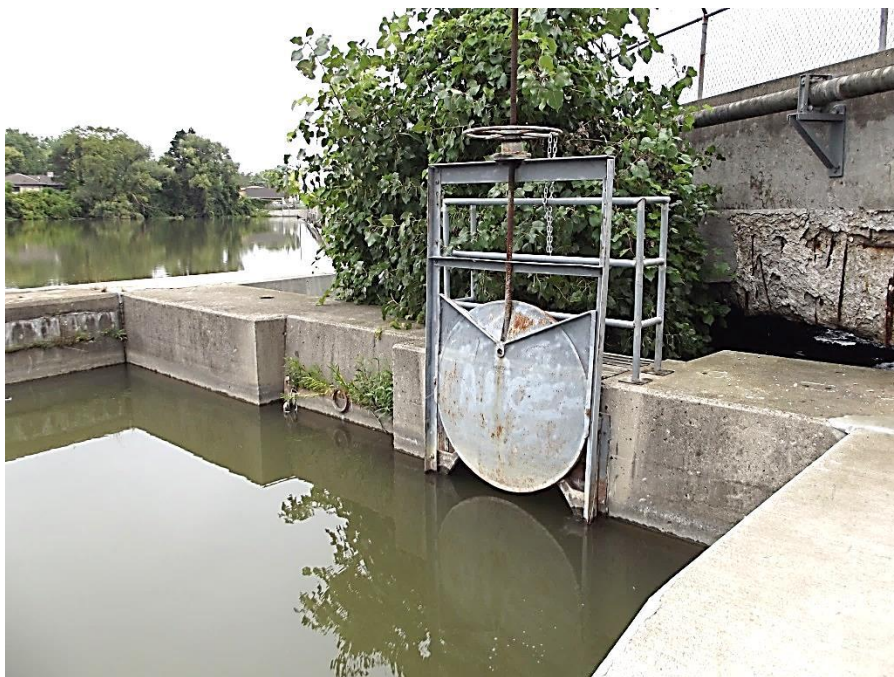
**Photograph 14 – Gate system for abandoned locks.
Note the raised gate now provides water for a downstream fish ladder.**

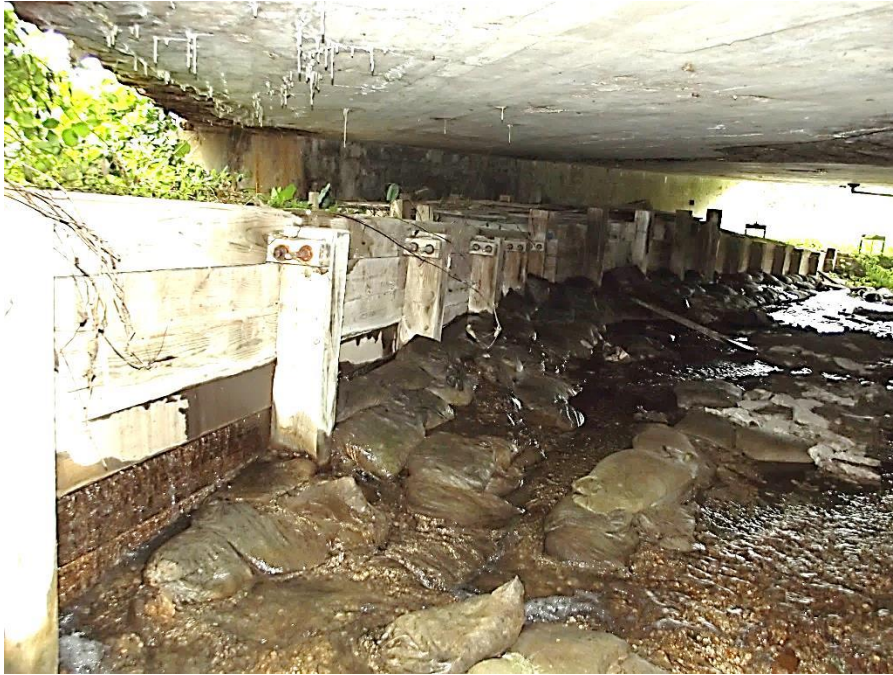
Photograph 15 – Fish ladder as it passes under bridge downstream of dam.

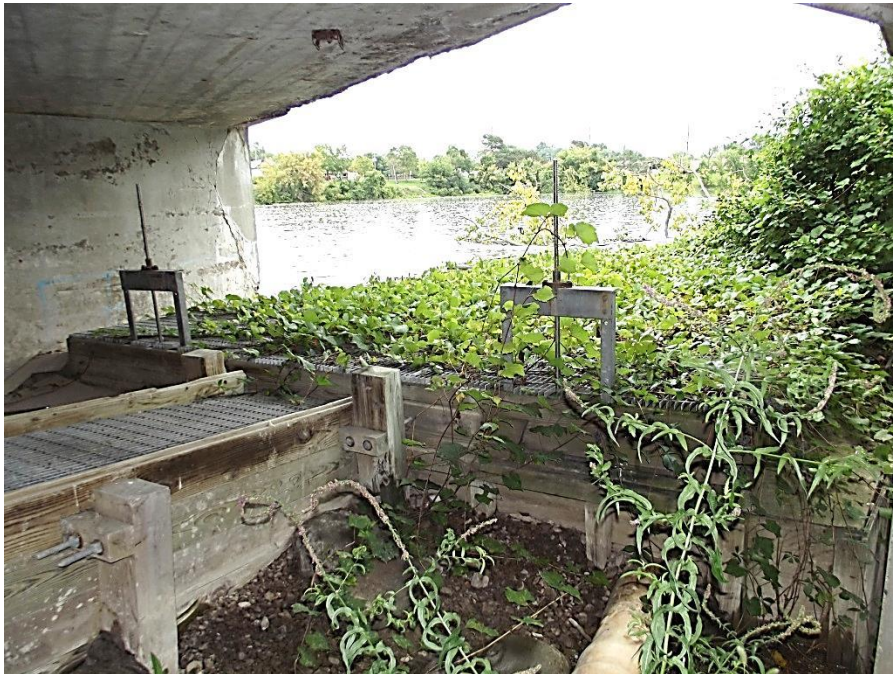
Photograph 16 – Fish ladder as it outlets downstream of the bridge.

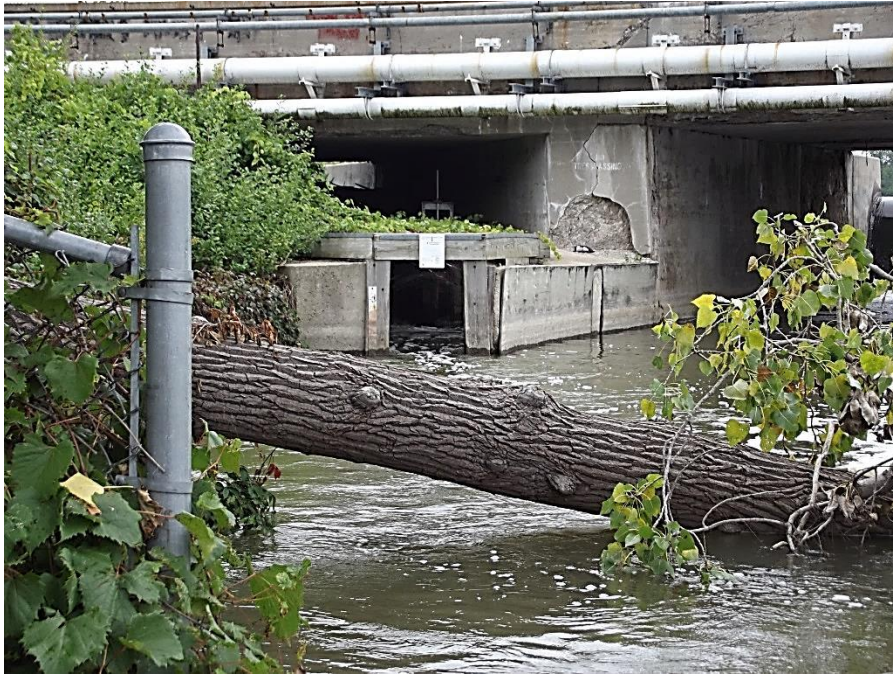
The fish ladder, shown in Photographs 15 through 17, is also in fair condition. No major deterioration was observed. However, leakage between the boards of the wooden structure continues to be an issue. This leakage is not currently causing concern for erosion adjacent to the structure, but as the boards deteriorate; leakage will increase, potentially causing erosion concerns. Therefore, the wooden fish ladder structure should be observed quarterly for significant deterioration and increased leakage. Repairs should be implemented as needed.

**Photograph 17 – Fish ladder outlet viewed from downstream.
Note the overgrowth of vegetation.**

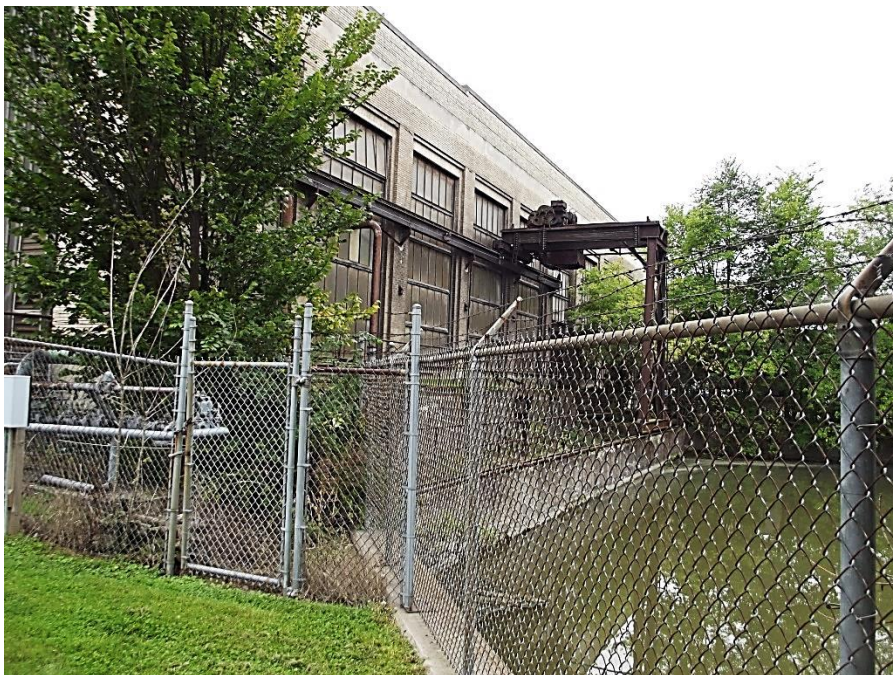
The former powerhouse, located approximately 250 feet right of the principal spillway, is owned by Flat Rock Metal, Incorporated and was not entered as part of this inspection. Photographs 18 and 19 were taken from the exterior of the structure and show significant deterioration of the concrete foundation. Additionally, flow was observed in the channel adjacent to the left wall of the powerhouse building, indicating open or deteriorated gates at the powerhouse inlet. To our knowledge, the powerhouse structure has not recently been inspected by a licensed professional engineer. As part of the regulated dam, an engineering inspection of the structure should be completed as soon as reasonably possible. The responsibility for completing this inspection lies with the owner of the structure, per [Section 324.31518](#) of Part 315.

Photograph 18 – Abandoned powerhouse (now Flat Rock Steel) viewed from left.

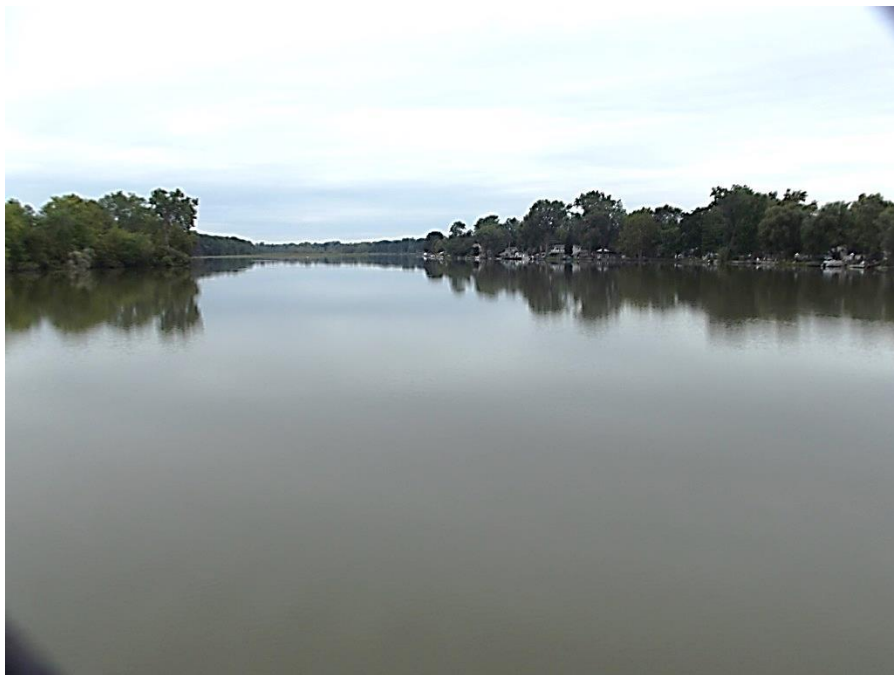
Photograph 20 – Impoundment viewed from downstream bridge.

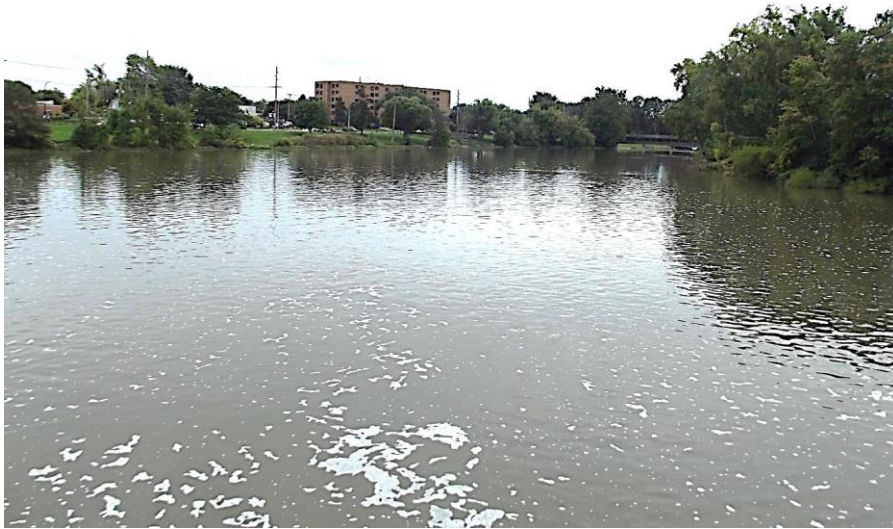
Photograph 21 – Downstream Huron River viewed from bridge.
